FINAL
APRIL 2022

2021 Land Use Controls Inspection Report

Naval Air Station Whidbey Island, Oak Harbor, Washington

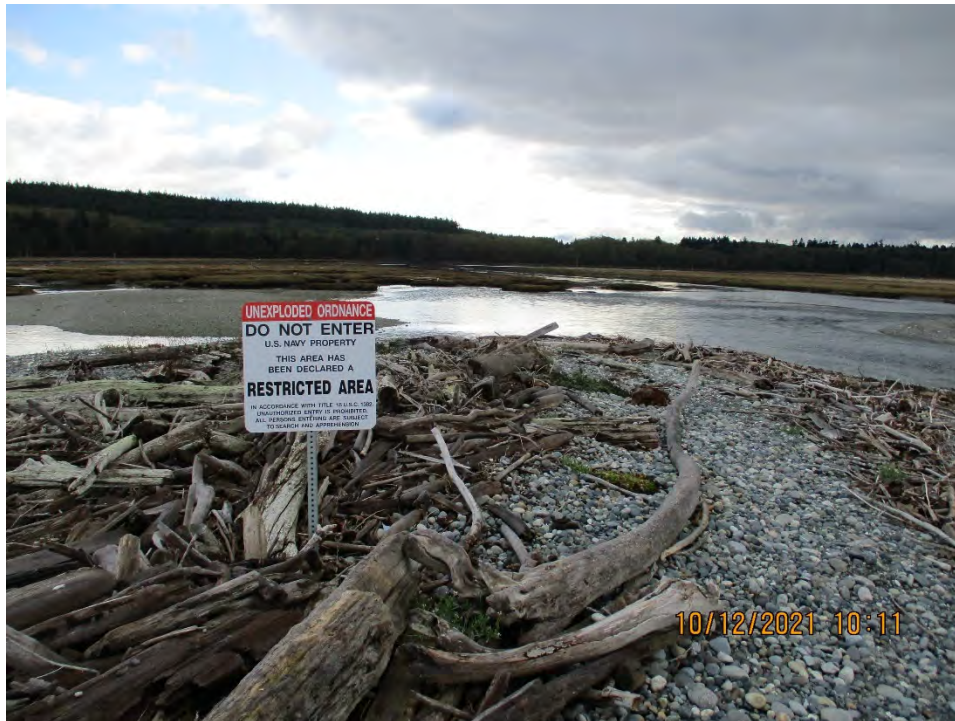
O19: New signage

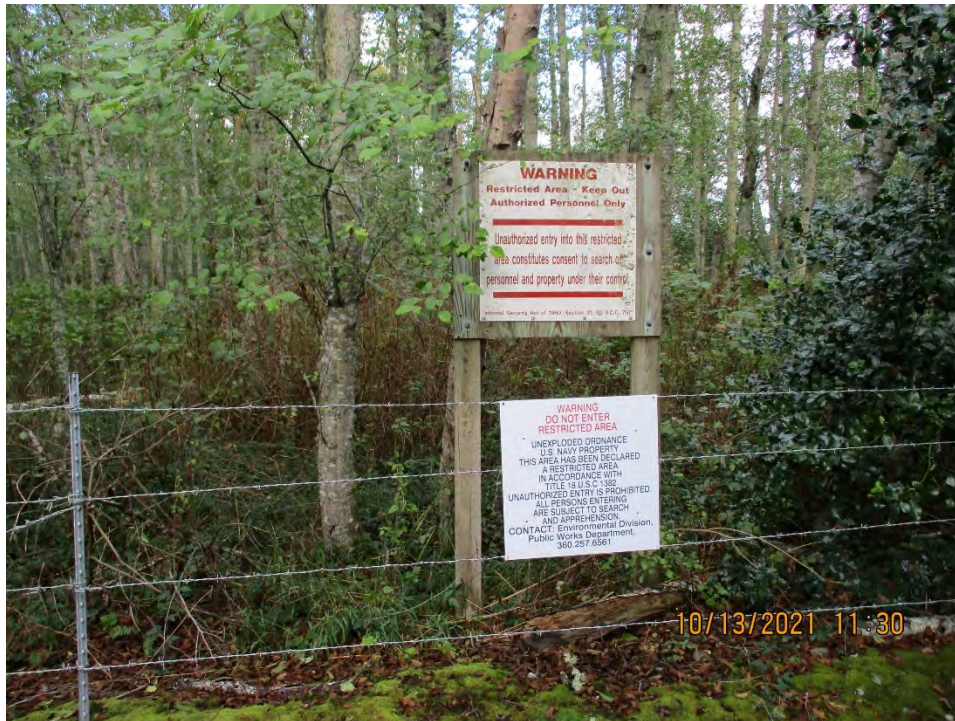
O23: Warning signage
along southern
boundary

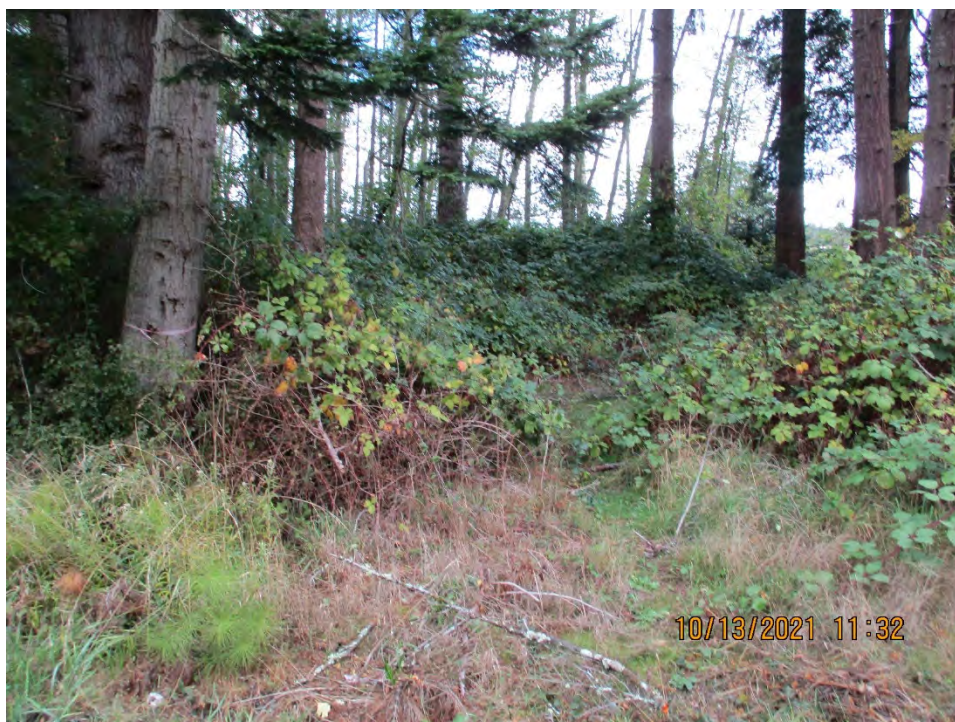
O24: Southeast corner
of site

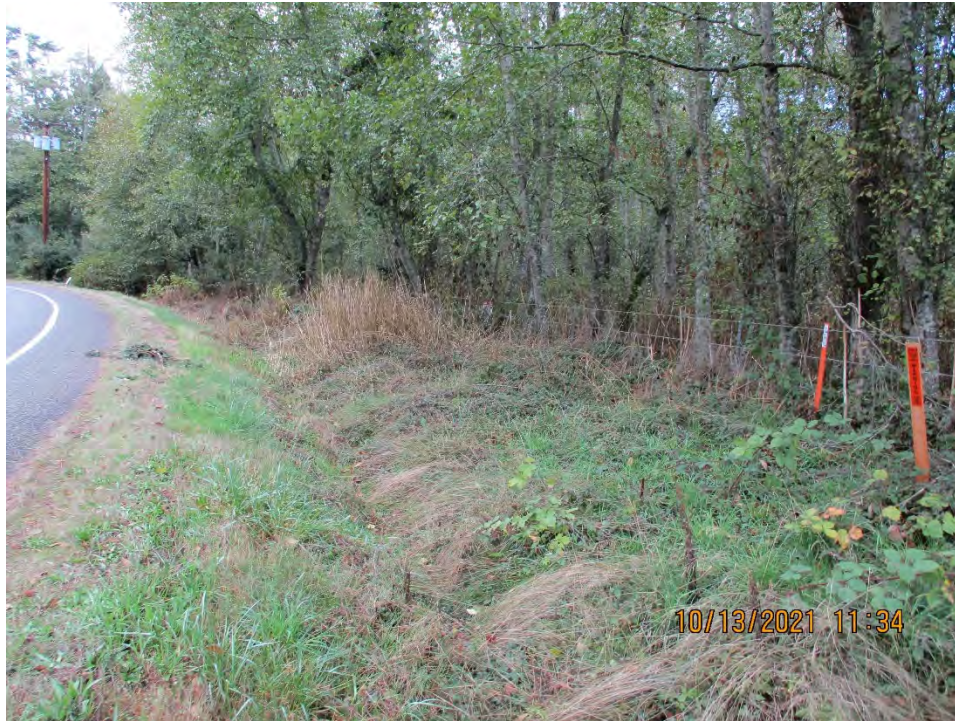
O25: Fenceline along
southeastern boundary

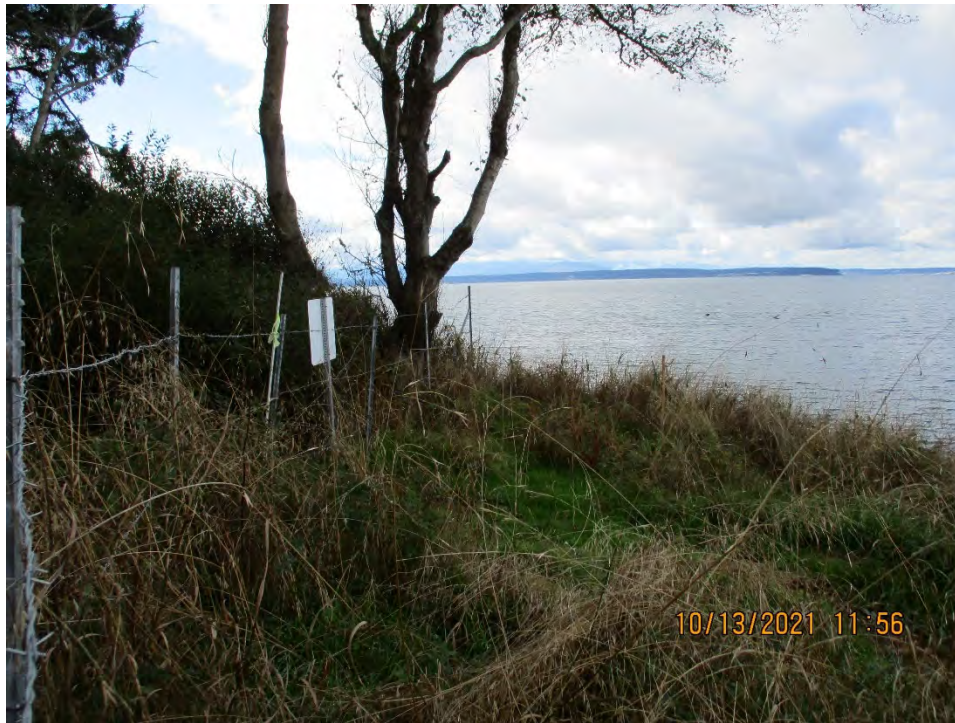
O29: Southwest corner
and end of fenceline

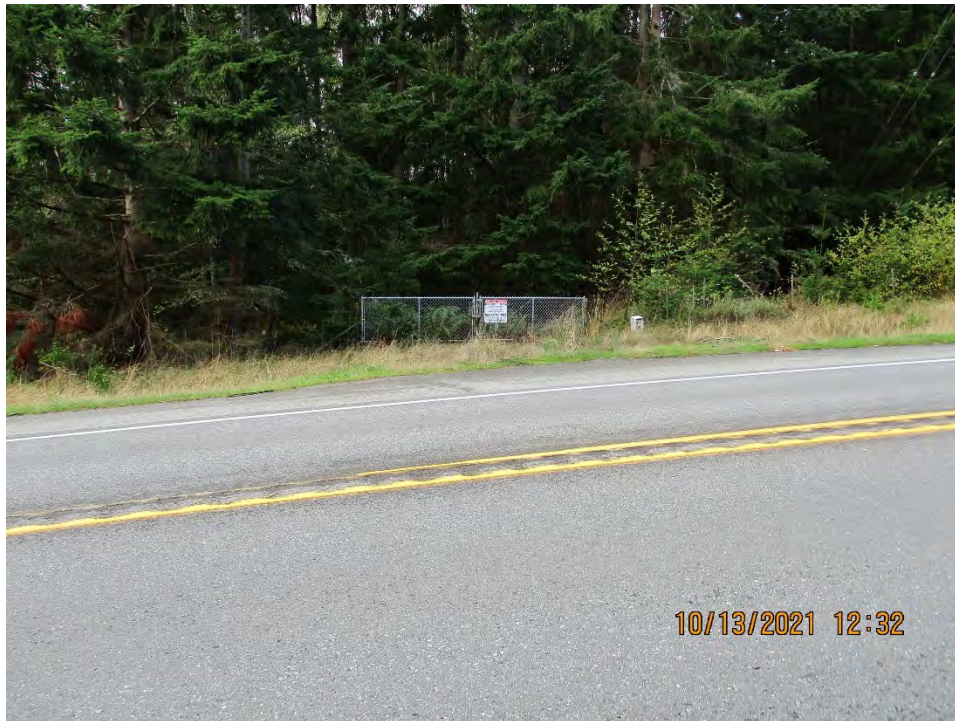
O35: Newly installed
fencing and gate

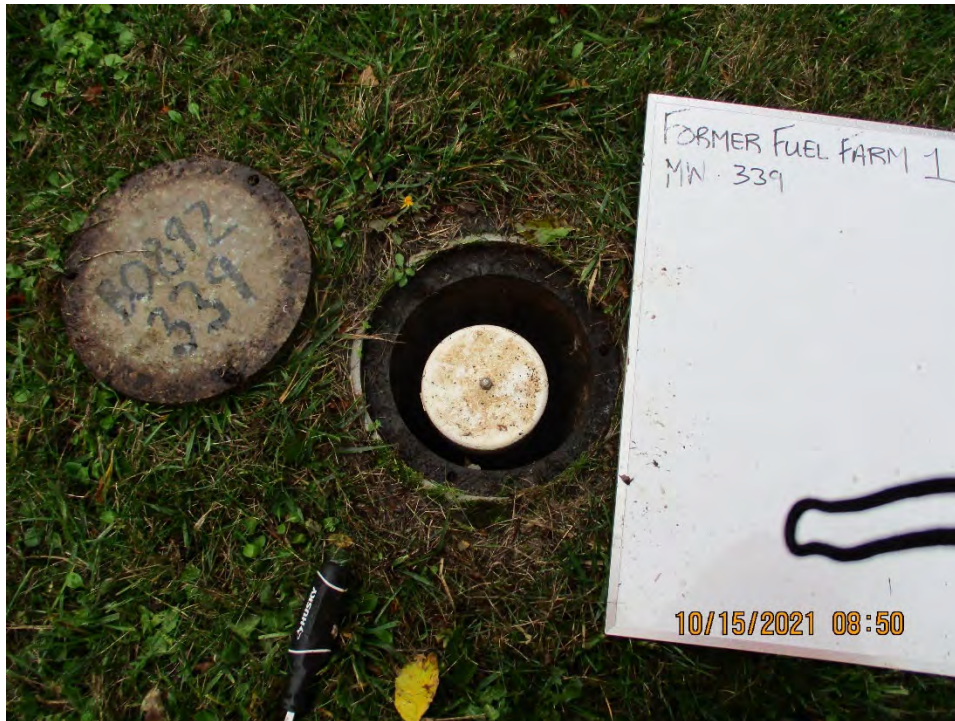
P15: MW-339

Well ID	Northing	Easting	Photograph No. (Appendix B)	Comments from 2021 Inspection
MW-337	473665	1204485	P3	-
MW-338	473624	1204528	P18	Missing cover bolts
MW-339	473523	1204565	P15	Unable to secure new lock on slip cap; missing cover bolts
MW-342	473594	1204479	P17	Missing cover bolts
MW-343	473477	1204630	P1	Missing cover bolts
MW-344	473494	1204773	P11	Unable to secure new lock – well cap damaged, missing cover bolts
MW-501	473818	1204385	P5	Missing cover bolts
MW-502	473755	1204395	P4	Missing cover bolts
MW-503	473698	1204468	P2	Missing cover bolts
MW-601	473688	1204498	P6	Vault full of water
MW-602	473699	1204711	P7	Missing cover bolts
MW-603	473695	1204719	P9	Missing cover bolts
MW-604	473709	1204778	P10	-
Site 35, Former Fuel Farm 2				
MW-001	471180	1204168	Q14	Bollards not plumb
MW-306	471389	1204146	Q2	-
MW-307	471299	1204148	Q11	-
MW-505	471322	1203973	Q8	Missing cover bolts
MW-506	471313	1204029	Q3	Missing cover bolts

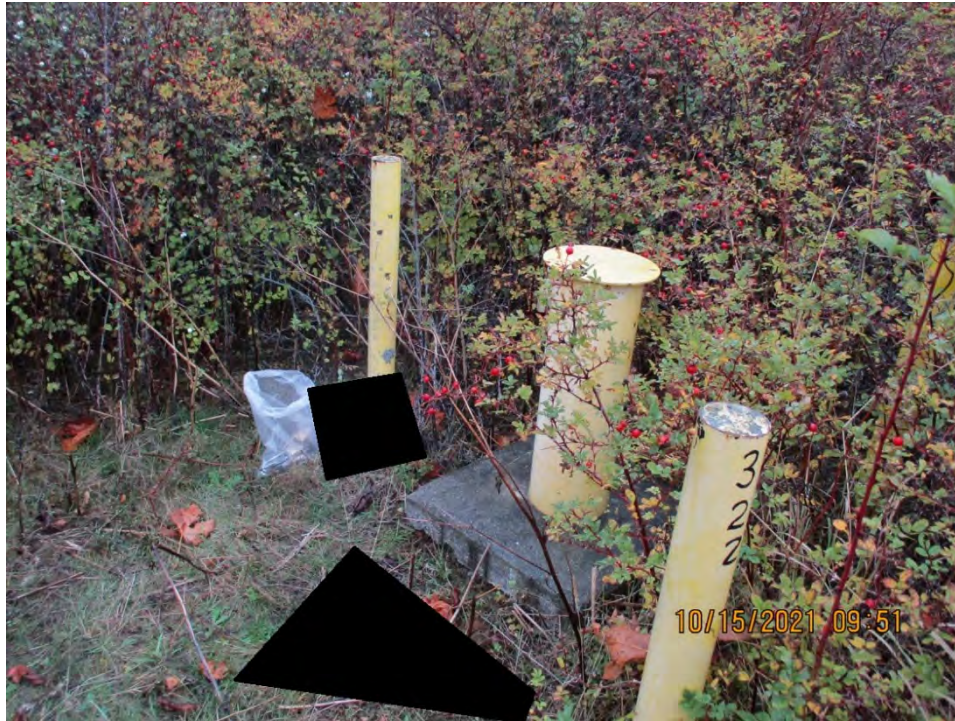
P27: MW-322

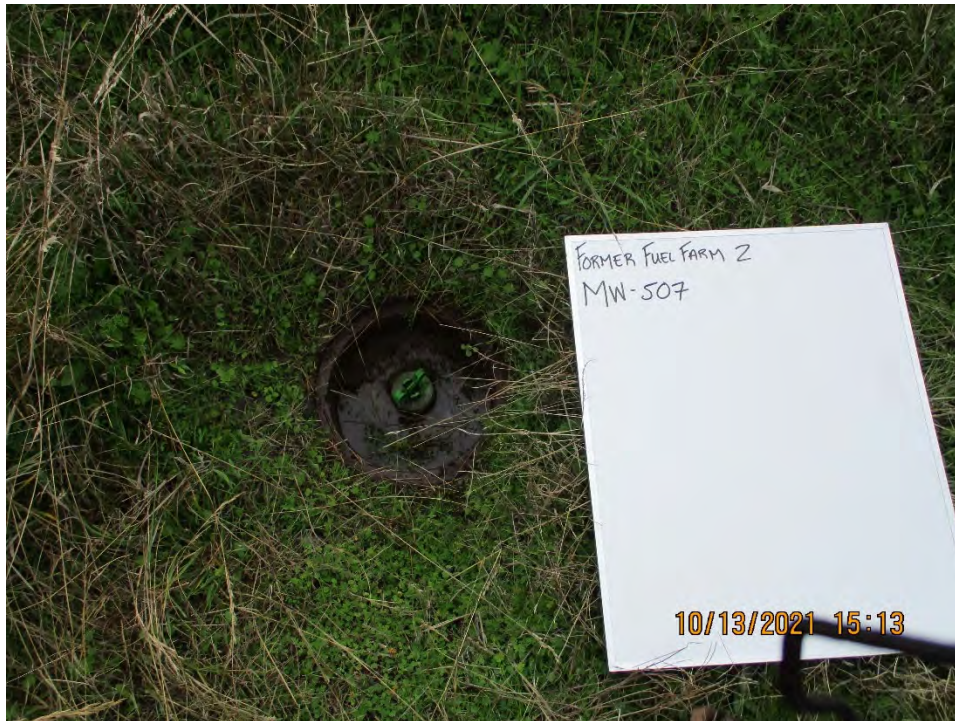
Q4: Unmarked
monitoring well

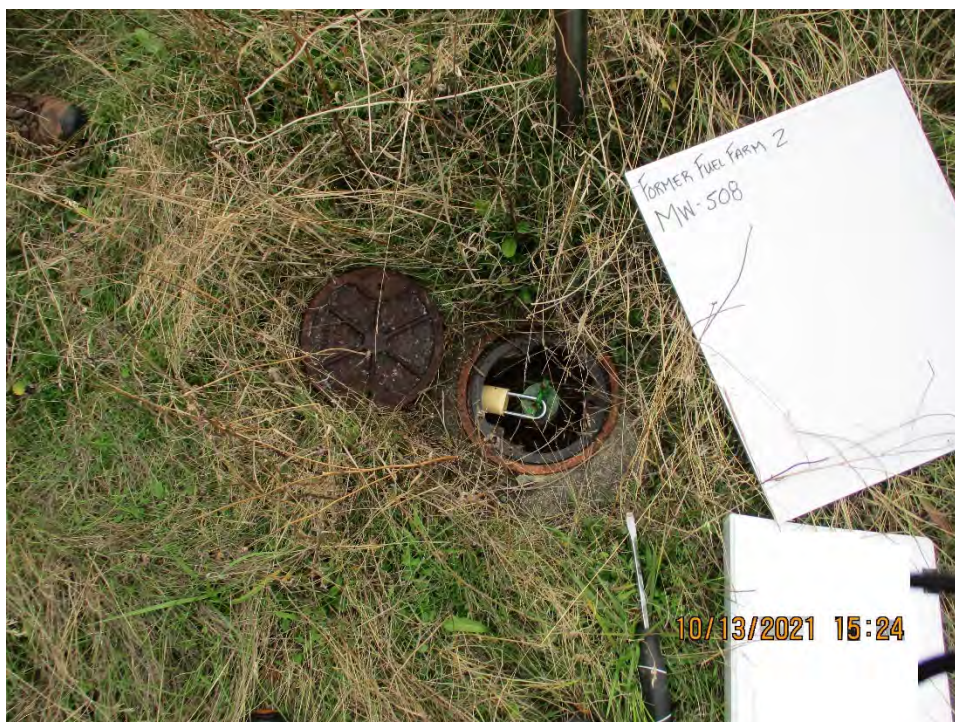
Q5: MW-507

MW-507	471297	1204081	Q5	Missing cover bolts
MW-508	471357	1204016	Q6	Missing cover bolts
MW-716	471288	1204150	Q12	-
MW-717	471247	1203982	Q9	-
Site 13, Former Fuel Farm 3				
MW-001	493167	1194253	R55, R56	Unable to secure new lock on slip cap

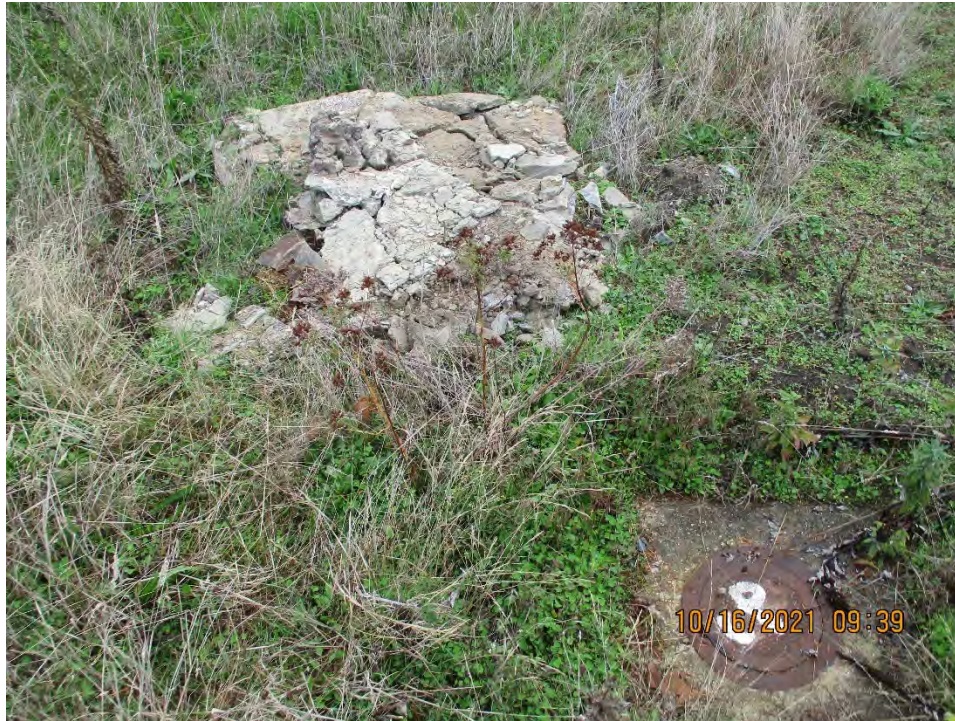
R31: Stockpiled
construction debris

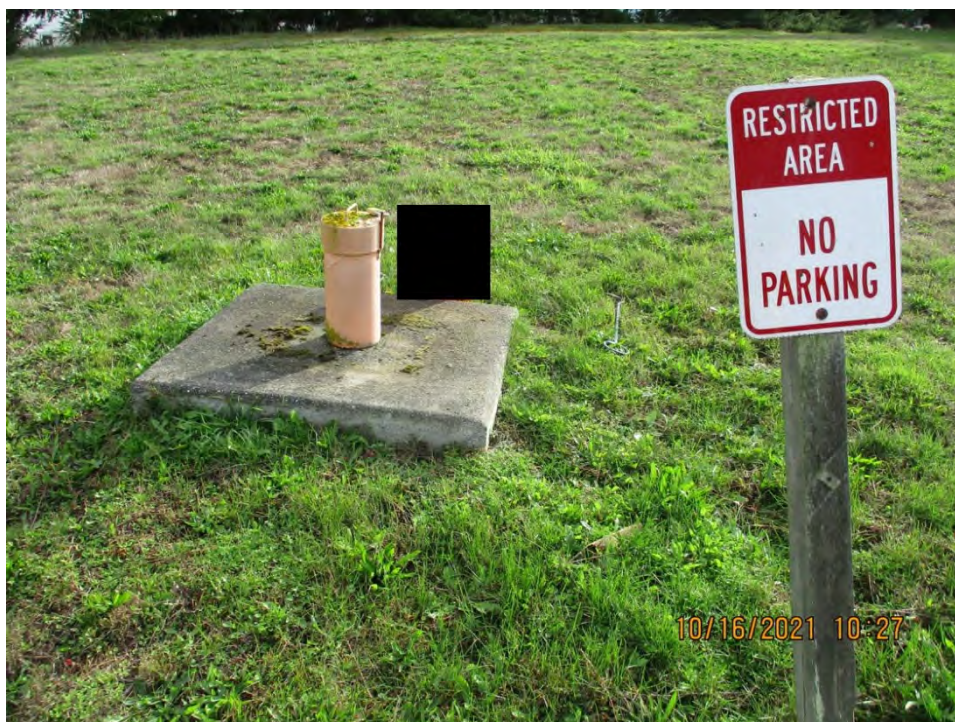
R44: MW-003

Well ID	Northing	Easting	Photograph No. (Appendix B)	Comments from 2021 Inspection
MW-002	493412	1194579	R49, R50	Missing cover bolts; unable to secure new lock, vault size does not accommodate shank length
MW-003	493243	1194835	R44	No bollards present
MW-302	492775	1194172	R11	Lid nearly rusted shut
MW-303	492809	1194515	R20	-
MW-305	493019	1194490	R32	-
MW-311	493317	1194259	R60	-
MW-334	493000	1194752	R30	-
MW-335	491017	1194206	R34	Lid nearly rusted shut; bollards partially buried
MW-350	493270	1194386	R62	Unable secure new lock, vault size does not accommodate shank length
MW-351	493226	1194488	R63	-
MW-352	493198	1194362	R38	-
MW-353	493209	1194741	R41	-
MW-354	493163	1194911	R42	Lid nearly rusted shut
MW-355	493055	1194942	R26	-
MW-356	492932	1194879	R23, R24	-
MW-357	492885	1194756	R22	Missing cover bolts
MW-358	492744	1194560	R18	-
MW-359	492733	1194456	R15	Unable to secure new lock on vault or well cap; no hasp or previous lock present

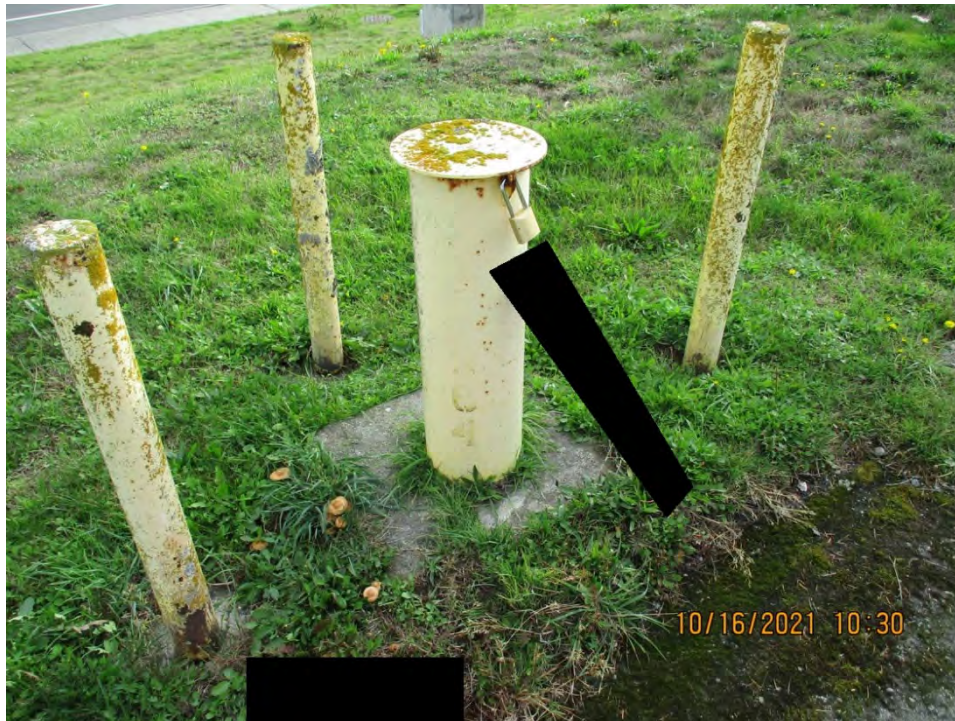
R45: MW-364

MW-360	492735	1194314	R13	-
MW-361	492892	1194065	R10	-
MW-363	493154	1194154	R57	Missing cover bolts
MW-364	493340	1194845	R45	-
MW-365	493330	1194769	R48	Missing cover bolts; vault full of water
MW-368	492488	1194911	R5	-

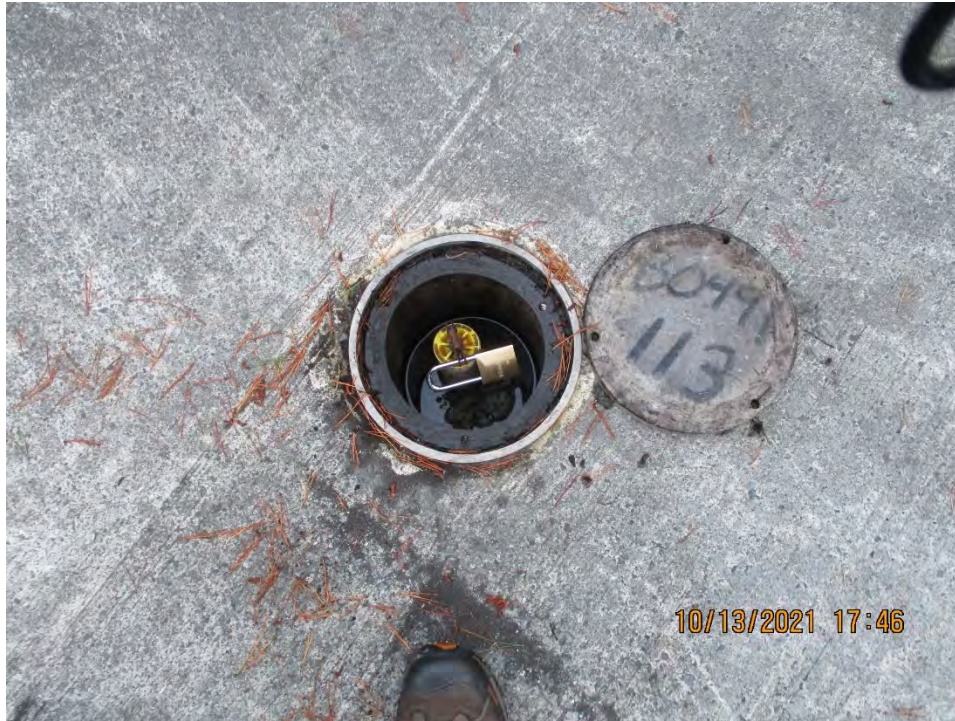
S20: MW-115 (491)

MW-701	493268	1194613	R51	Missing cover bolts; well lid nearly buried in asphalt (new pavement)
MW-702	492589	1194471	R8	Missing cover bolts; well vault sunken
Site 11, Former Fuel Farm 4				
MW-109	489905.553664	1196219.914920	S12	-
MW-114	489922.665974	1196122.374720	S13	-
MW-113 (491)	490110.901448	1196098.417480	S21	Missing cover bolts
MW-114 (491)	490155.393467	1196098.417480	S19	Unable to install new lock on well cap; missing cover bolts
MW-115 (491)	490153.682236	1196127.508420	S20	Unable to install new lock on well cap; missing cover bolts

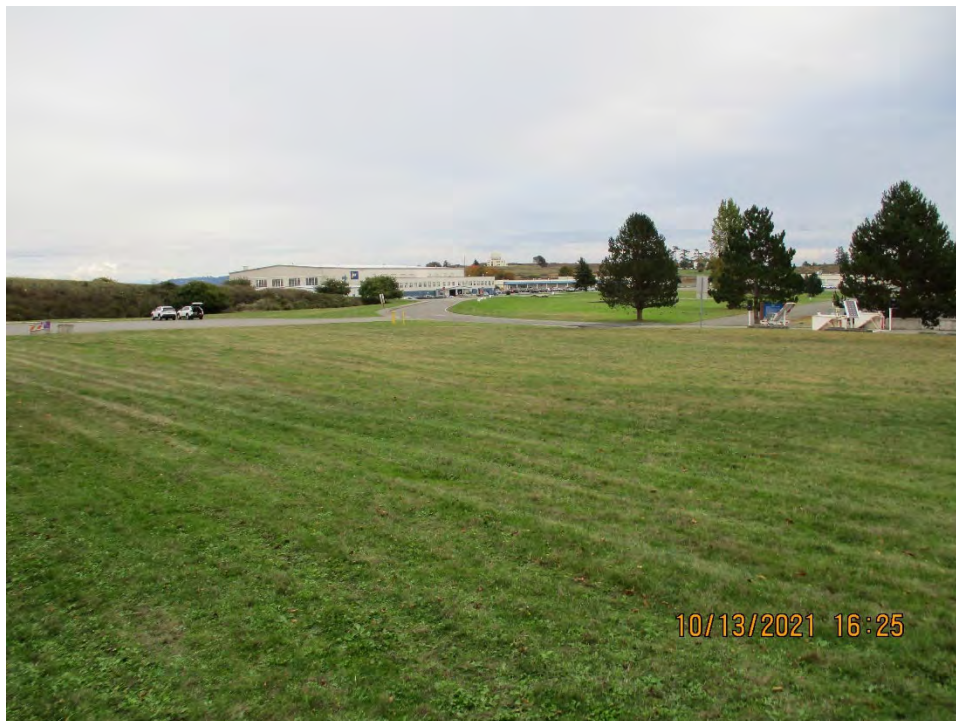
T5: Animal burrowing
along northern
boundary
