# Memorandum

**To:** Ron Woolworth, W&W Everett Investments, LLC  
**Copies:** Frank Winslow, Washington State Department of Ecology  
**From:** Kristin Anderson, LHG, Floyd|Snider  
**Date:** June 16, 2026  
**Site Name:** Jeld-Wen Site  
**Re: Cap Condition Survey**

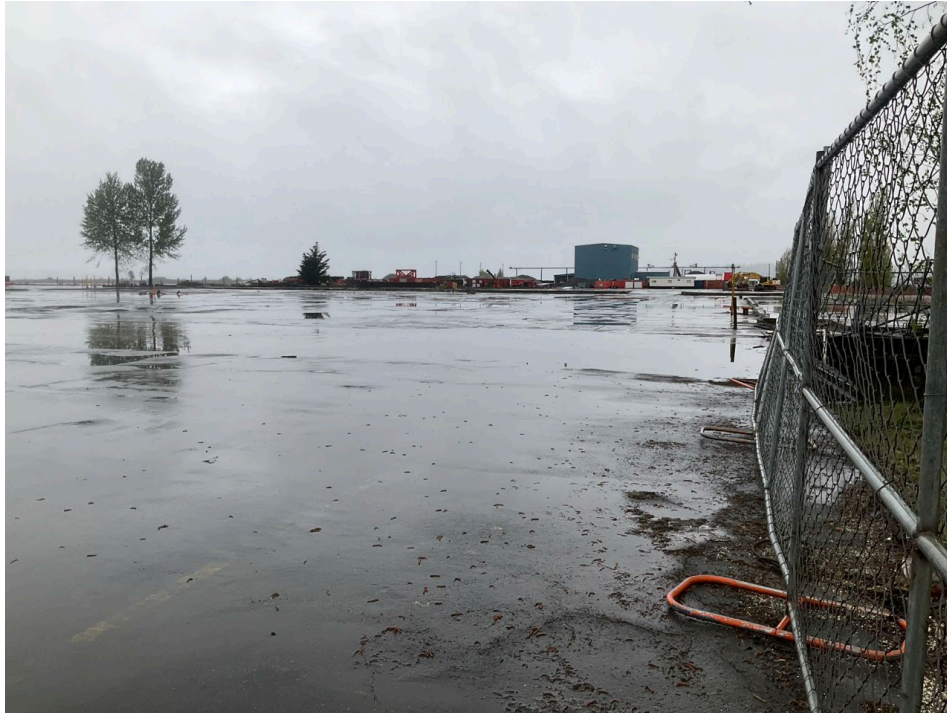
Photograph 1. Polygon A1 facing west from the northeast corner of the Jeld-Wen Site (Site).

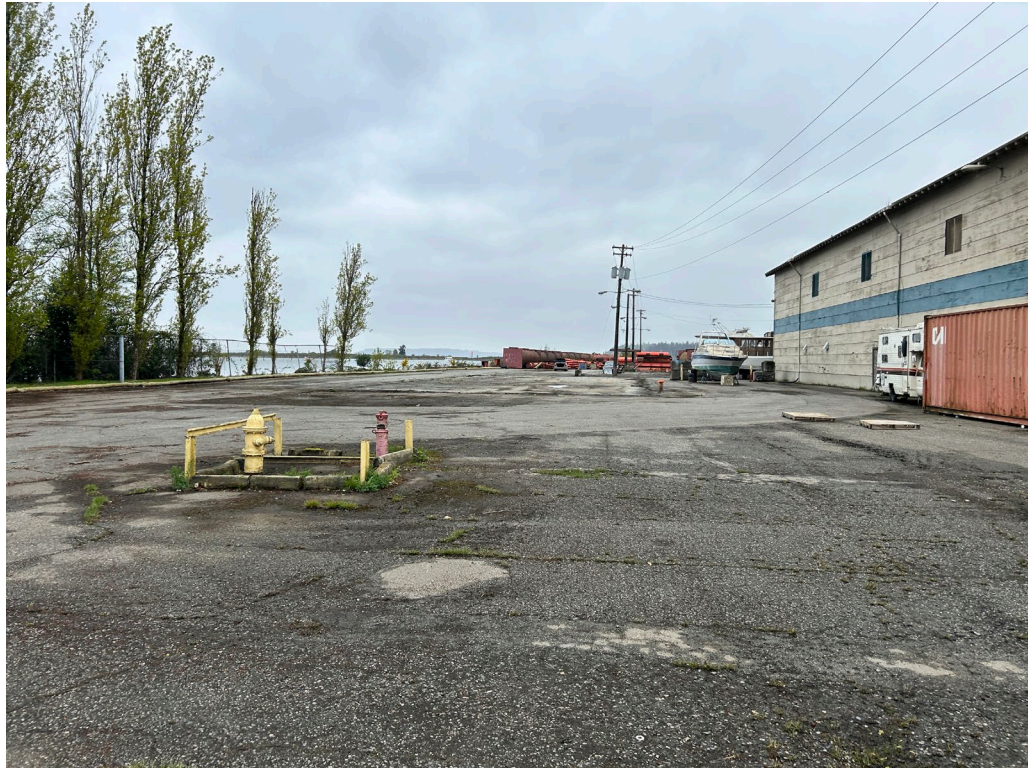
Photograph 3. Polygon A1 on the south side of F19 building.

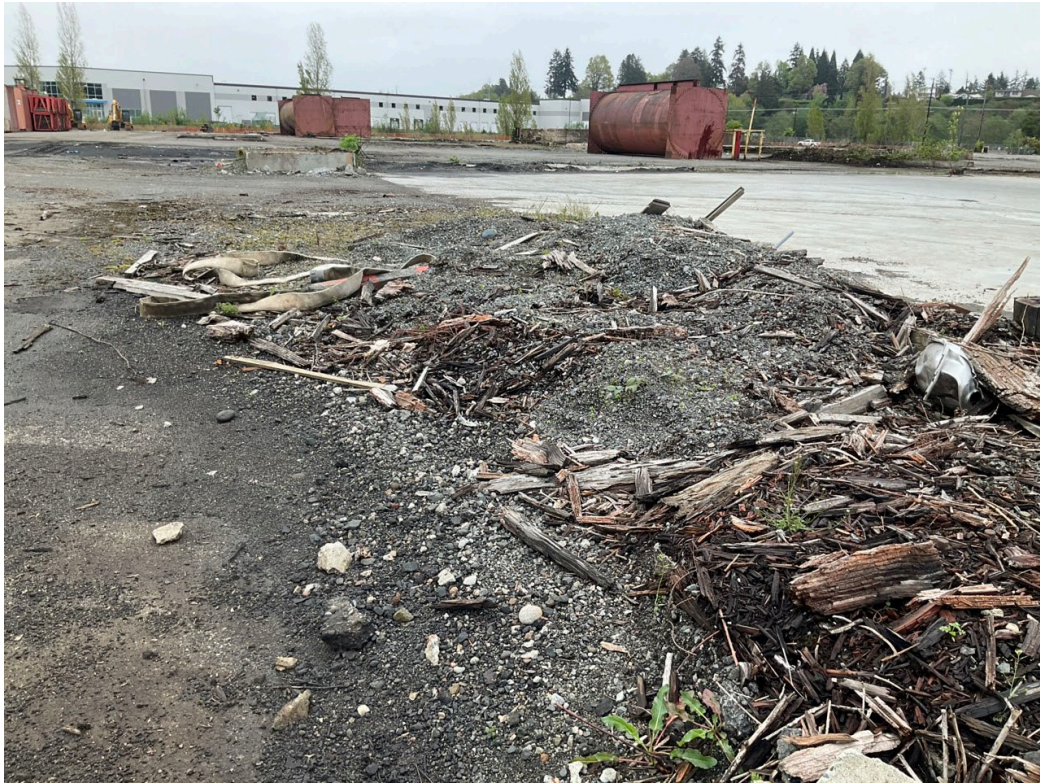
areas are labeled on Figure 1 as C1 through C20. Polygons C1-C8 and C15-C20 were identified as having the potential to wash out during storm events due to their exposed configuration and lack of containment by berms or curbing. Erosion or migration of gravel from these areas could contribute suspended solids to stormwater runoff; however, the gravel is from a clean quarry source provided by HM and is therefore unlikely to contribute contaminants to stormwater. Polygons C9-C14 were observed to be contained within concrete berms, which are expected to reduce the transport of sediment during precipitation events.

Photograph 11. Polygon C18: a gravel pile with wood debris.

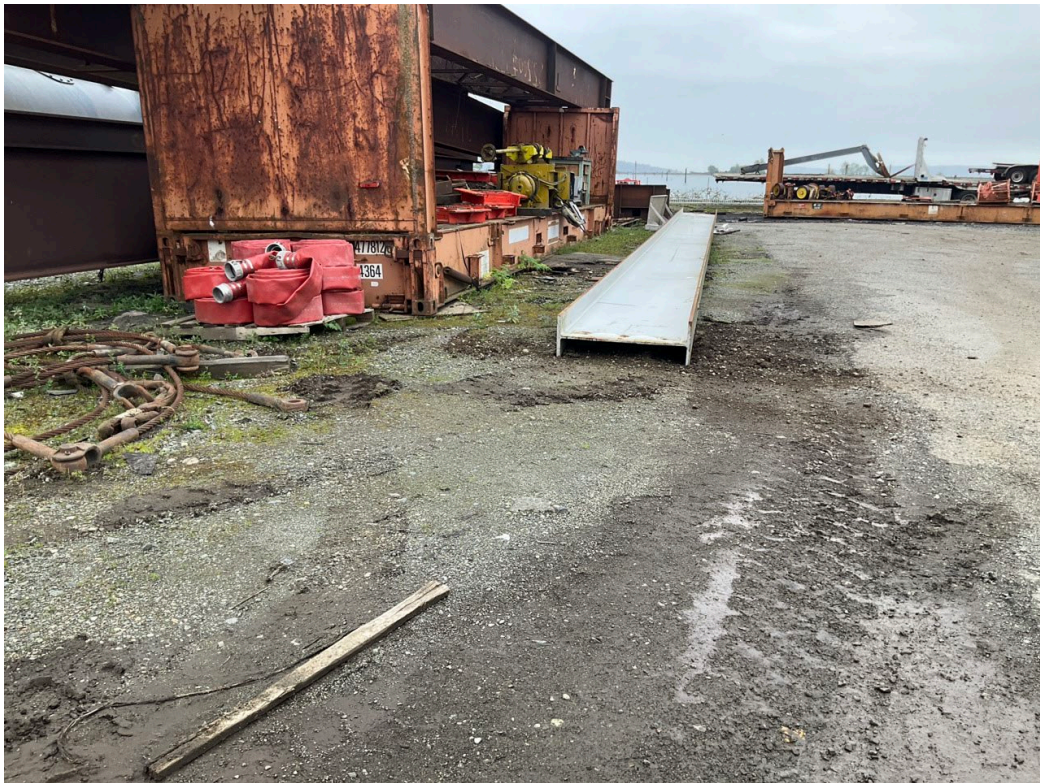
Photograph 12. Polygon C19: gravel area with stored materials.

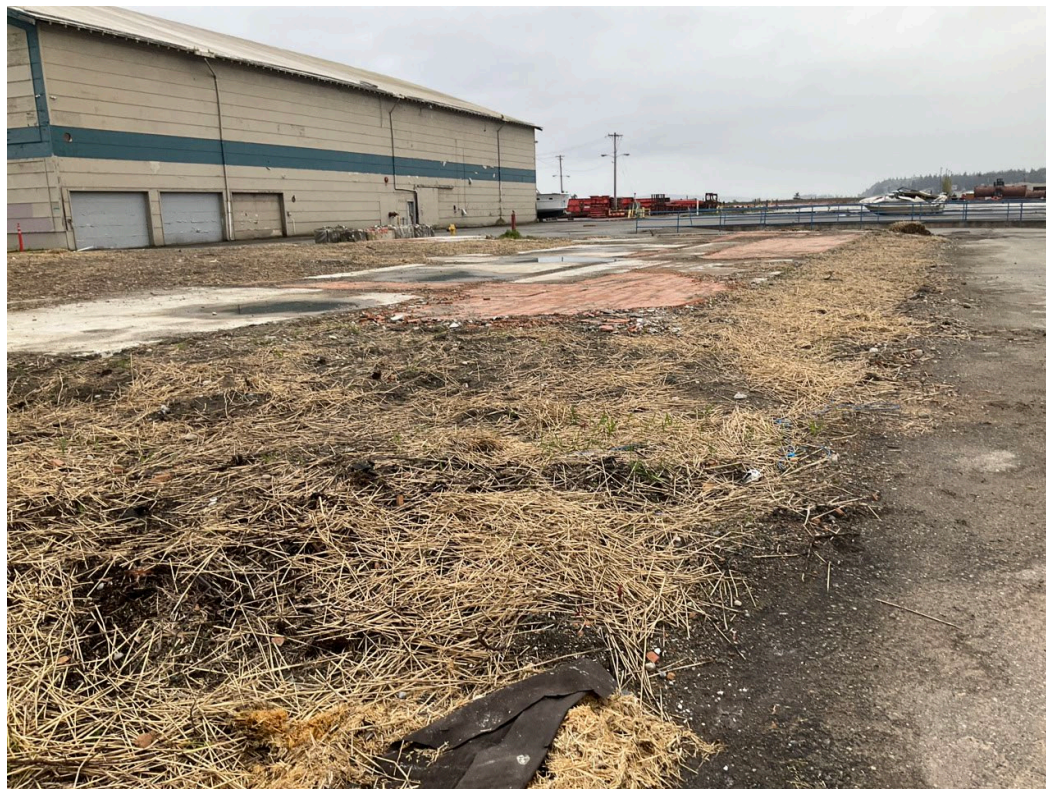
Photograph 14. Polygon D4: exposed soil with straw on the surface.

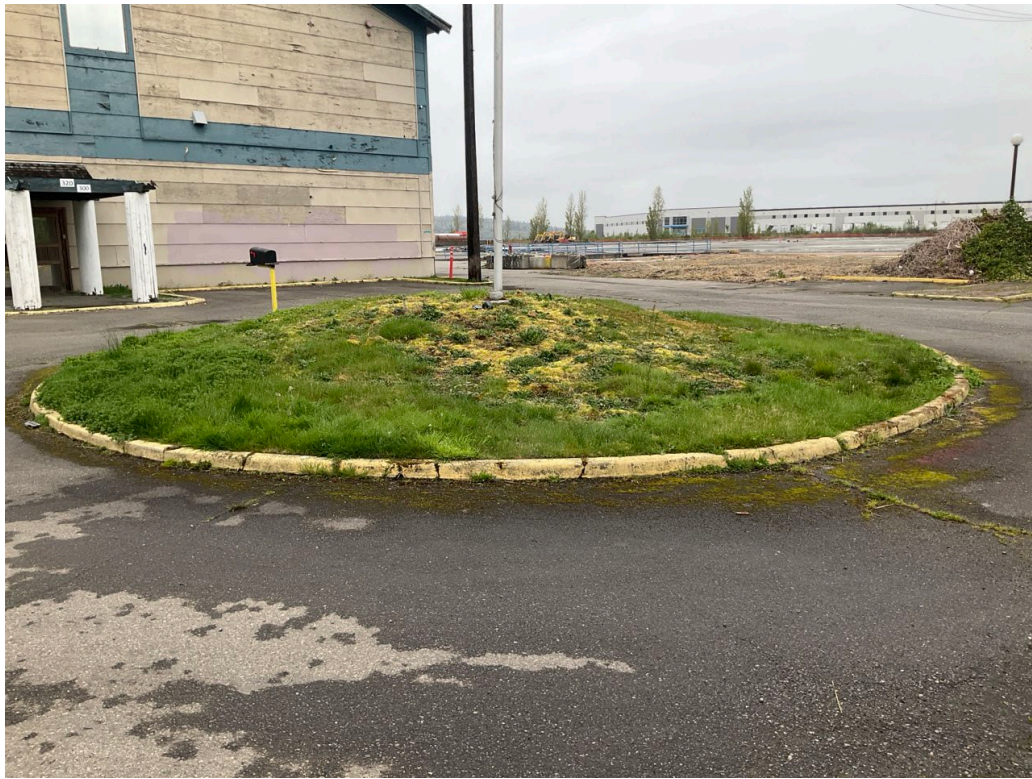
Photograph 19. Polygon E5: vegetated area adjacent to south truck bay.

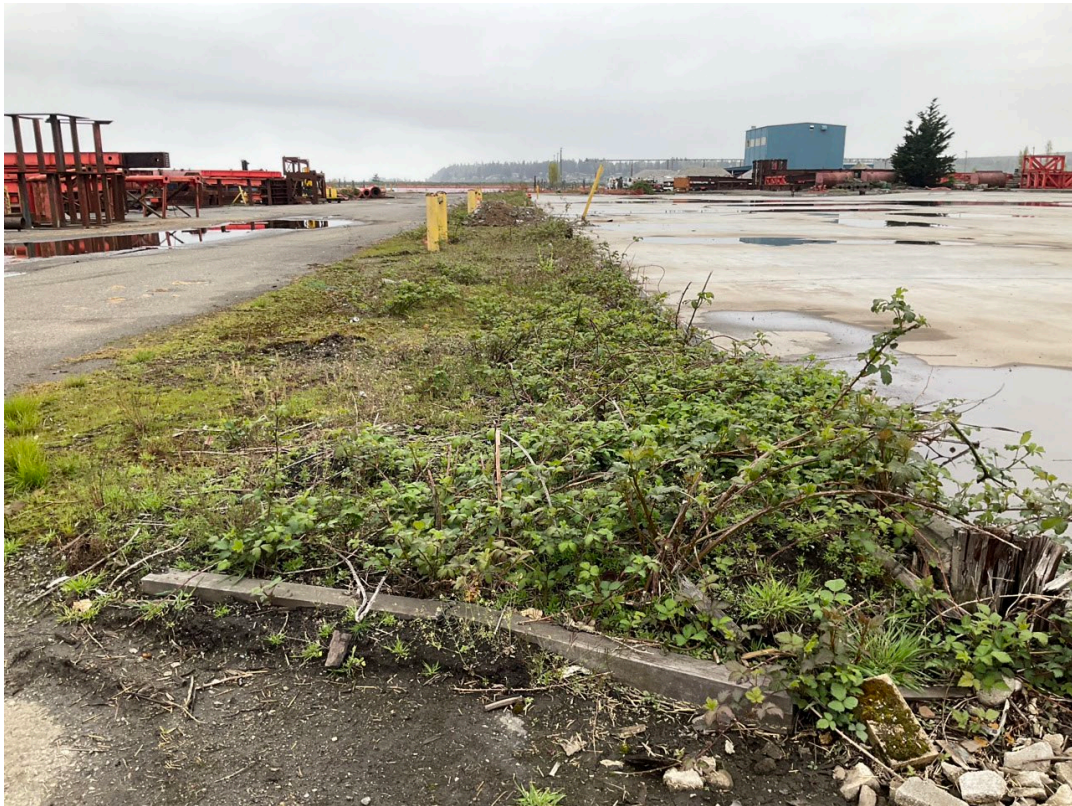
Photograph 20. Polygon E8: vegetated strip running from east to west.

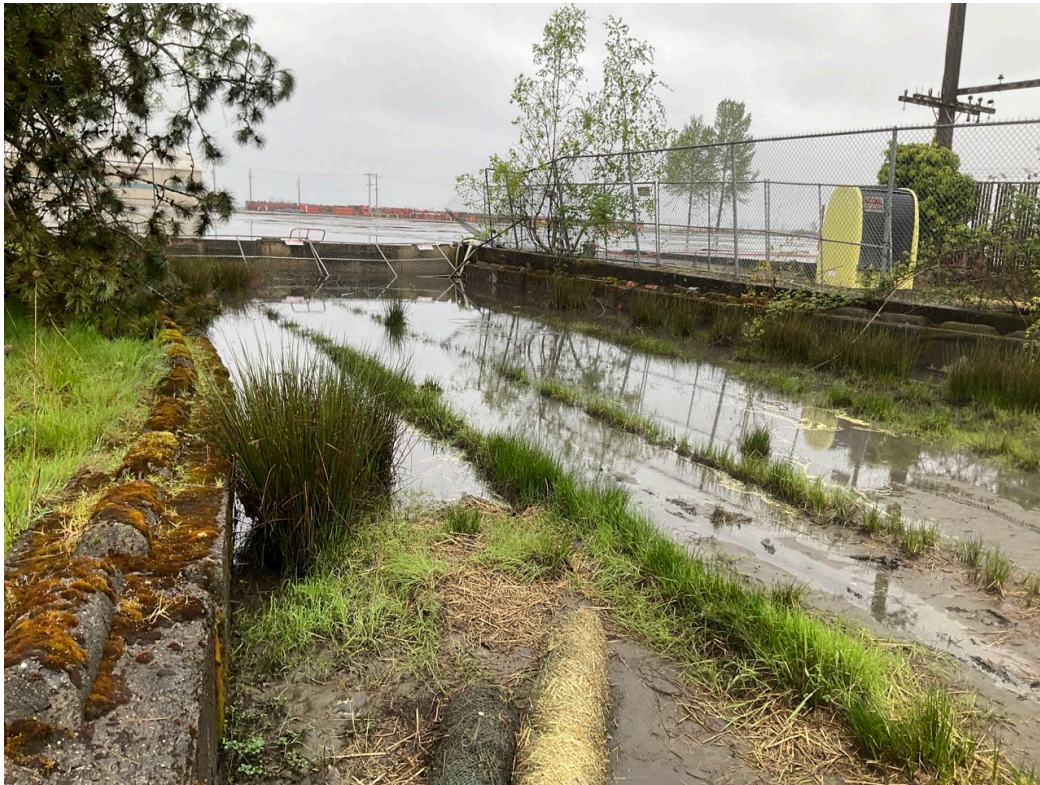
Ponded areas (as shown in Figure 1) with the potential to discharge to surface water include polygons F1, F2, F4, F5, F7, F8, F10, F16, and F17. These areas were generally associated with depressional and impermeable surfaces of the Site where accumulated stormwater could overflow, migrate across impermeable surfaces, or flow toward surface water during precipitation events. The proximity of ponded water to drainage pathways or sloped surfaces increases the likelihood that suspended sediment could be transported in stormwater during precipitation events. A pump was observed at the north truck bay ponding (polygon F1), with piping extending along the north side of the concrete pad, consistent with active water management to maintain driveway access in this area. However, no water flow from the pump was observed during the site visit.

Photograph 21. Polygon F1: north truck bay ponding.

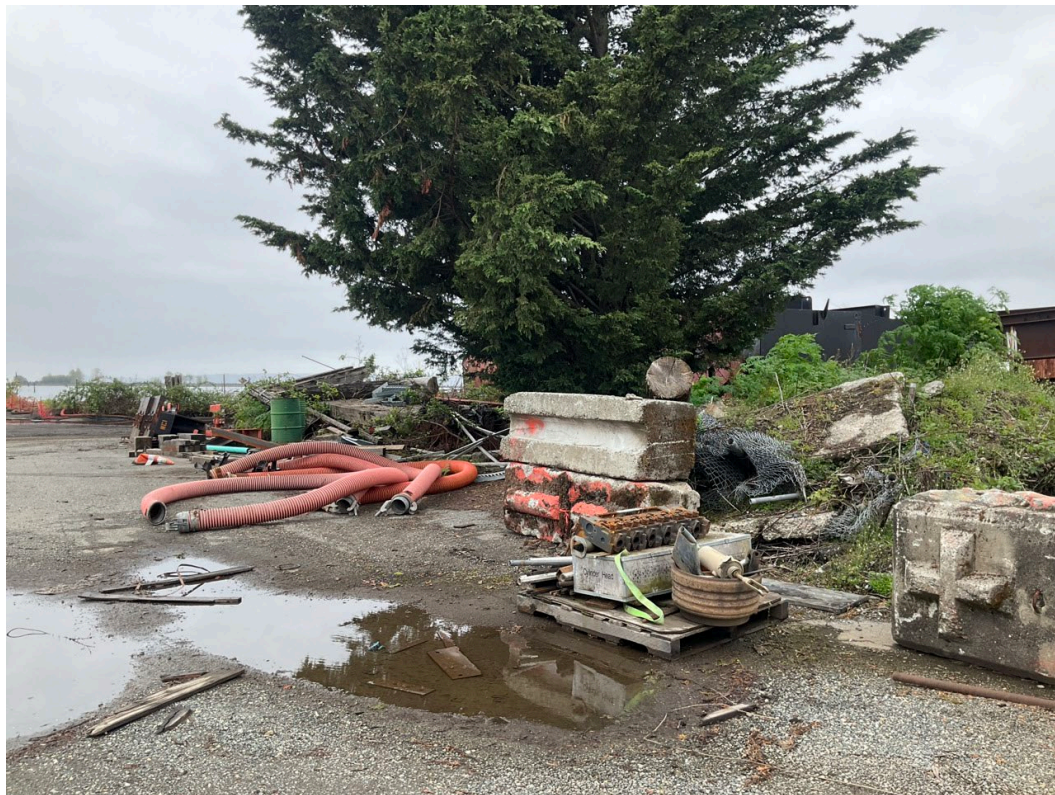
Photograph 26. Polygon F18: miscellaneous materials, debris, and vegetation.

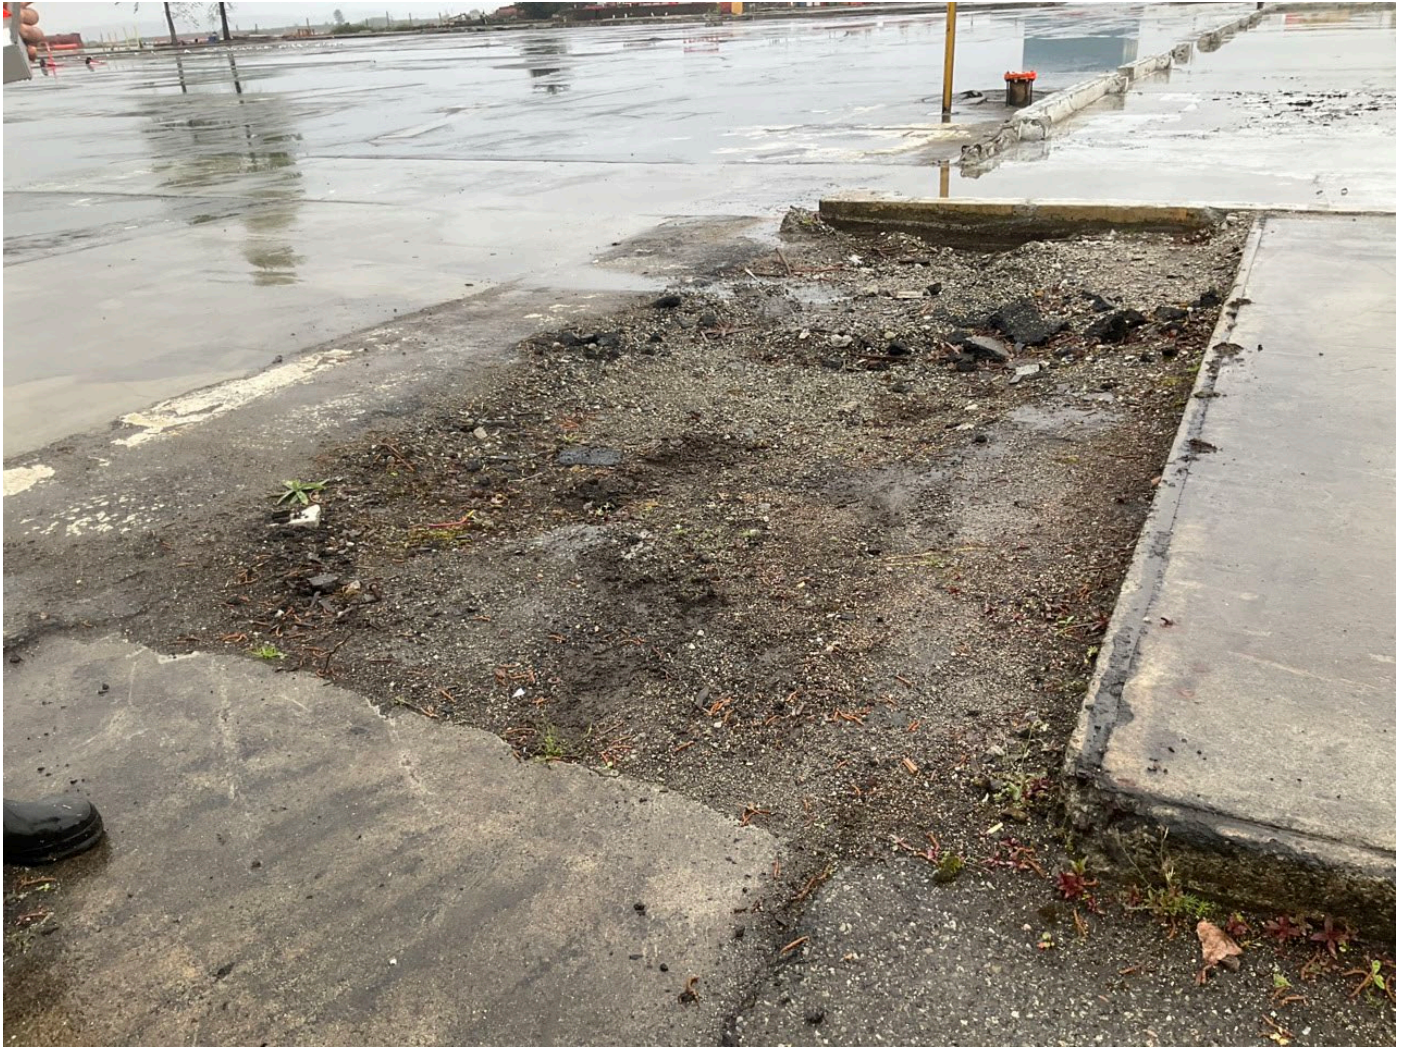
| Area ID | Surface Type | Erosion | % Bare Soil | Notes |
|---|---|---|---|---|
| B1 | Broken asphalt/gravel | Yes | 70 | Exposed fill |

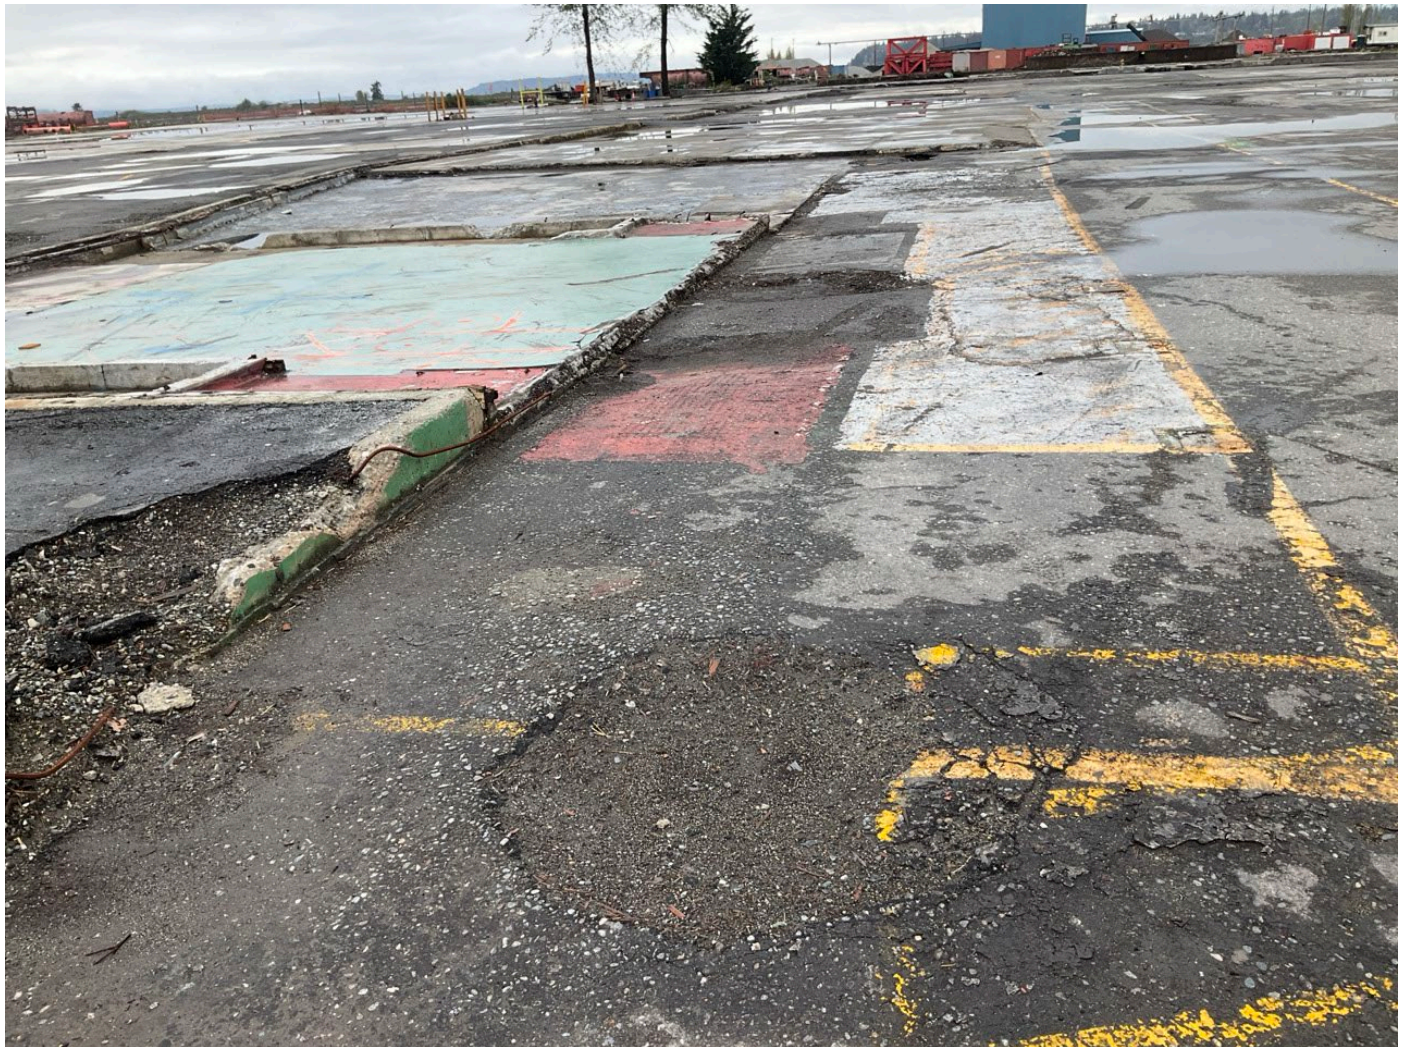
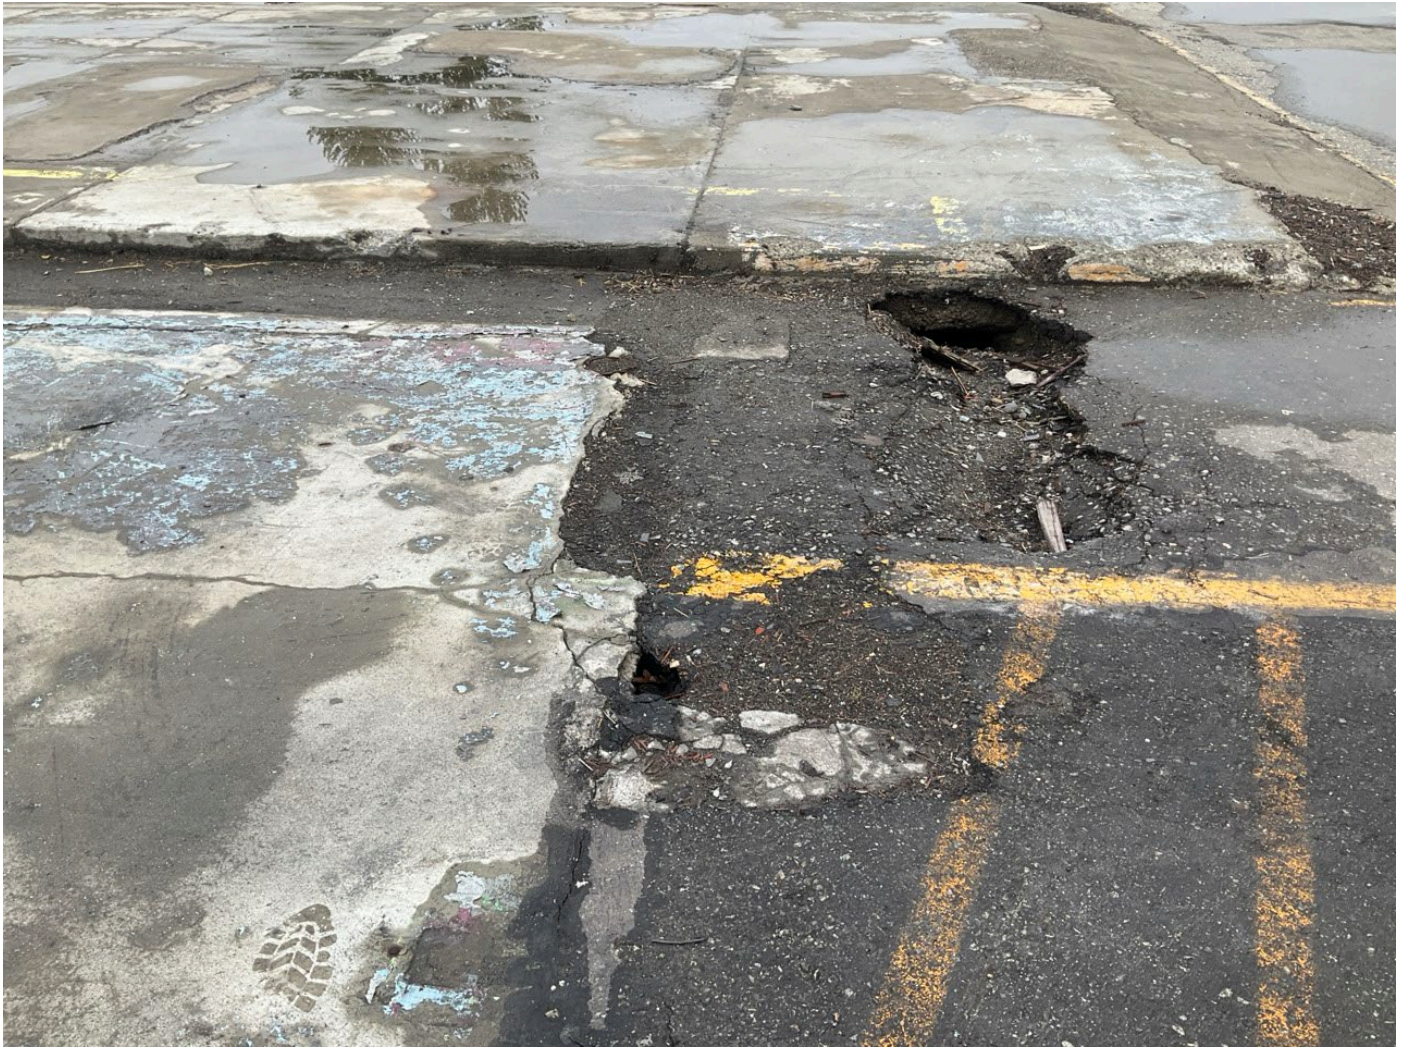
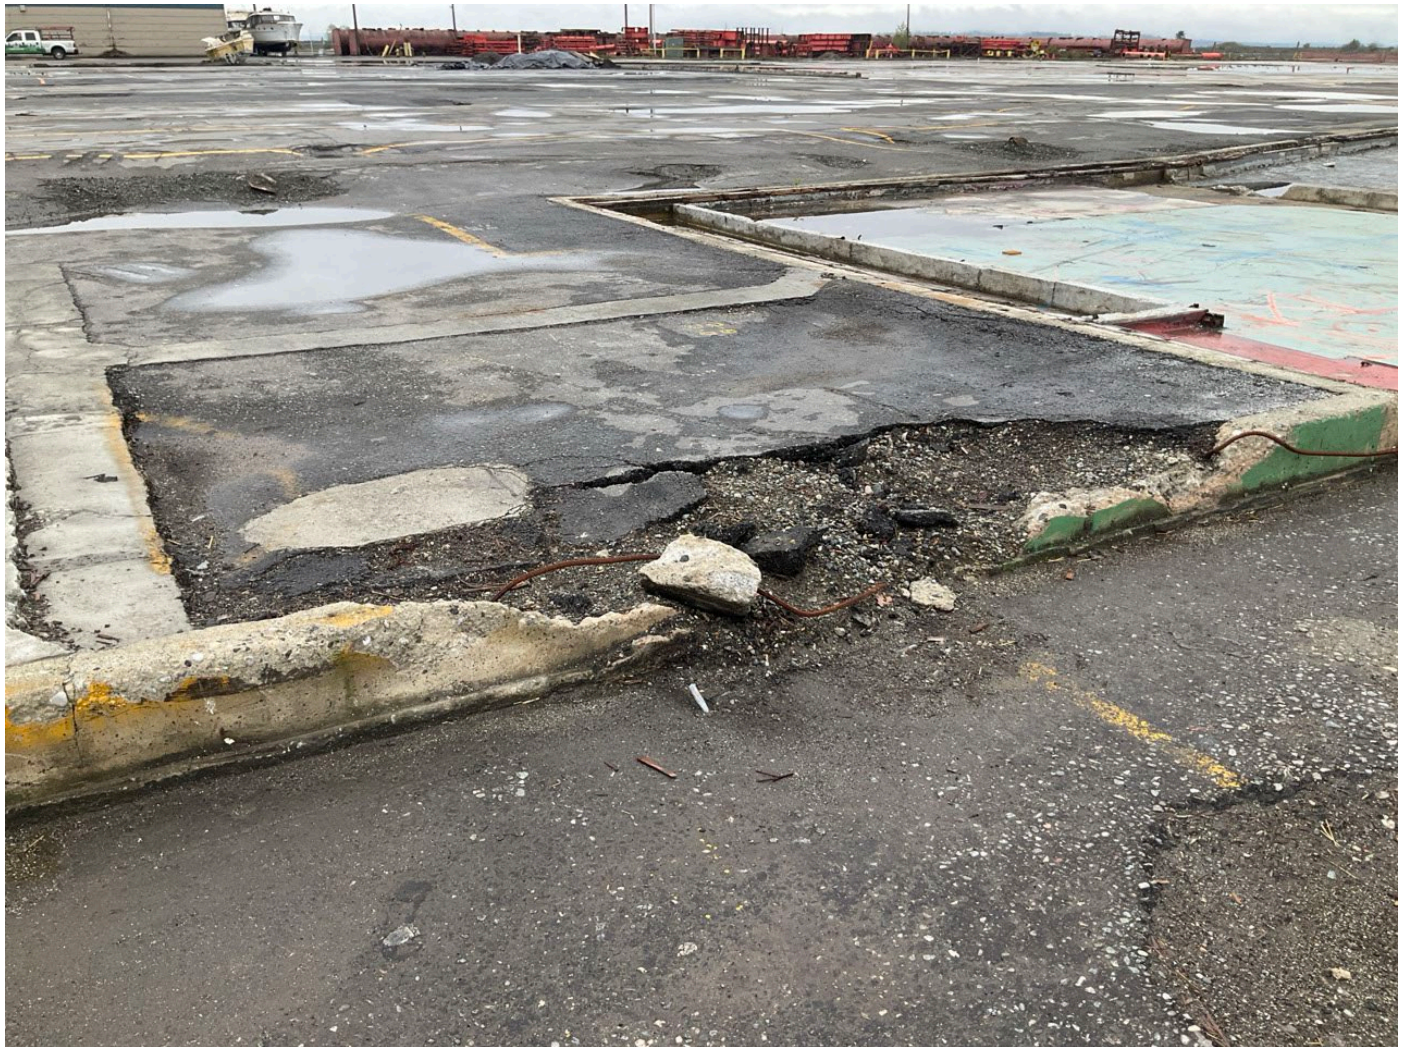
B10 (1)

| B10 | Broken asphalt/concrete | Minimal | 10 | Exposed soil, broken asphalt and concrete |

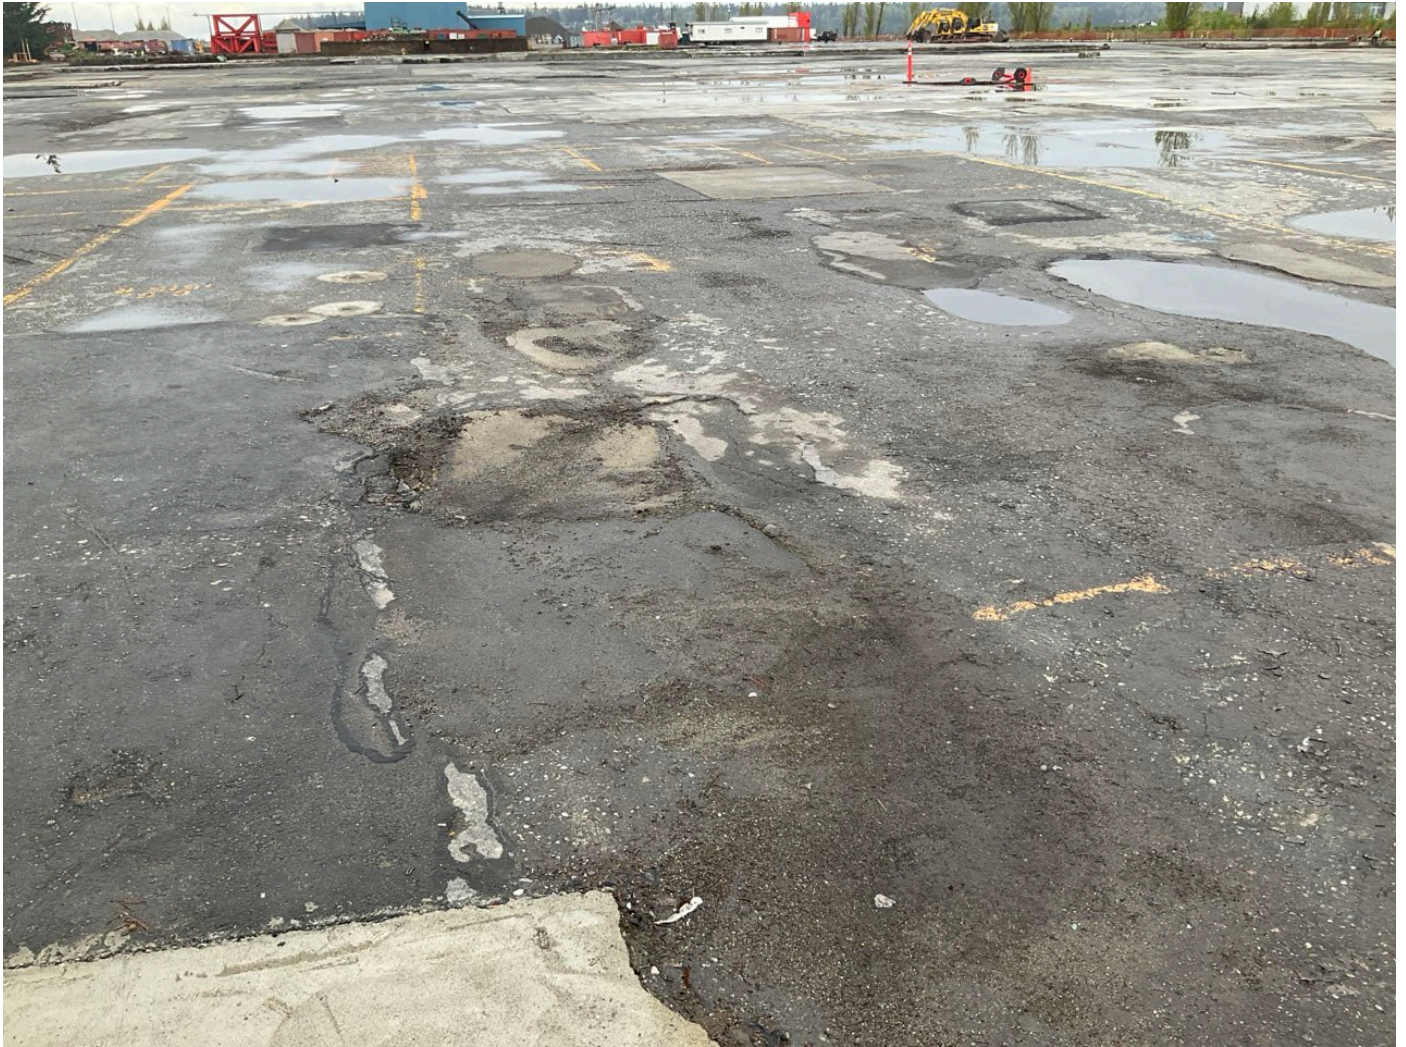
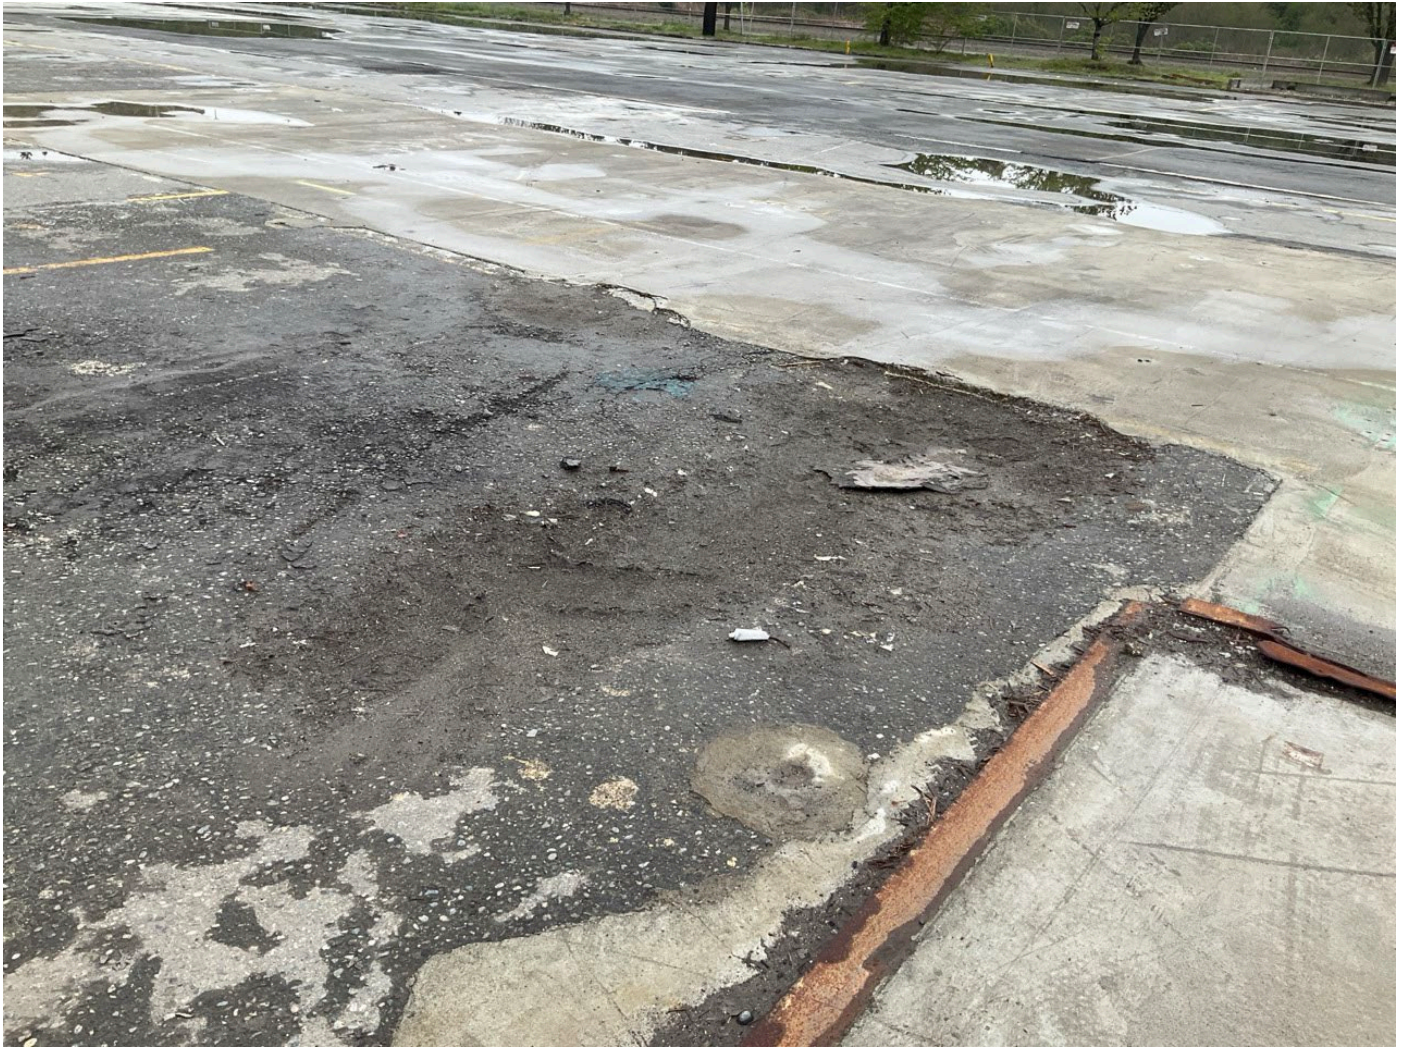
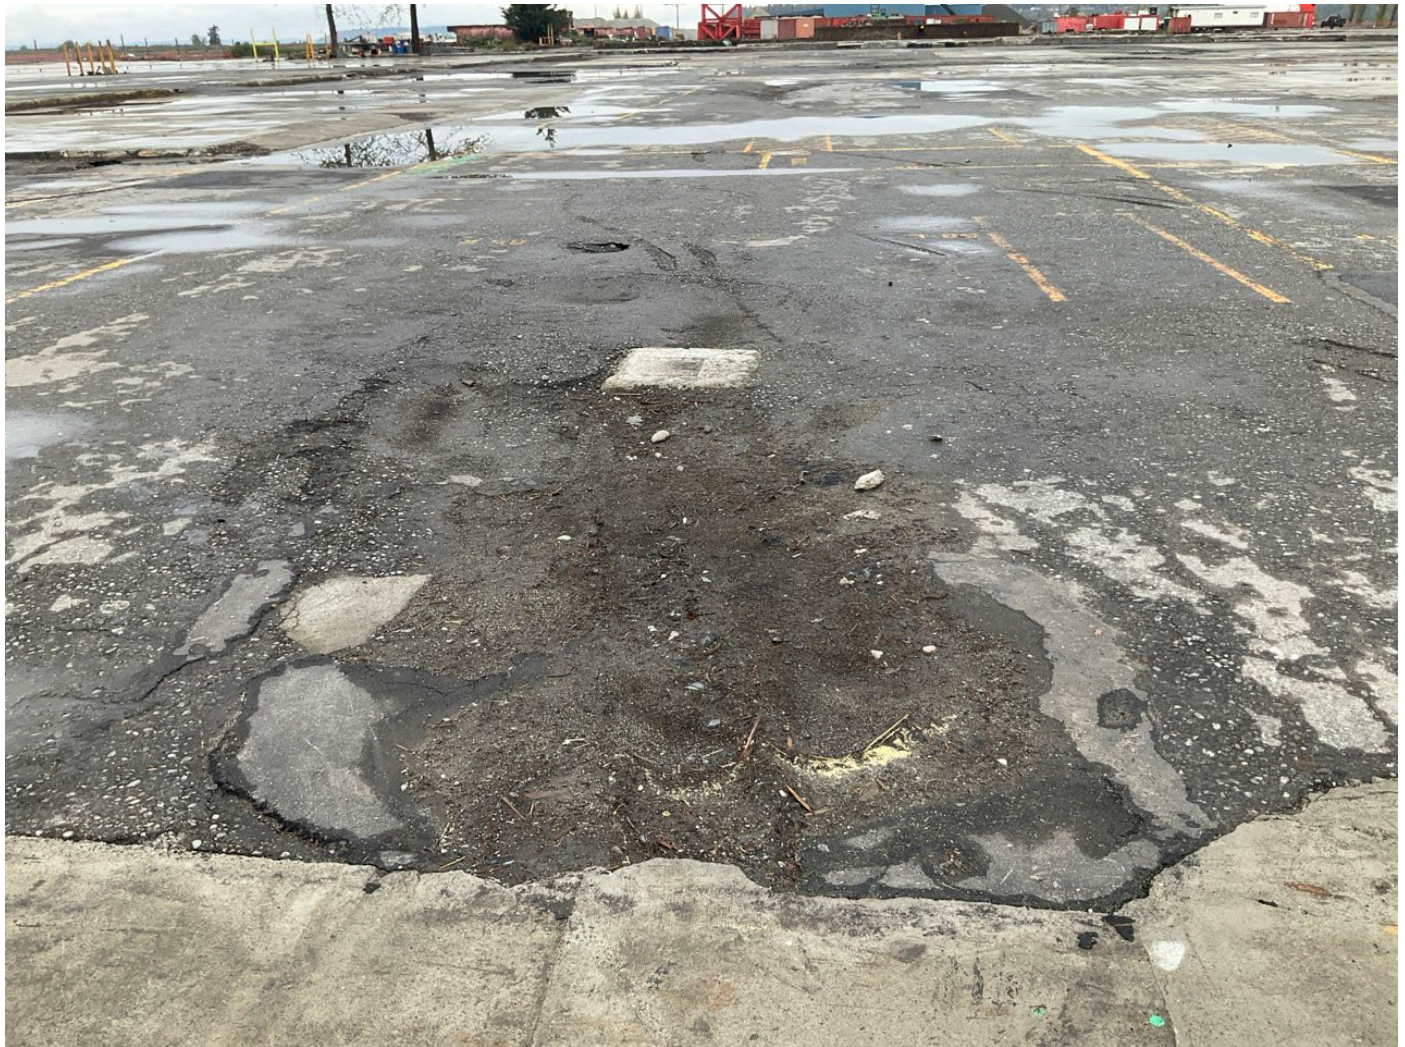
B11(1)

| B11 | Broken asphalt/concrete | Yes | 10 | Exposed soil, broken asphalt and concrete |

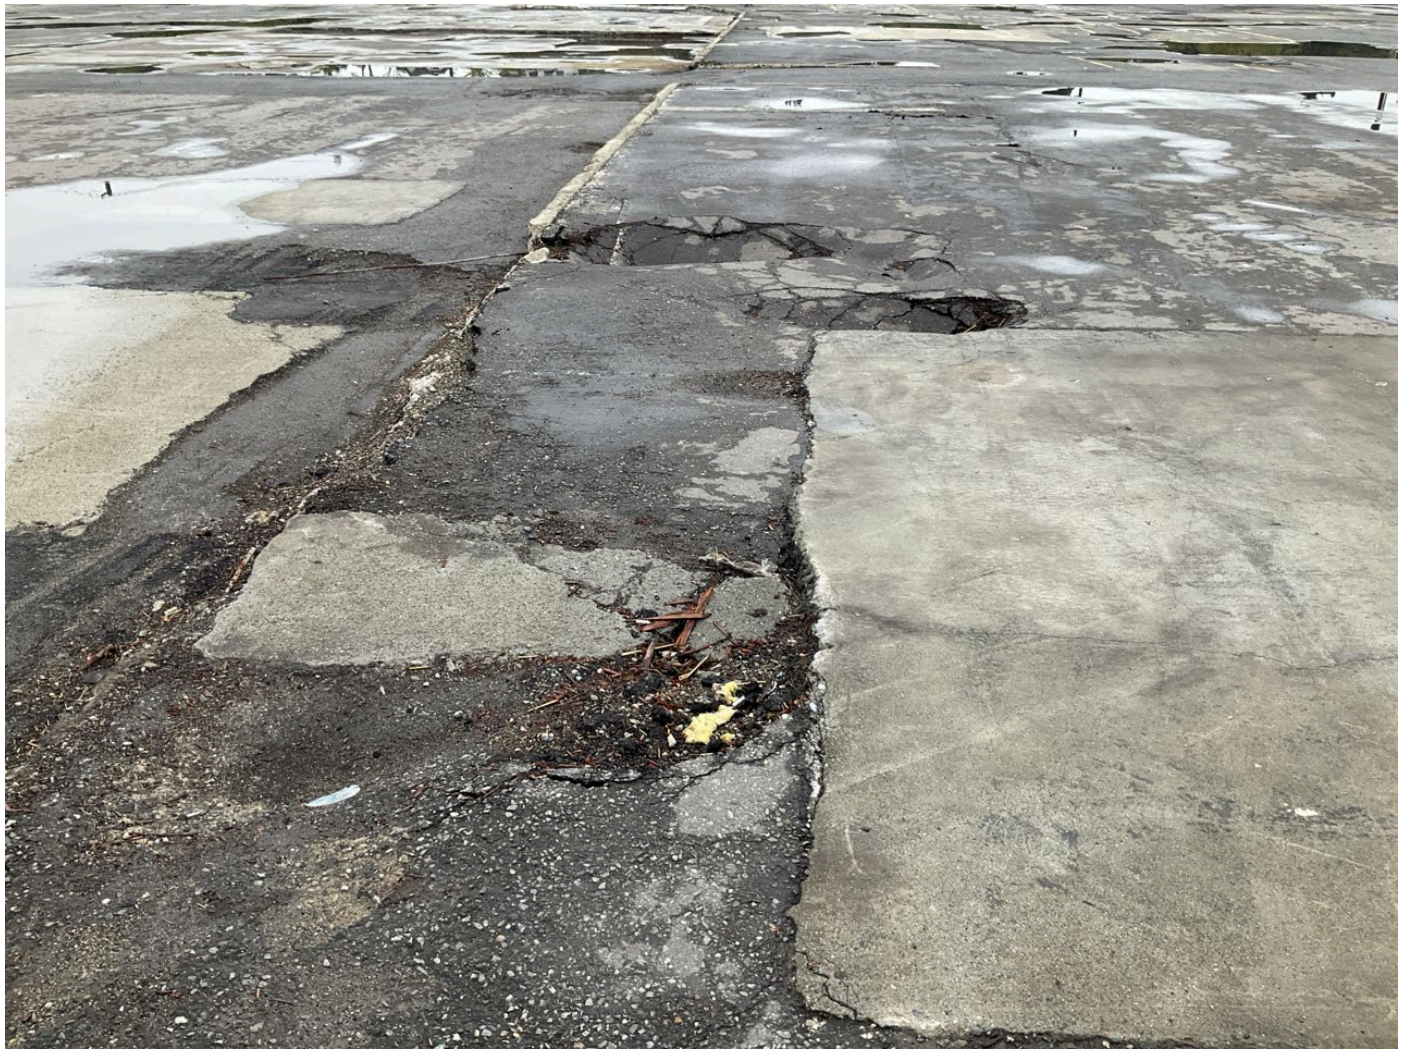
| B12 | Broken asphalt/concrete | Minimal | 15 | Exposed soil, broken asphalt and concrete |

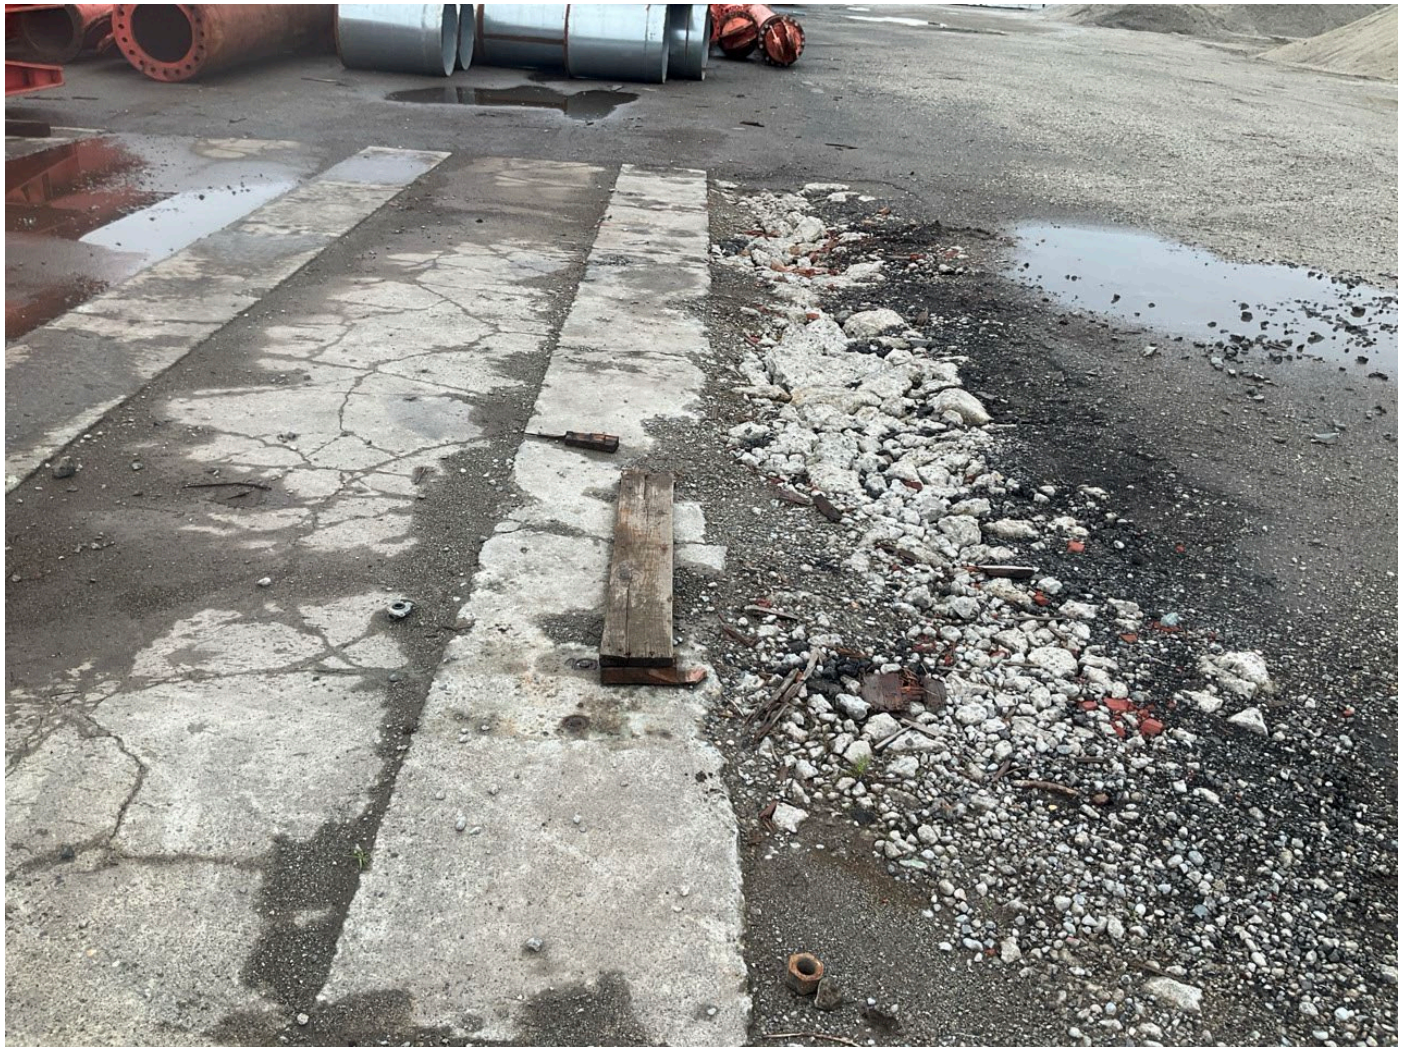
| B13 | Broken concrete | Yes | 10 | Broken concrete |

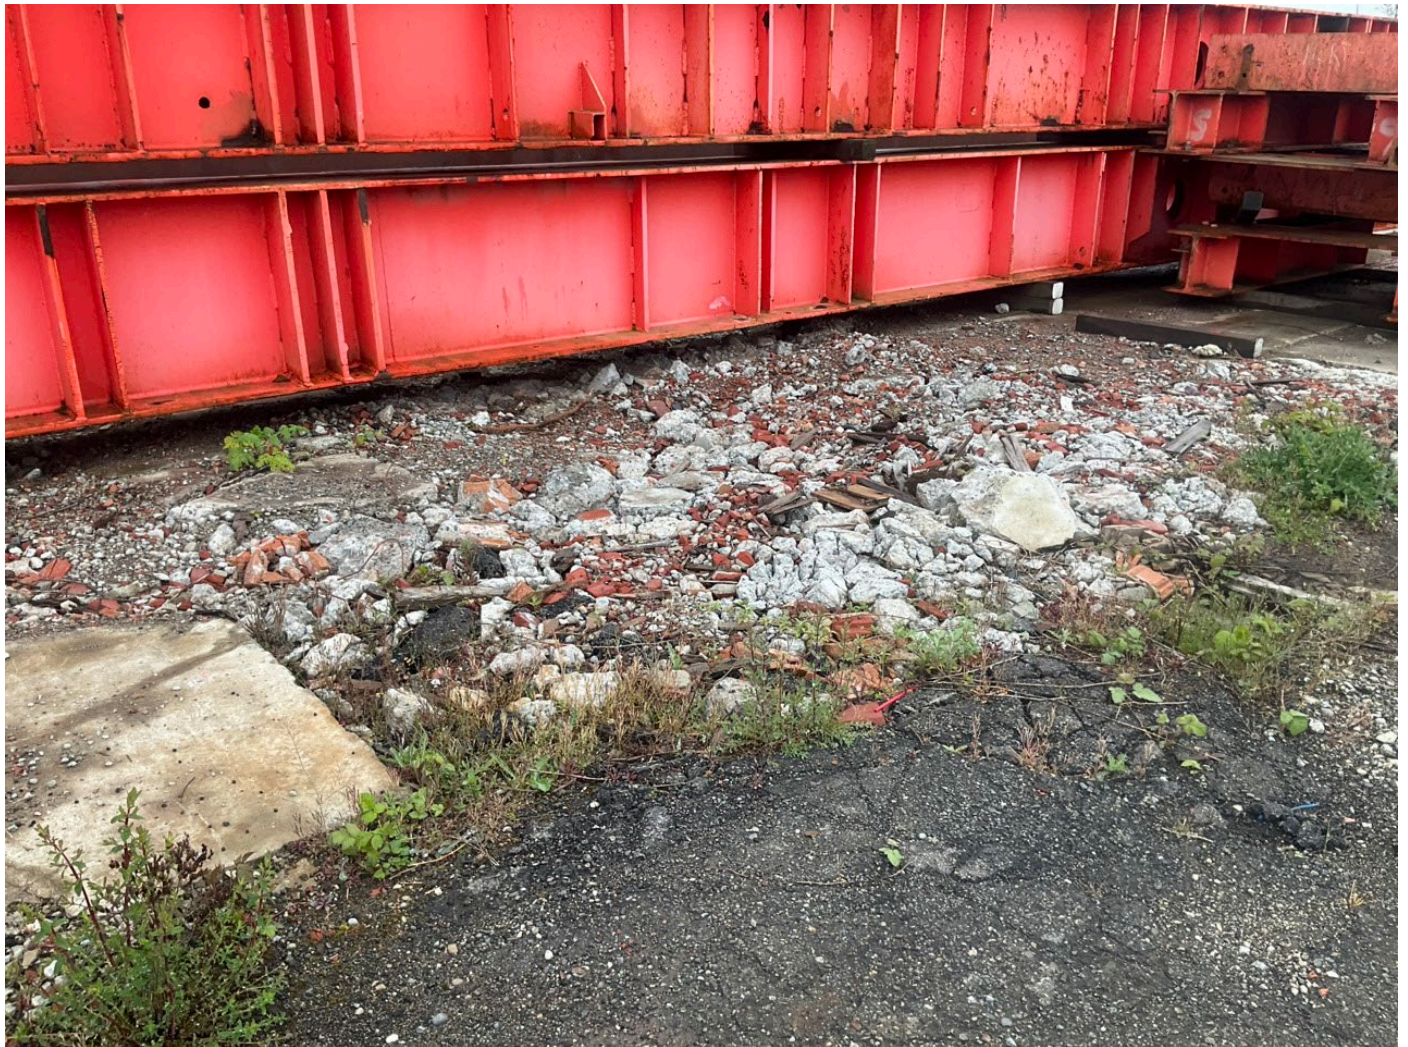
| B14 | Broken concrete | Yes | 5 | Broken concrete |
