# Memorandum

**To:** Ron Woolworth, W&W Everett Investments, LLC  
**Copies:** Frank Winslow, Washington State Department of Ecology  
**From:** Kristin Anderson, LHG, Floyd|Snider  
**Date:** June 16, 2026  
**Site Name:** Jeld-Wen Site  
**Re: Cap Condition Survey**

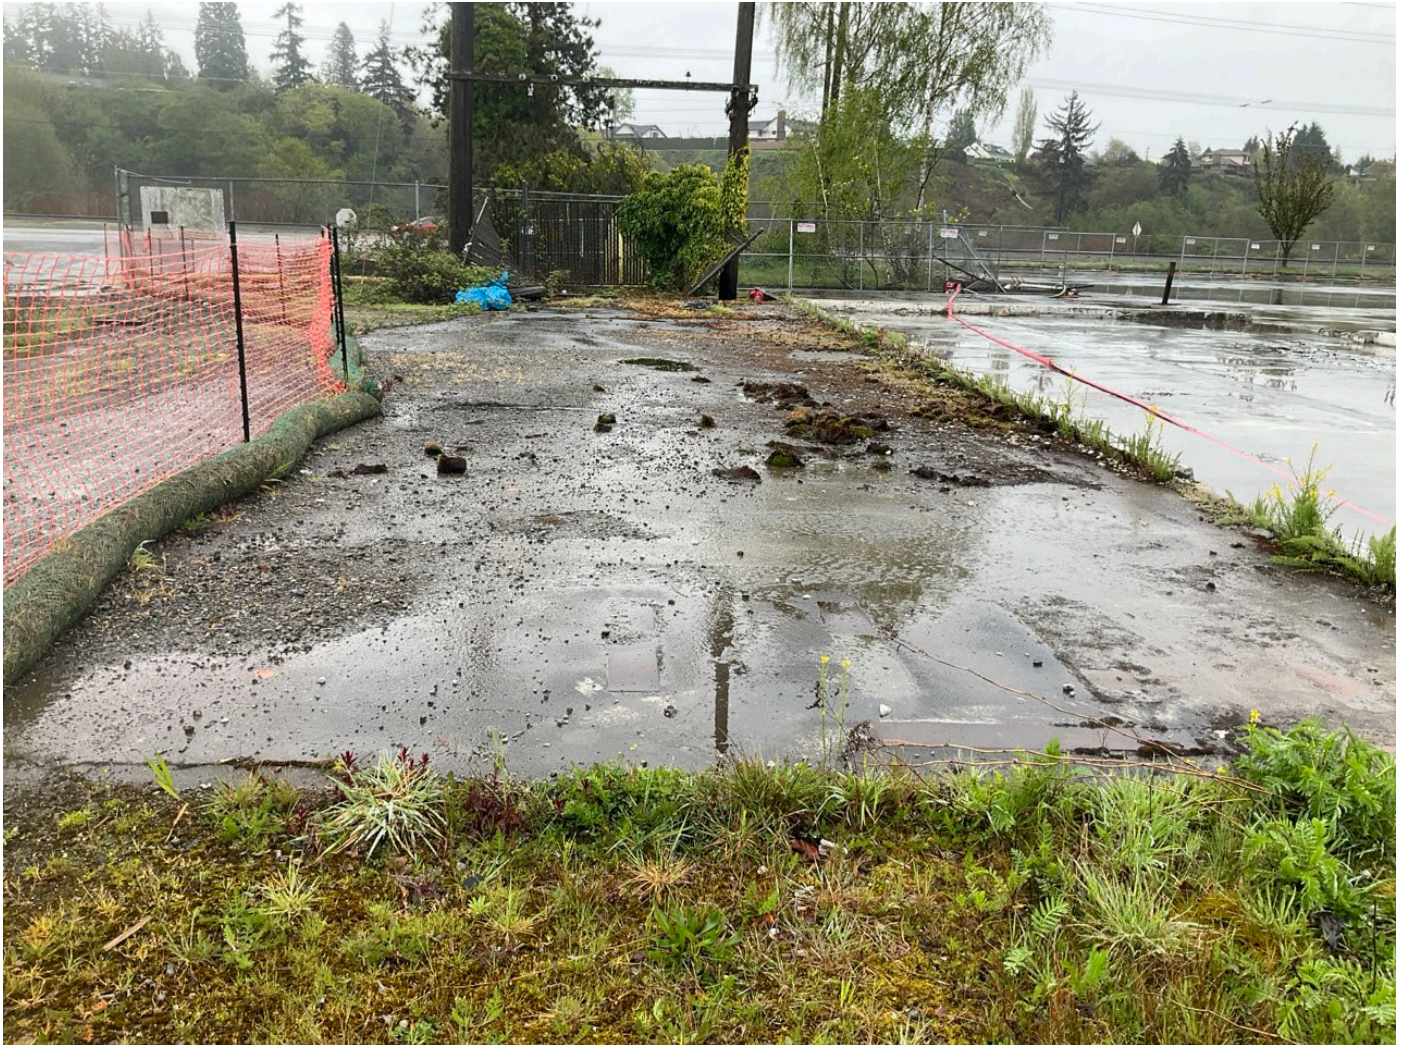
| Area ID | Surface Type | Erosion | % Bare Soil | Notes |
|---|---|---|---|---|
| B2 | Broken asphalt | Yes | 50 | Soil built up on surface, few plants |

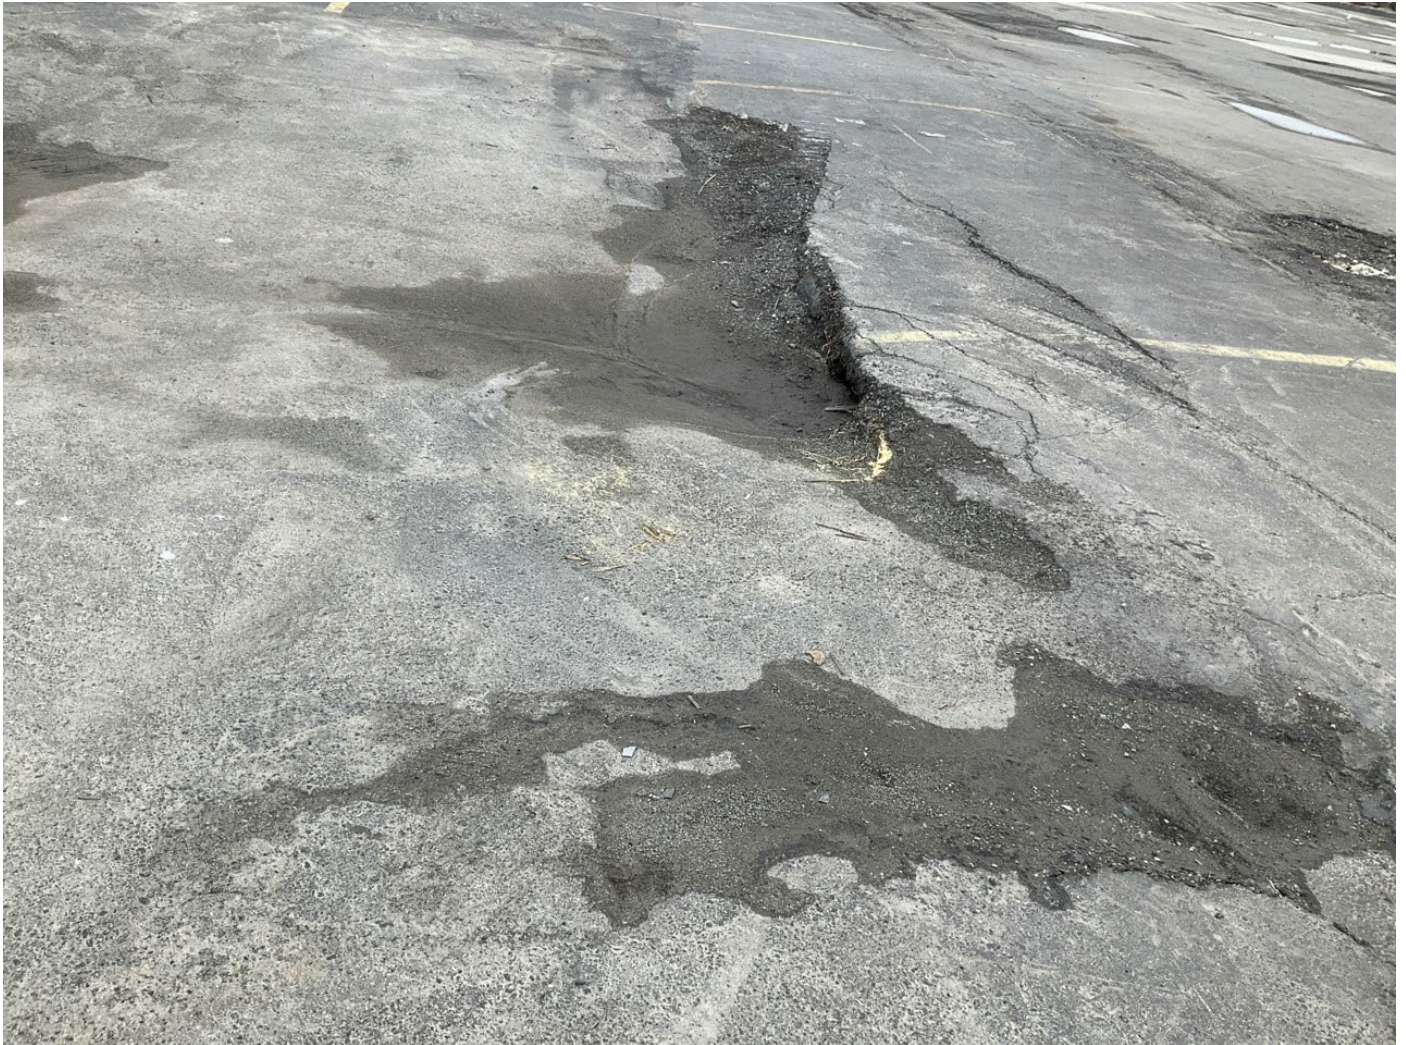
| B21 | Broken asphalt | Yes | 50 | Exposed fill, broken asphalt |

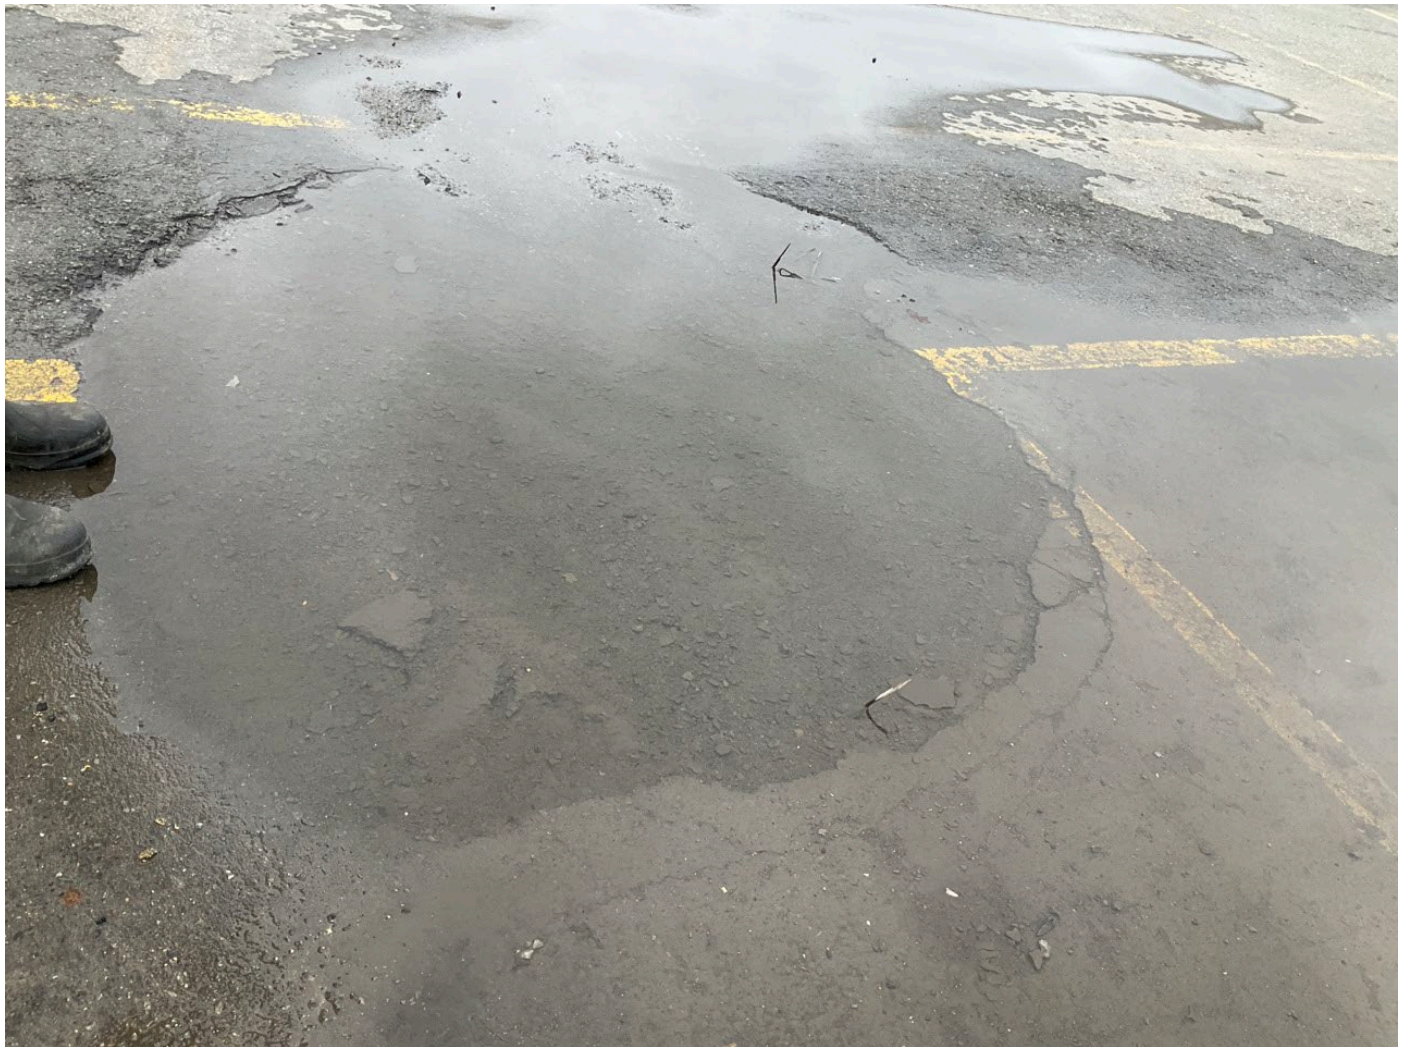
| B22 | Broken asphalt | Yes | 70 | Exposed fill |

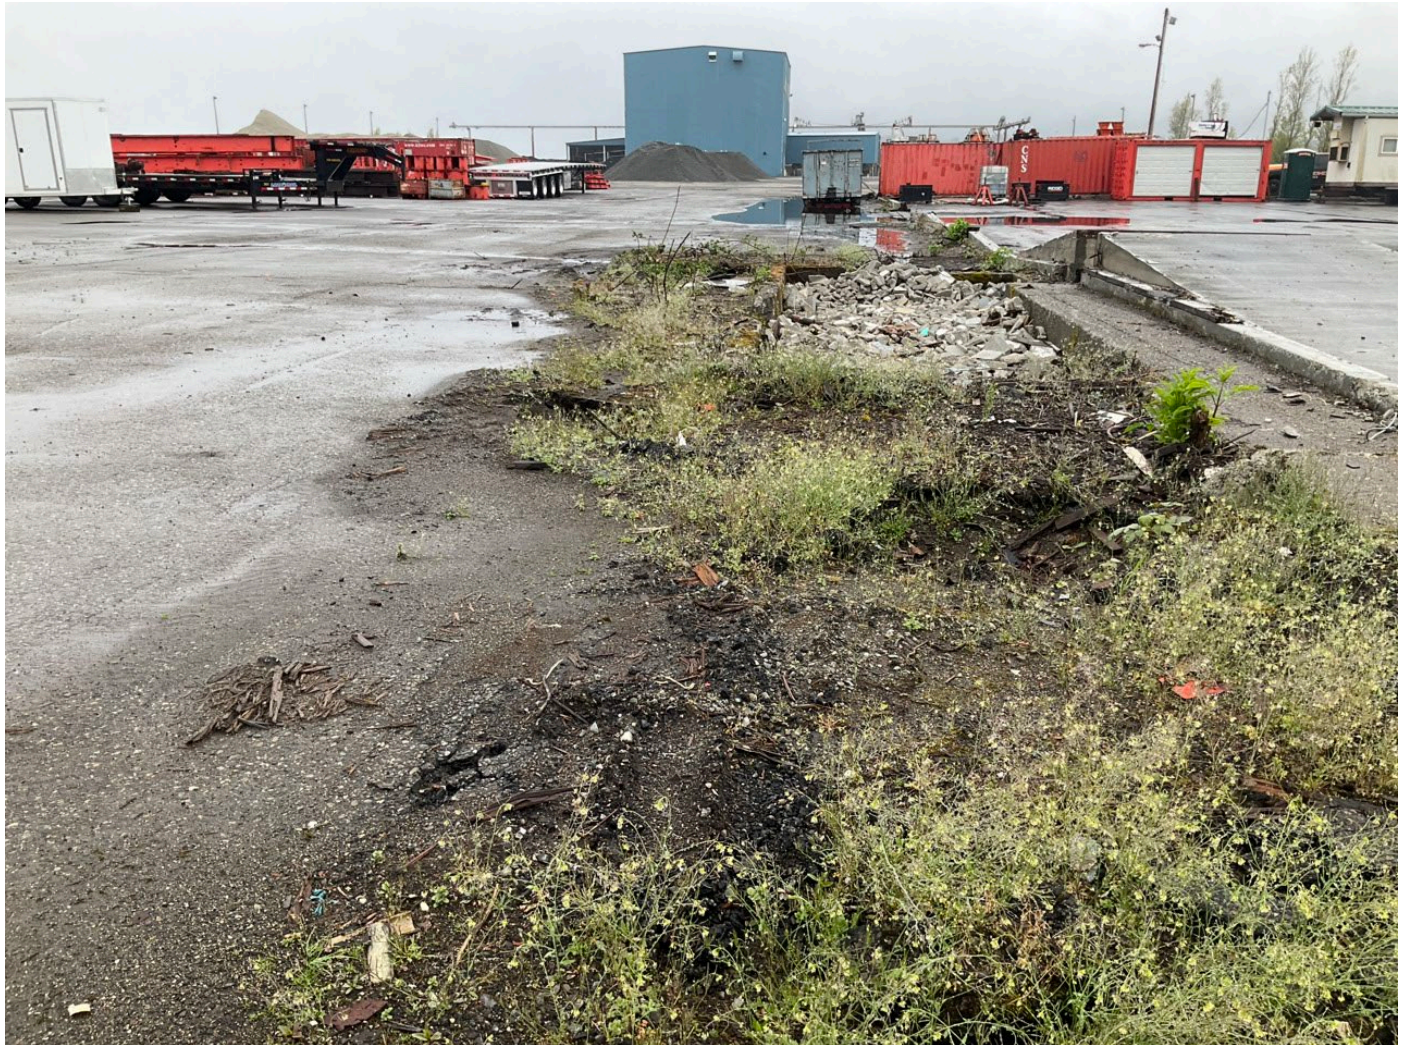
| B23 | Broken asphalt | Yes | 100 | Exposed fill, ponded water |

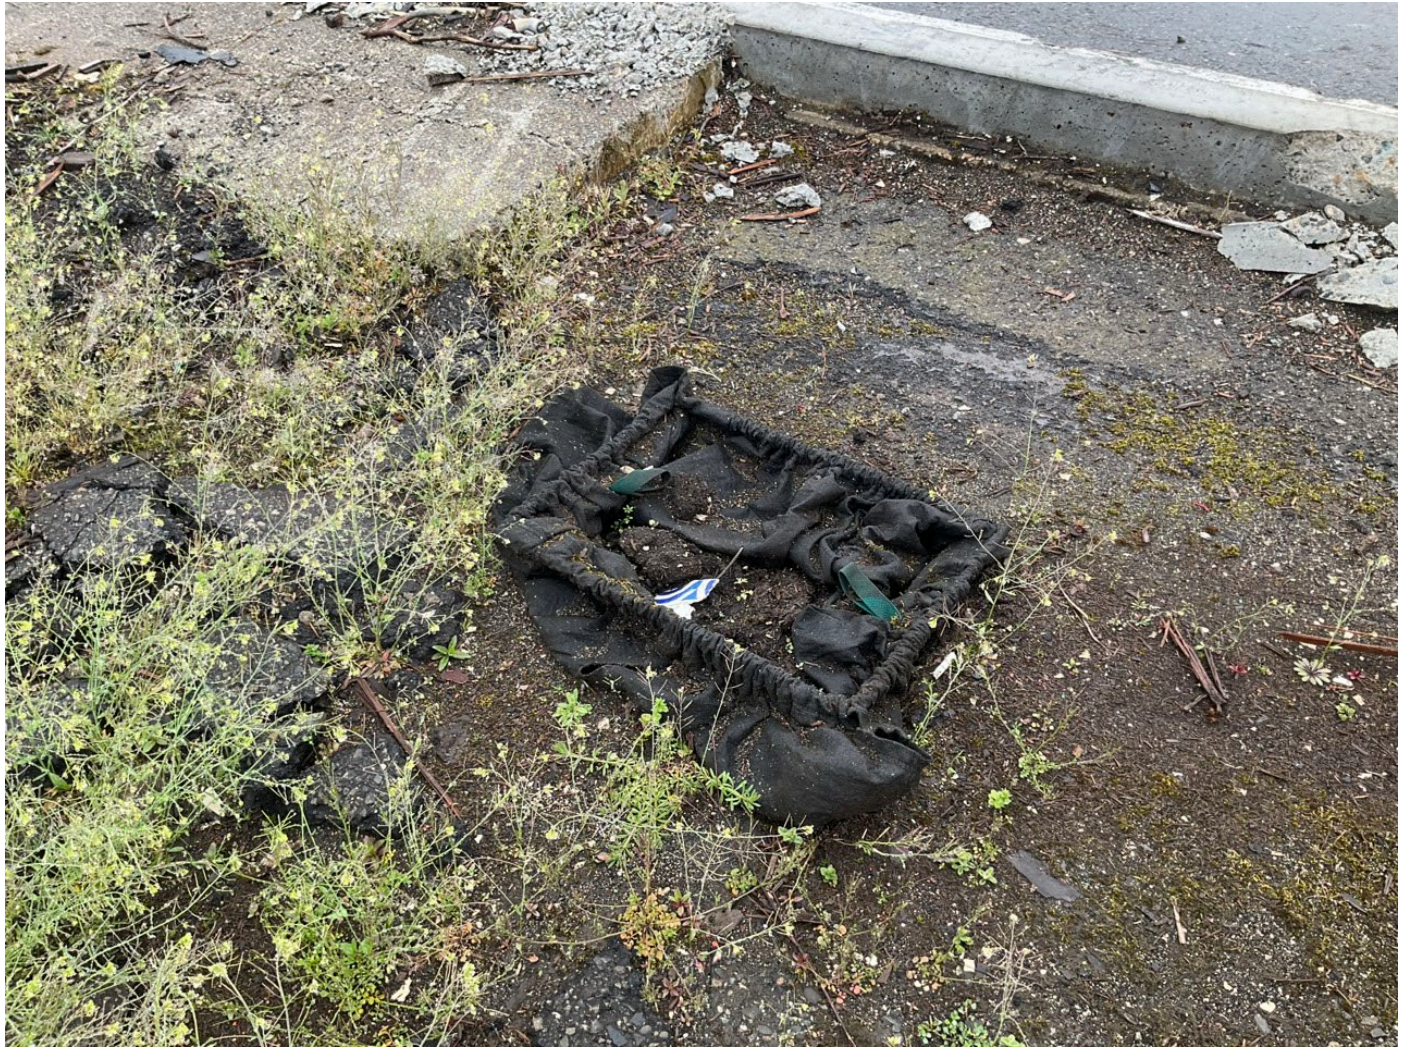
B3 1

| B3 | Broken asphalt | Yes | 70 | Exposed soil, vegetation, catch basin/filter |

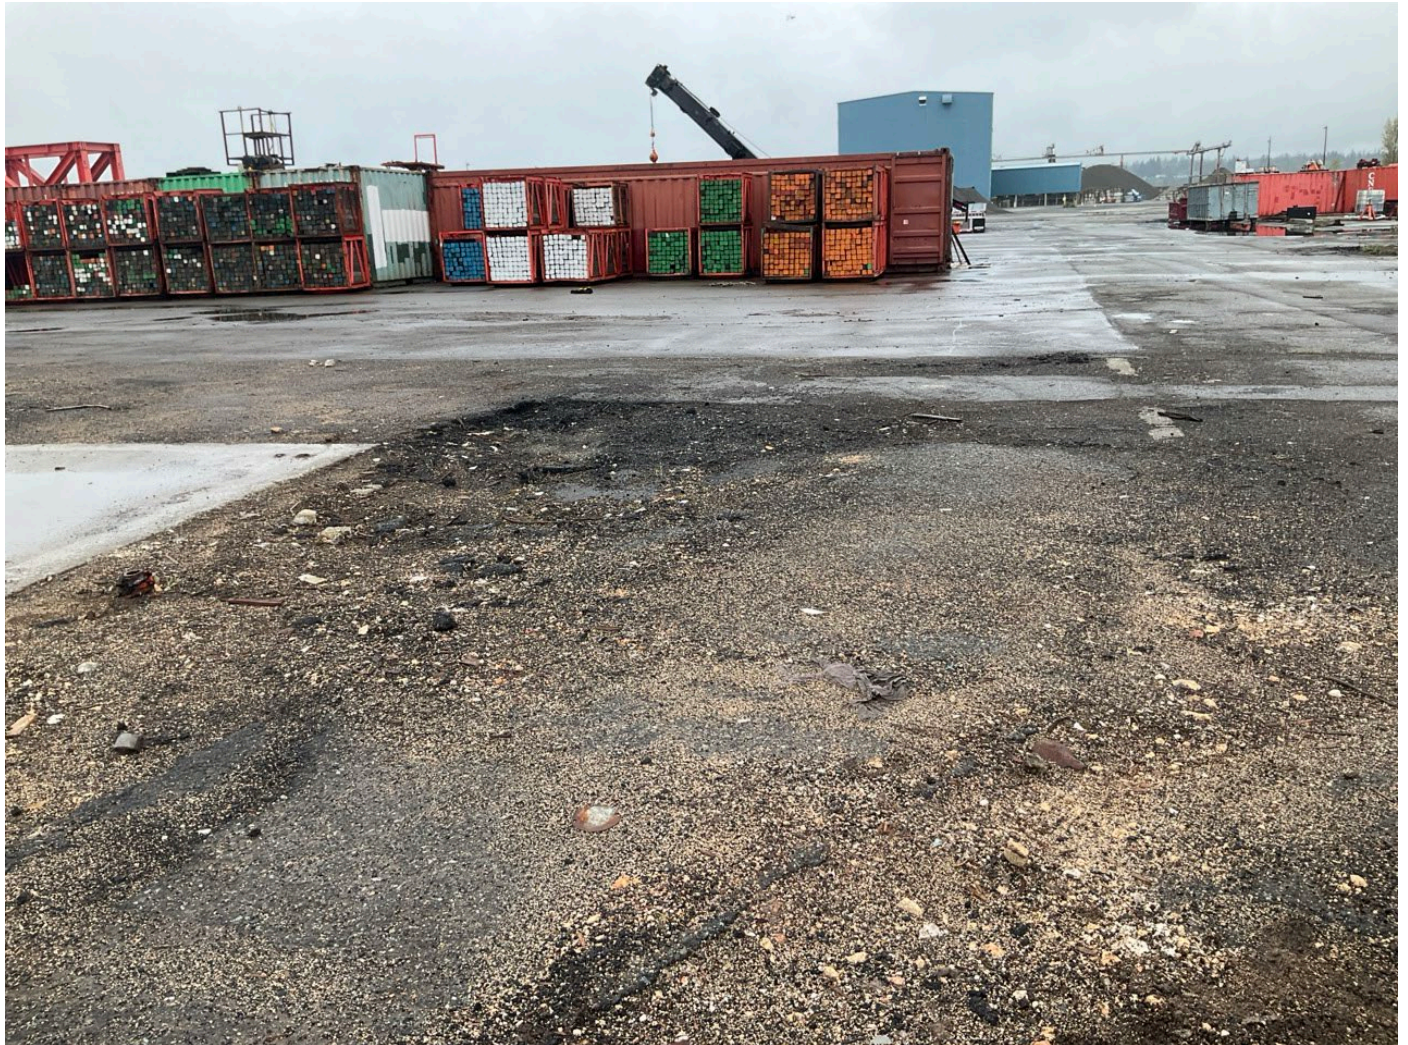
B4 1

Photograph 6. Polygon B4 with broken concrete/asphalt between slabs.

| B4 | Broken asphalt | Yes | 40 | Deteriorating asphalt, some exposed soil and vegetation |

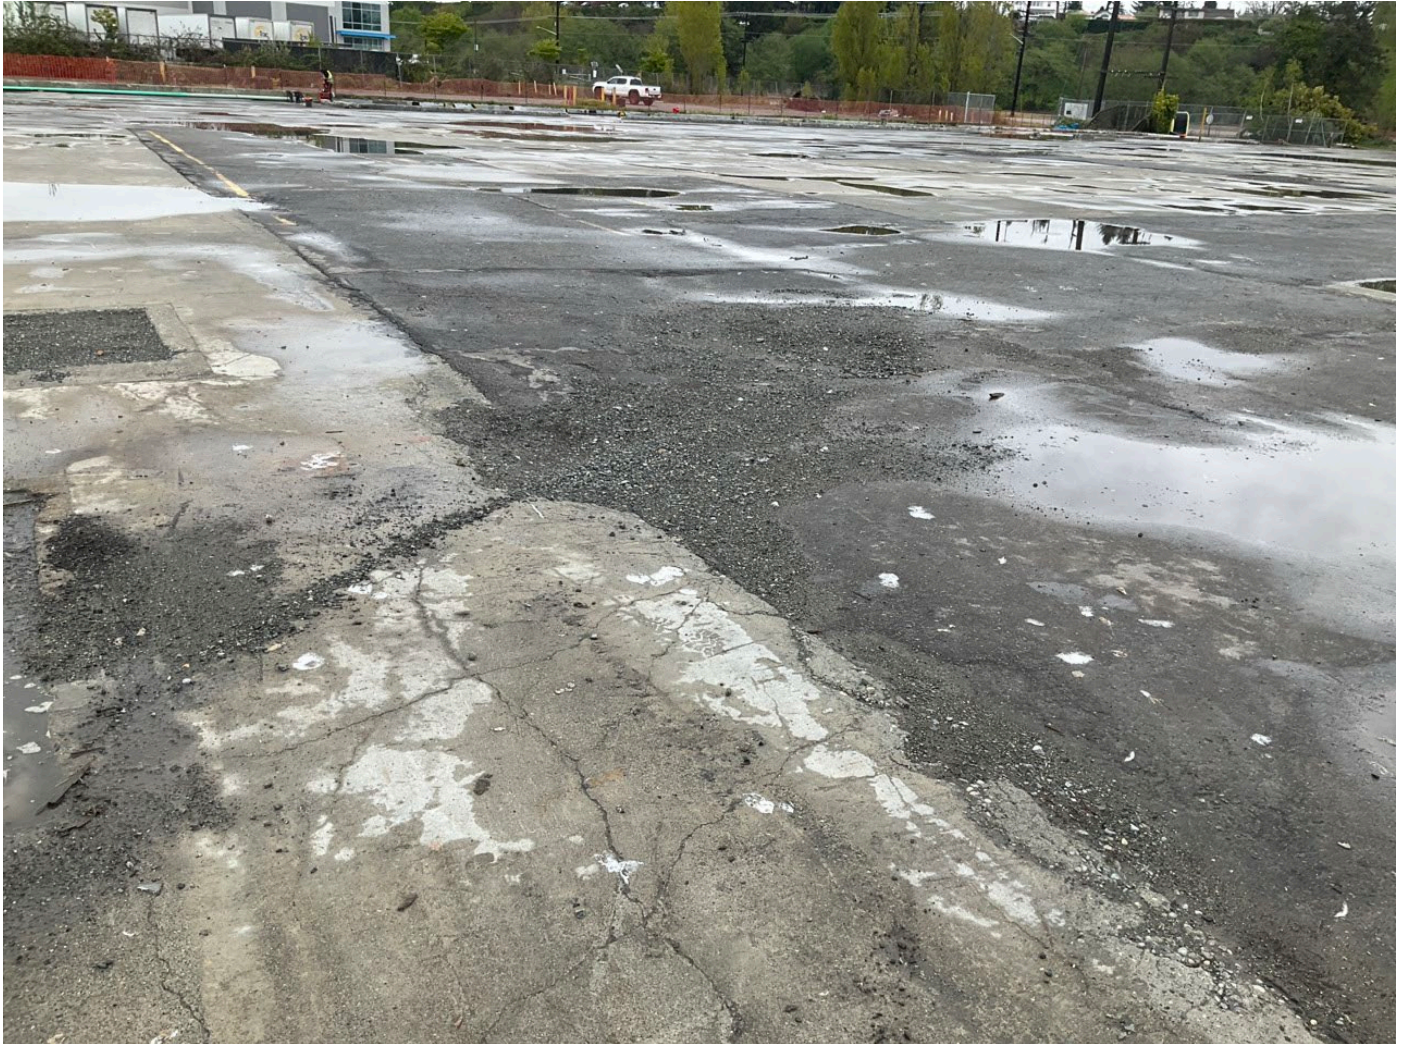
| B5 | Broken asphalt | Yes | 20 | Broken asphalt, some cracks/breaks |

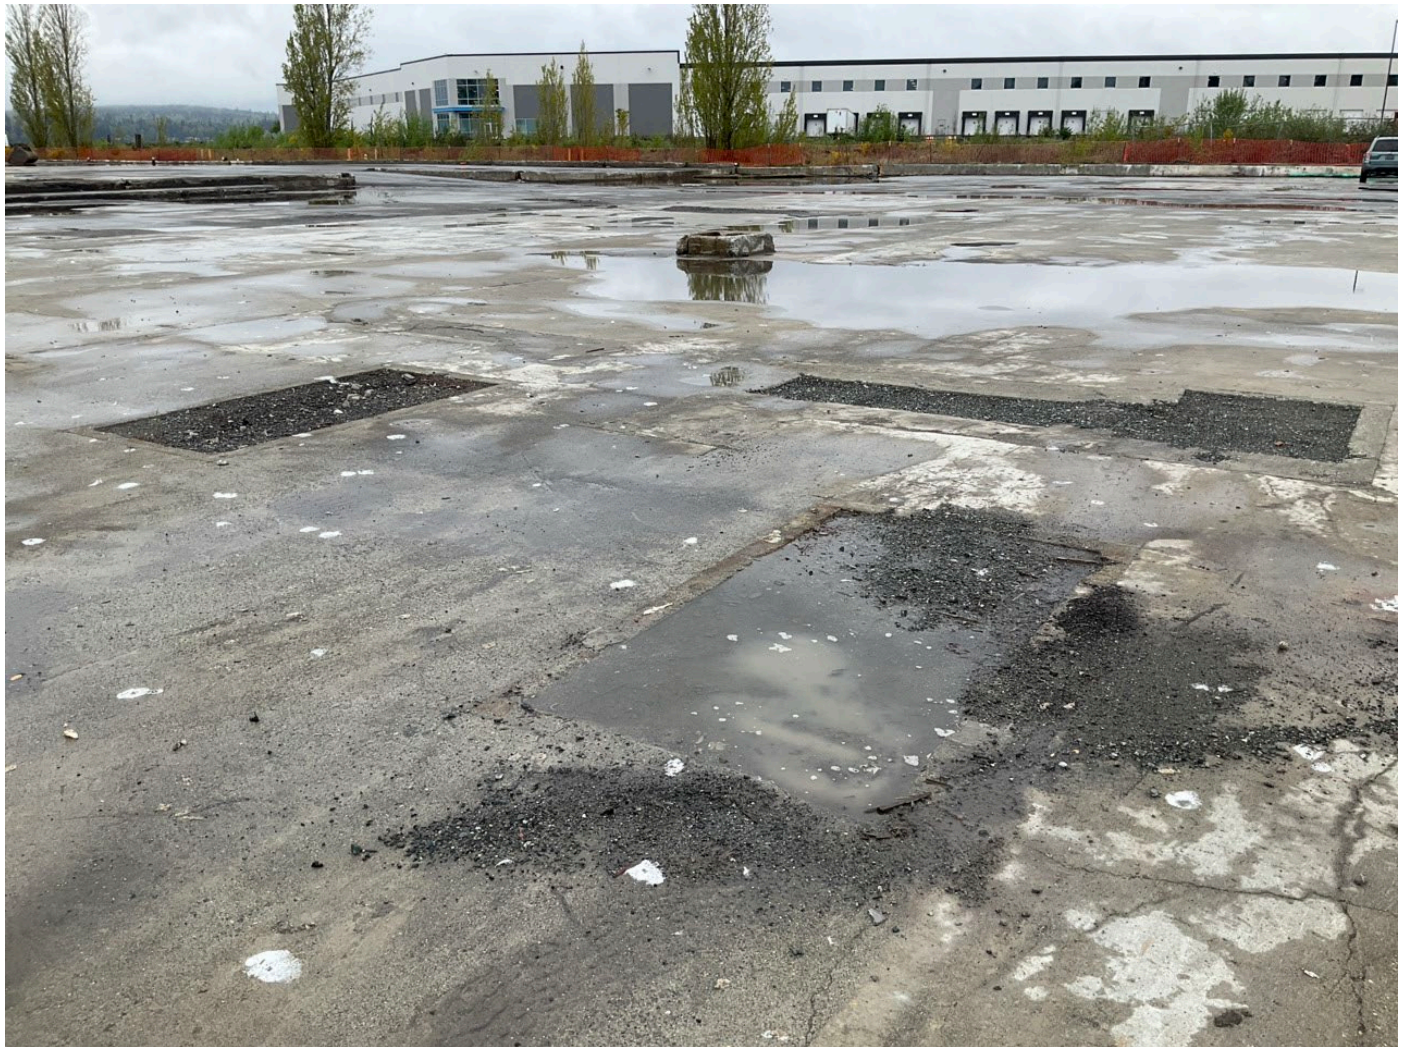
B6 1

| B6 | Broken concrete/asphalt | Yes | No | Deteriorating concrete/asphalt. Soil buildup |

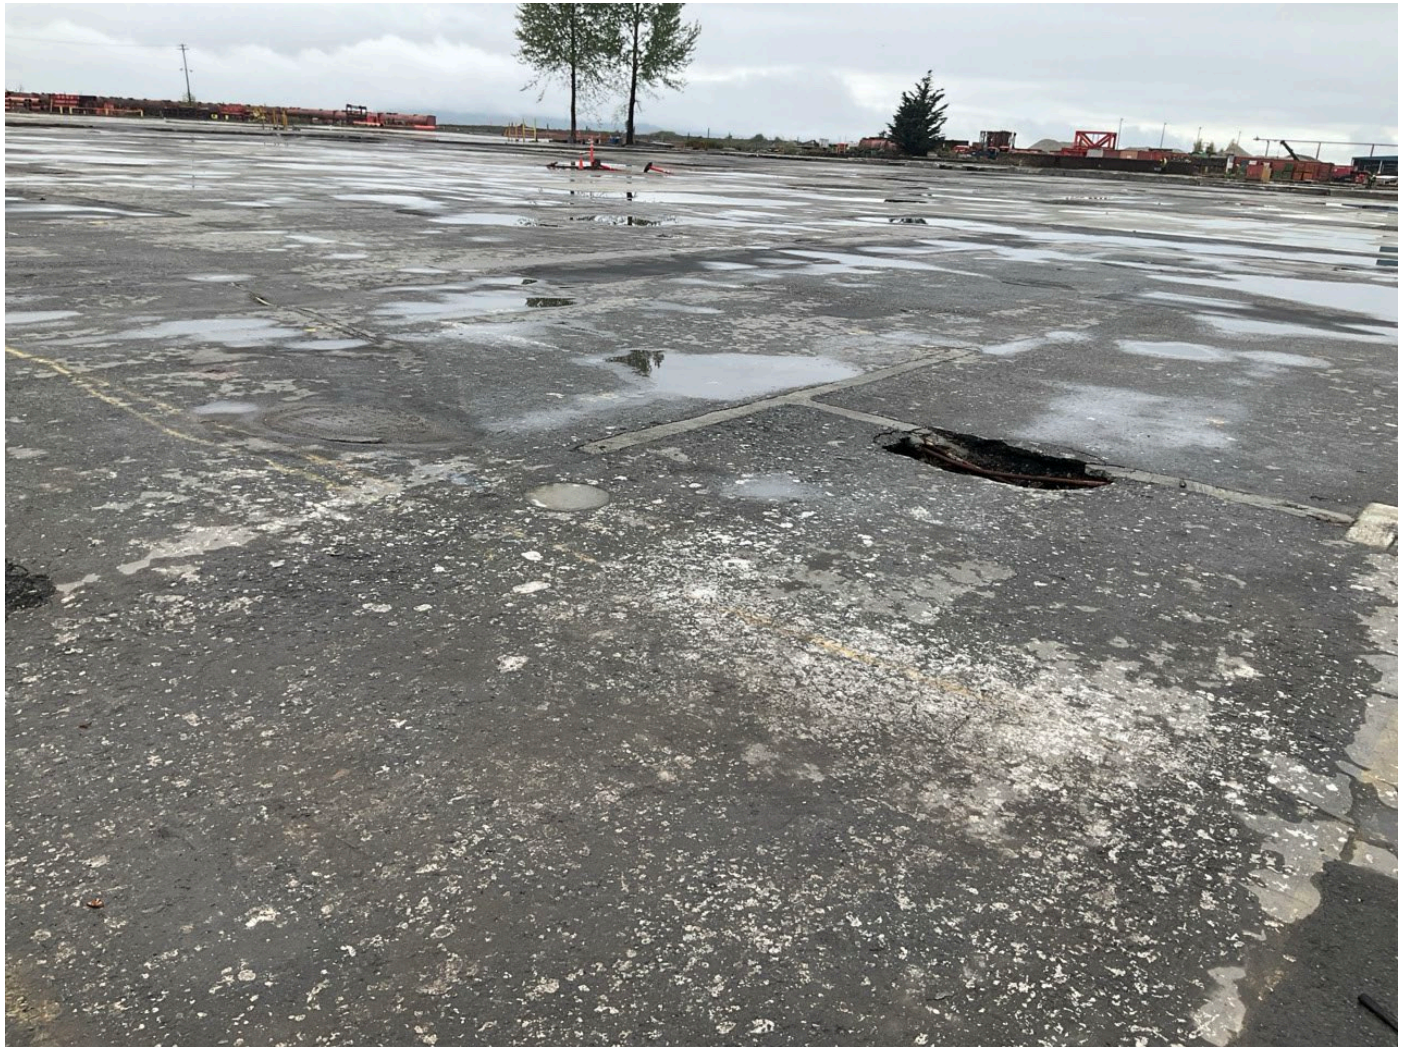
B7 2

| B7 | Broken asphalt | No | 20 | Deteriorating asphalt, pockets of exposed soil |

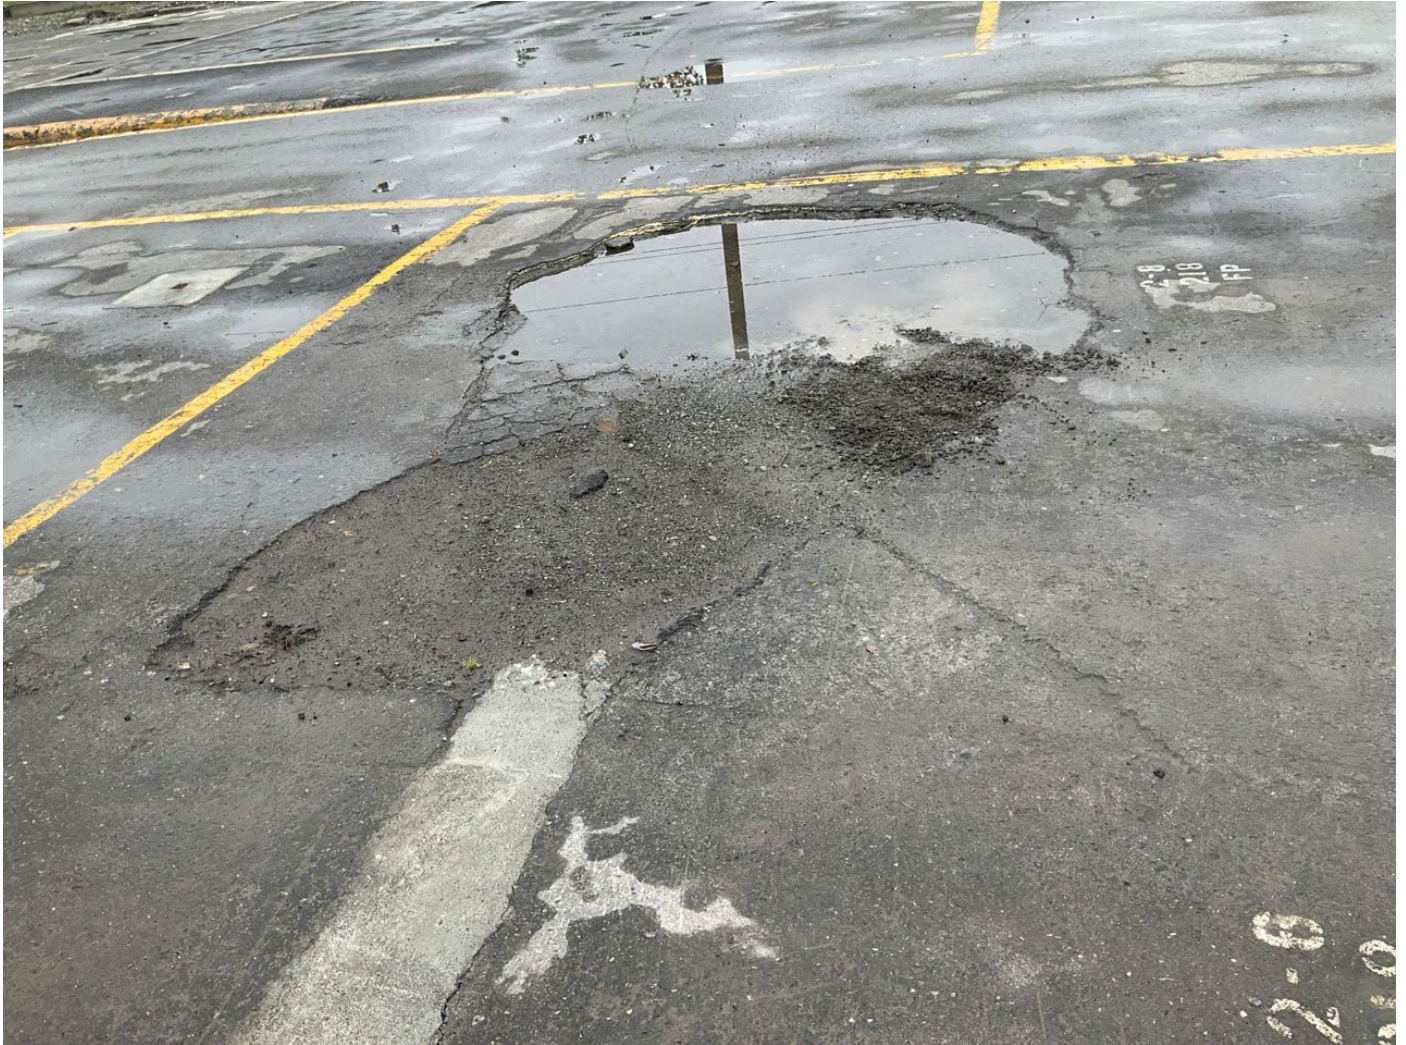
Photograph 8. Polygon B7 showing small areas of broken asphalt.

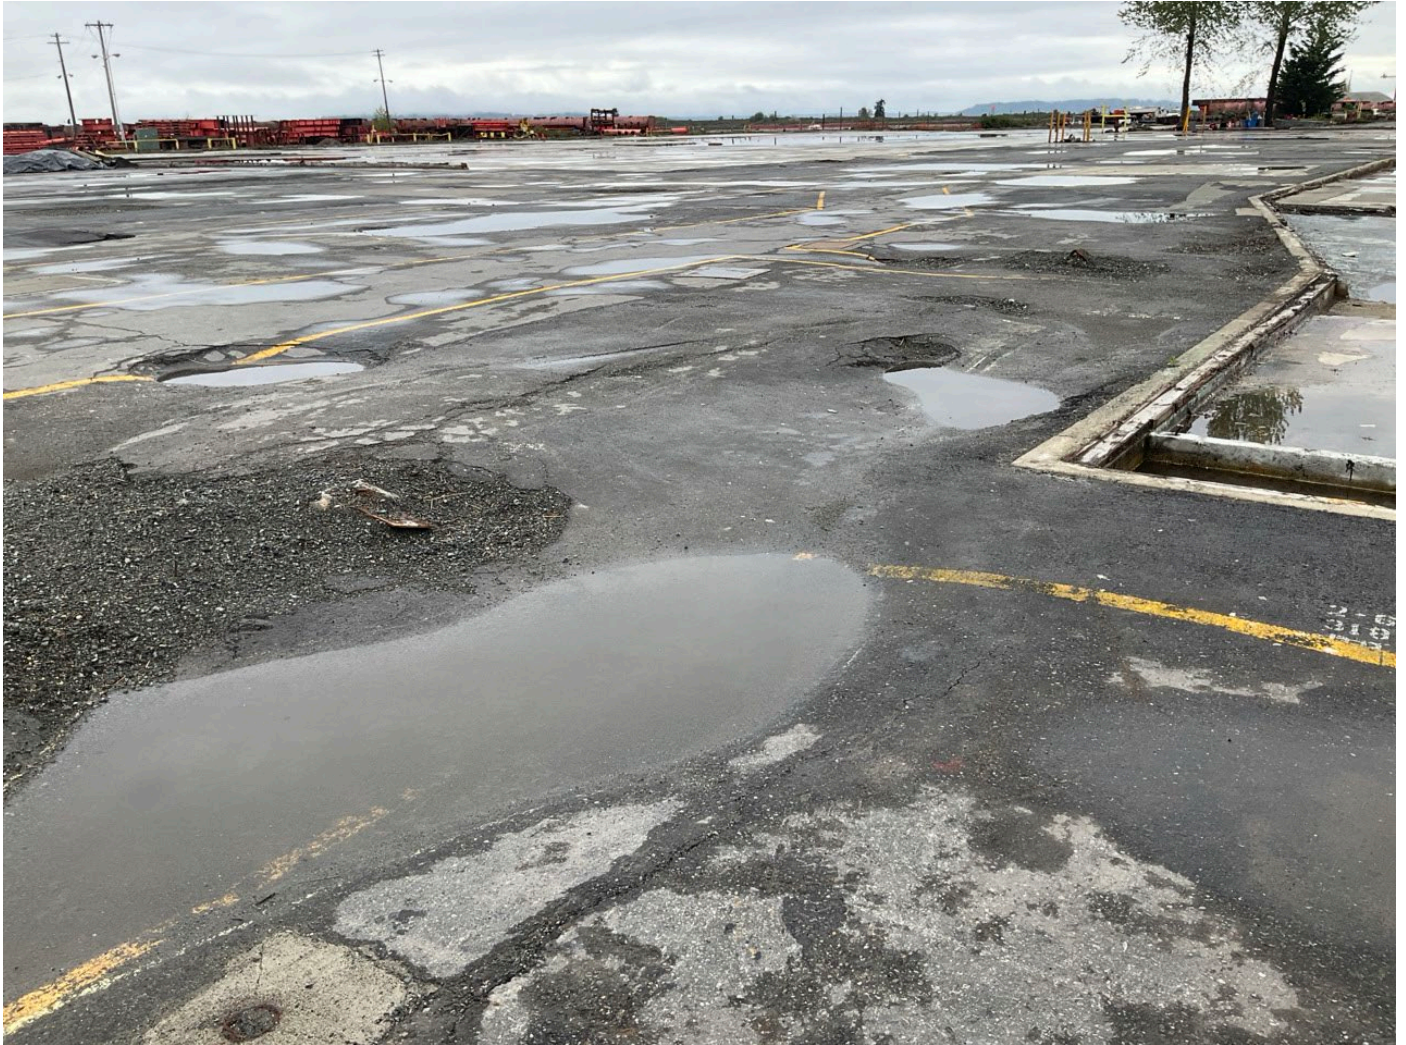
B8 (2)

| B8 | Broken asphalt | Yes | 70 | Broken asphalt, exposed soil |

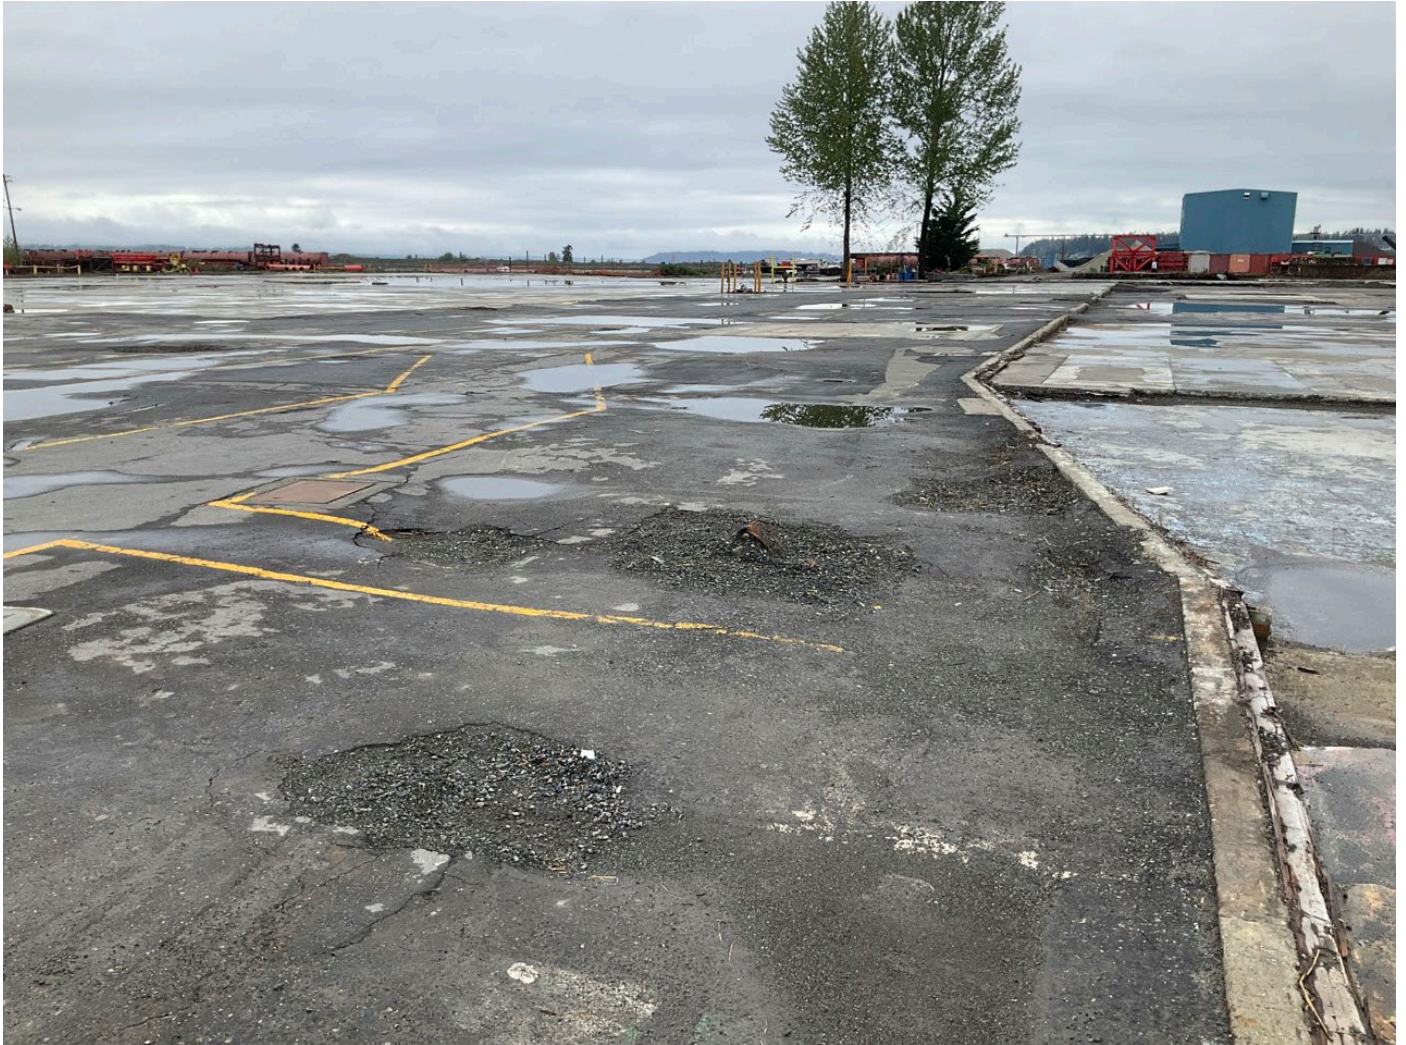
B9 (1)

| B9 | Broken asphalt | Minimal | 20 | Exposed soil pockets, broken asphalt with water |

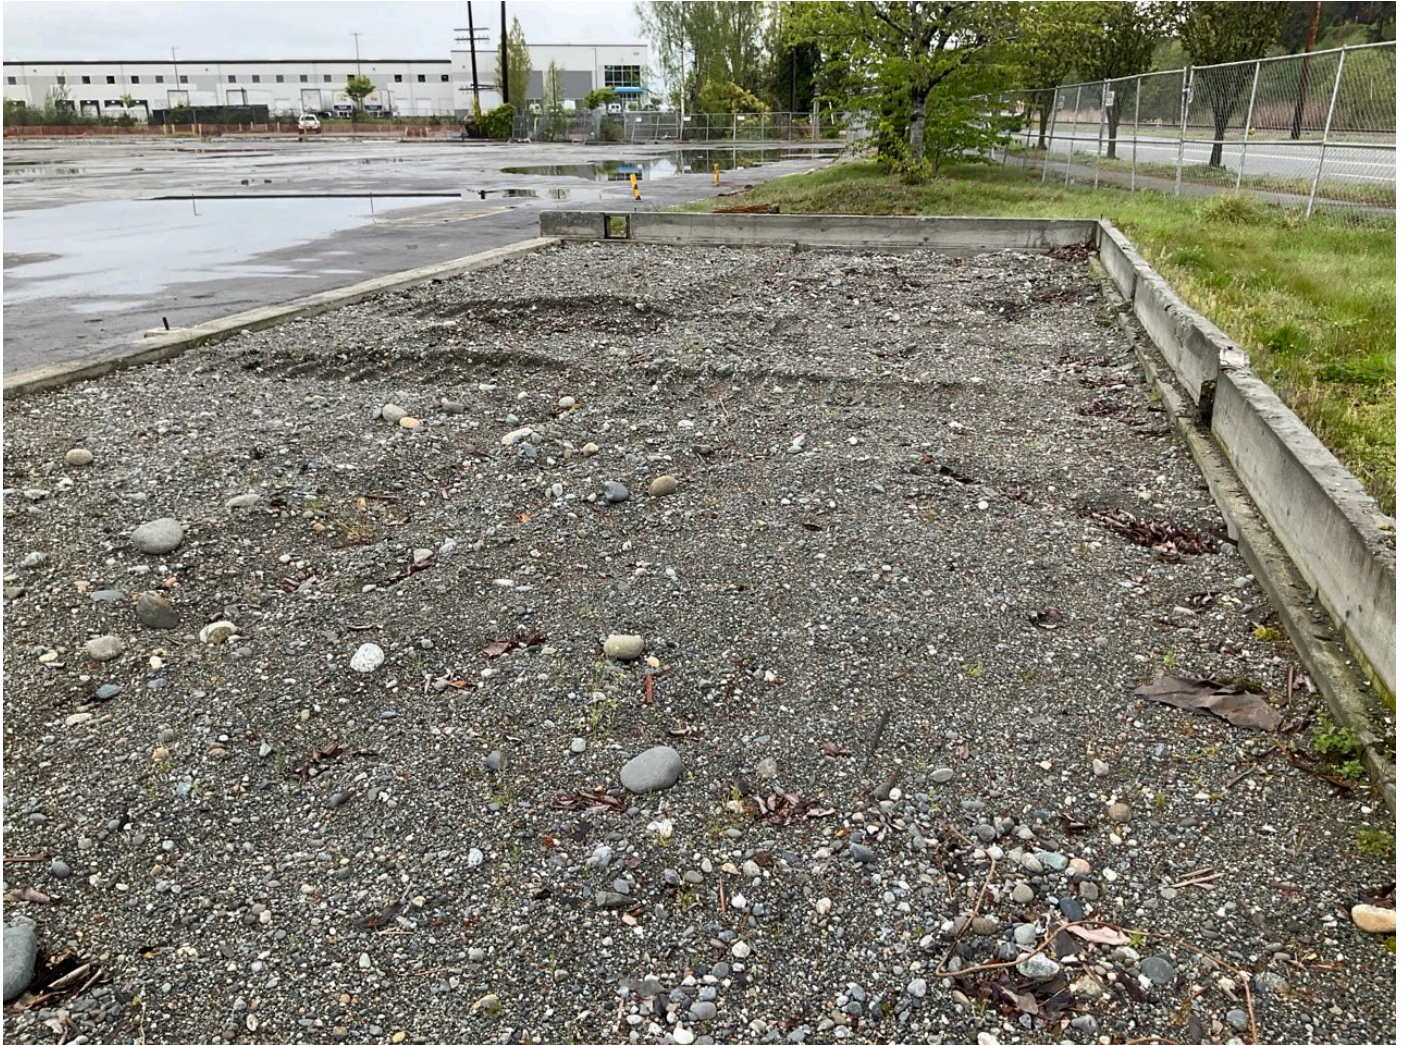
C9 (1)

| C9 | Gravel | Yes | 0 | Exposed fill, low sat and infiltrates |

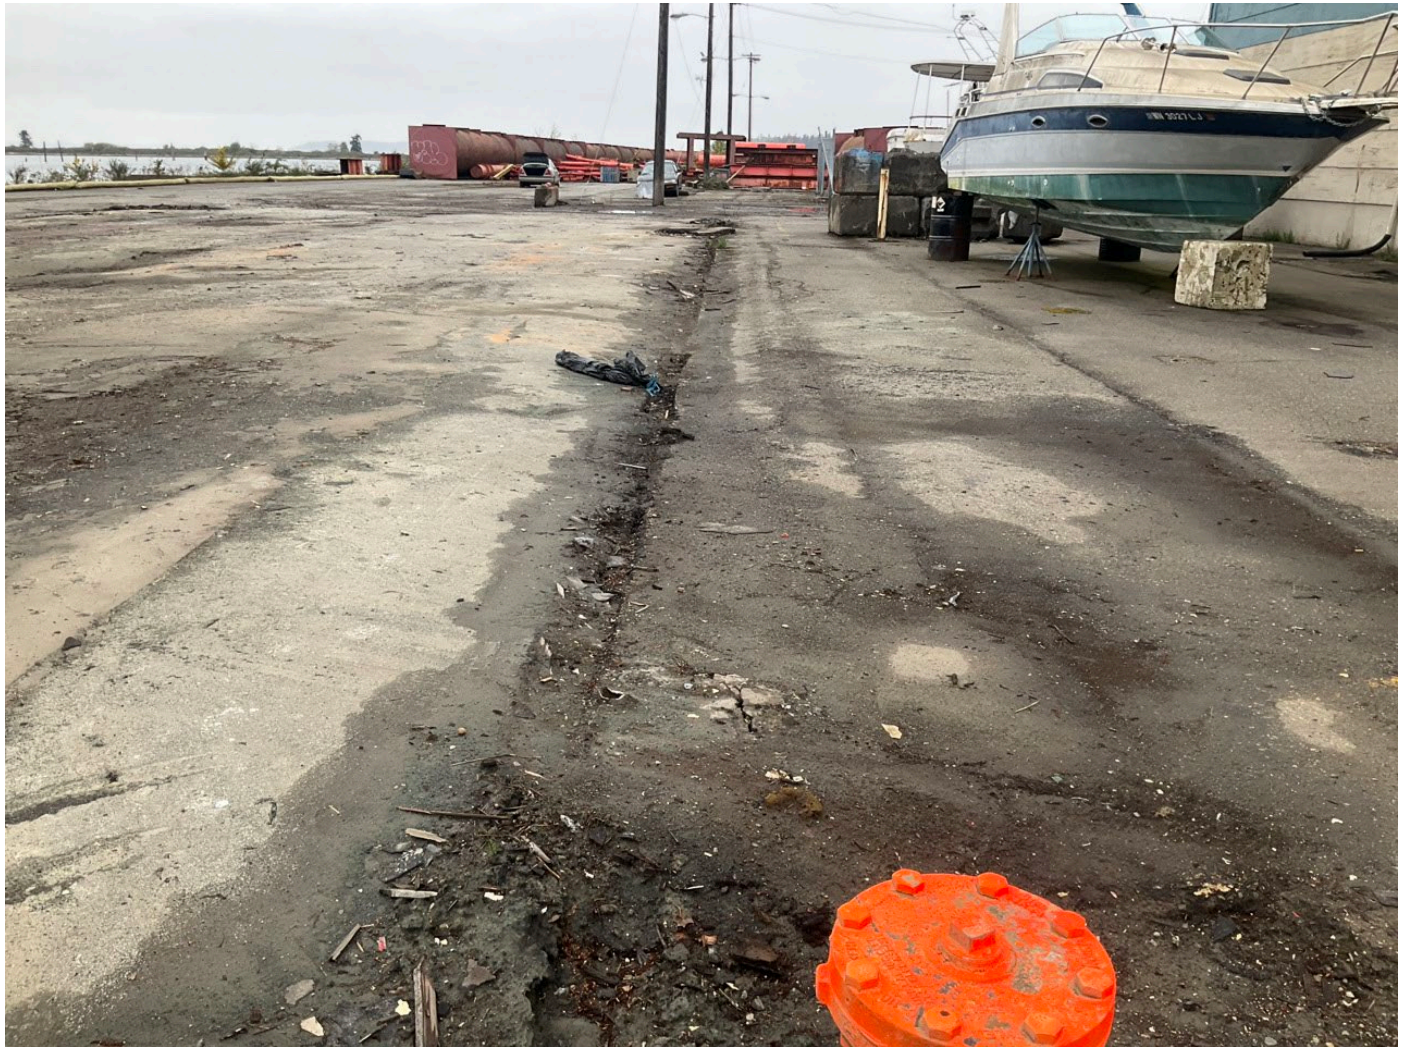
D5 (1)

Photograph 15. Polygon D5: exposed soil between asphalt and foundation.

| Area ID | Surface Type | Erosion | % Bare Soil | Notes |
|---|---|---|---|---|
| D5 | Exposed soil | Yes | 100 | Exposed soil between asphalt and concrete foundation |

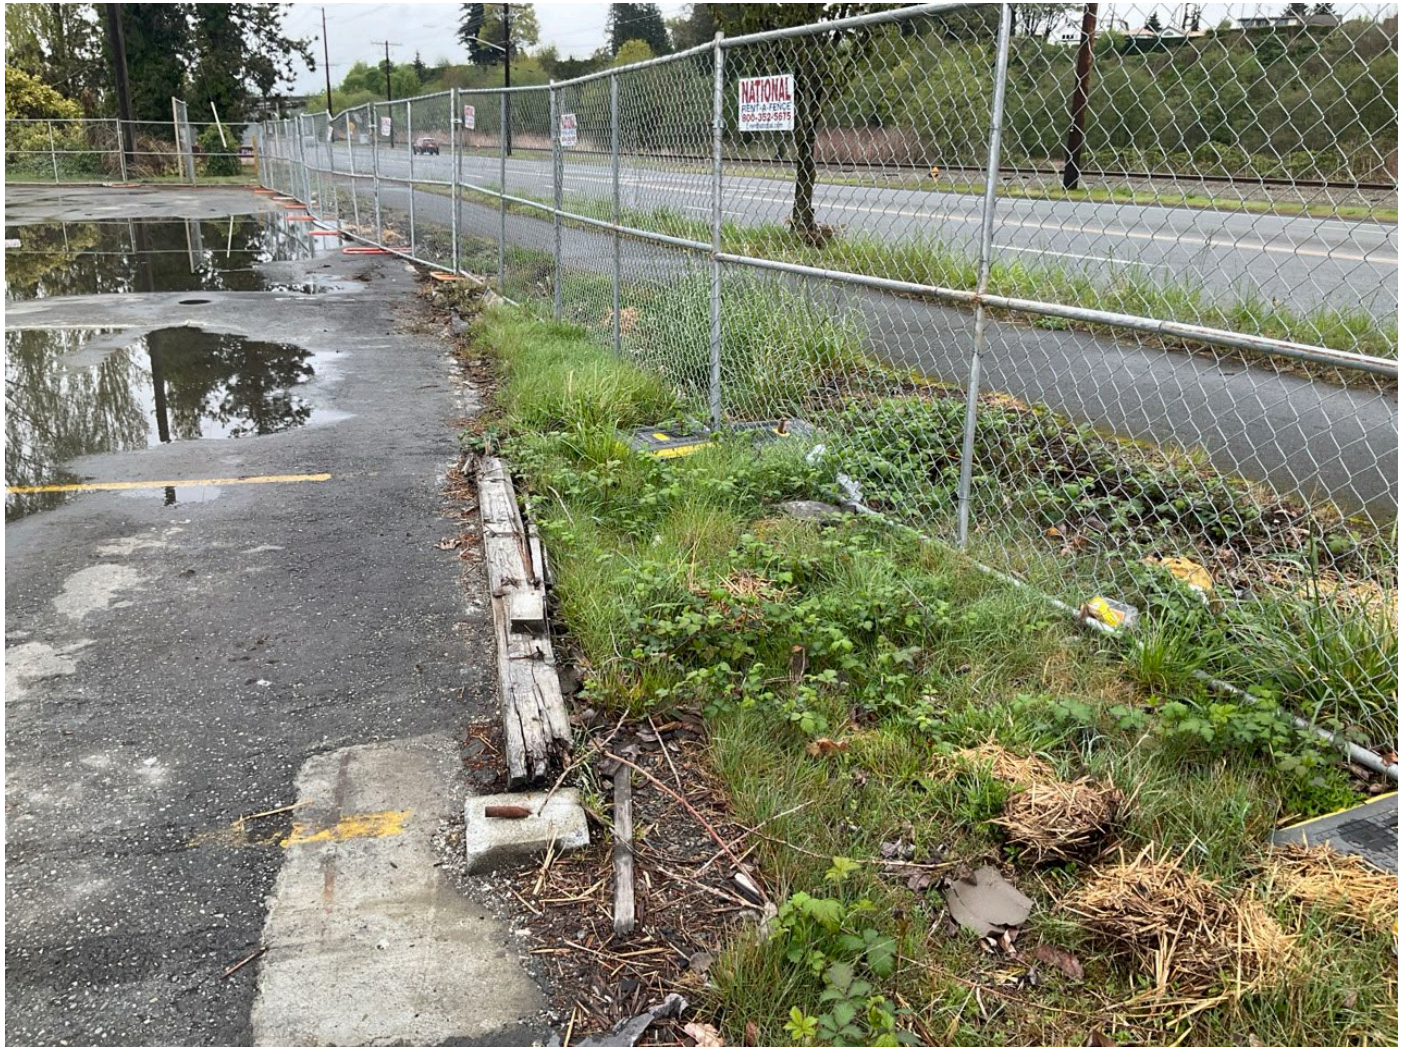
| Area ID | Surface Type | Erosion | % Bare Soil | Notes |
|---|---|---|---|---|
| E2 | Vegetation/gravel | Yes | 20 | Vegetation, gravel, soil mix, broken asphalt |
