# Memorandum

**To:** Ron Woolworth, W&W Everett Investments, LLC  
**Copies:** Frank Winslow, Washington State Department of Ecology  
**From:** Kristin Anderson, LHG, Floyd|Snider  
**Date:** June 16, 2026  
**Site Name:** Jeld-Wen Site  
**Re: Cap Condition Survey**

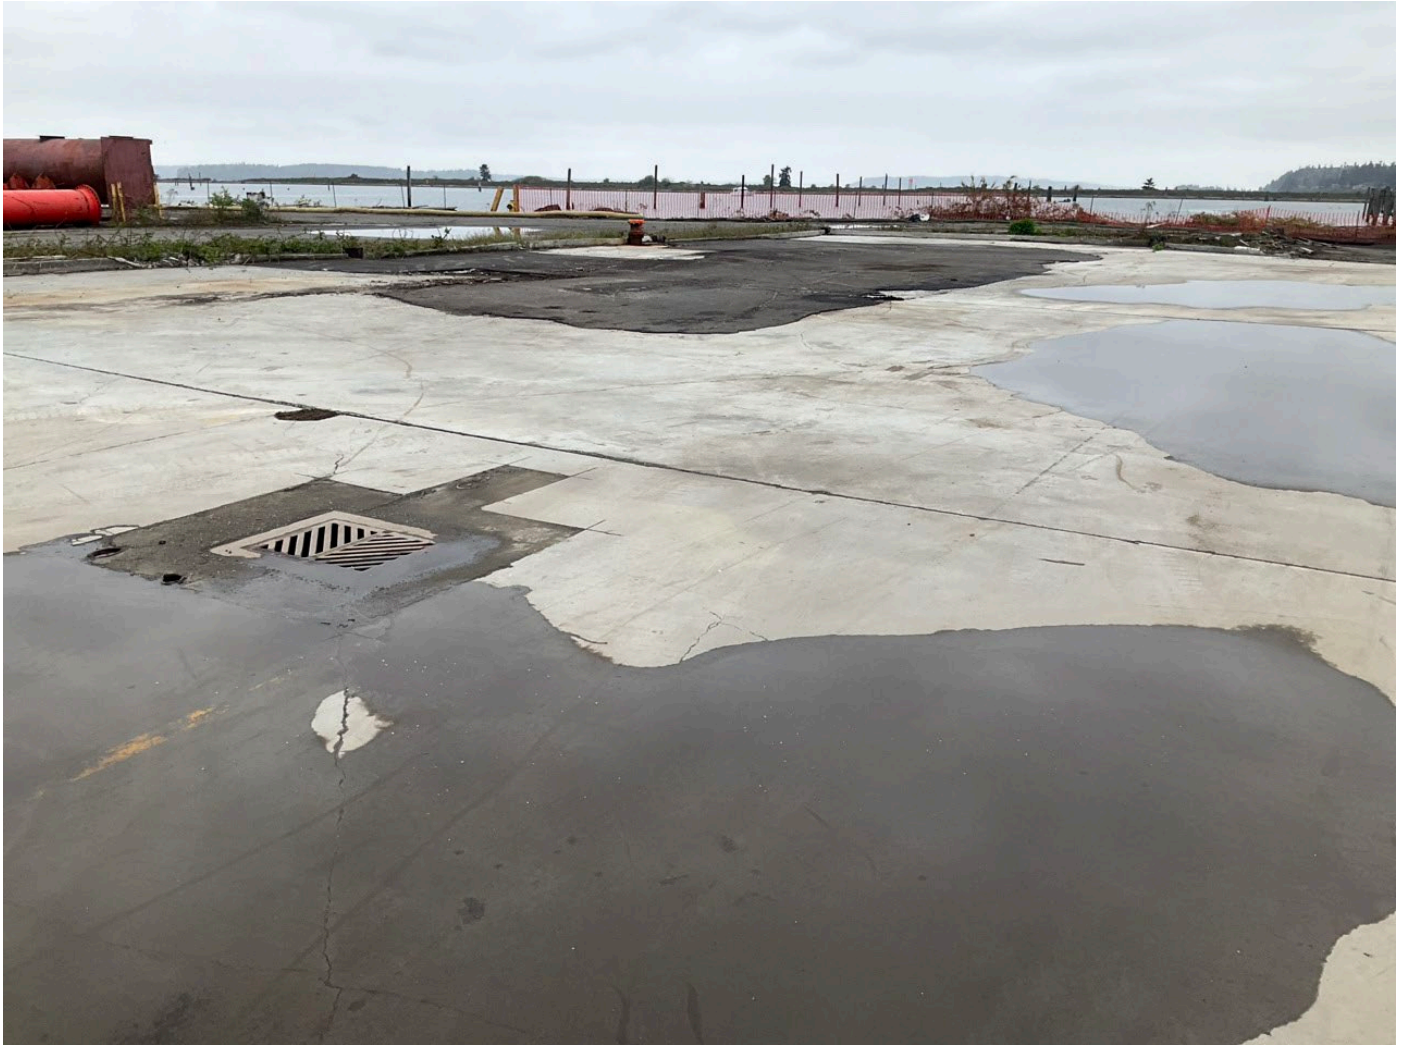
| Area ID | Surface Type | Erosion | % Bare Soil | Notes |
|---|---|---|---|---|
| F15 | Water | No | N/A | Ponded water near foundation |
