LANDSBURG MINE COAL MINE HAZARD ASSESSMENT

**Landsburg Mine Site PLP Group
31407 Highway 169
P.O. Box 10
Black Diamond, WA 98010**

**SubTerra, Inc.
PO Box 520
218 East North Bend Way
North Bend, WA 98045**

**Project No. 2001-45
May 2005**

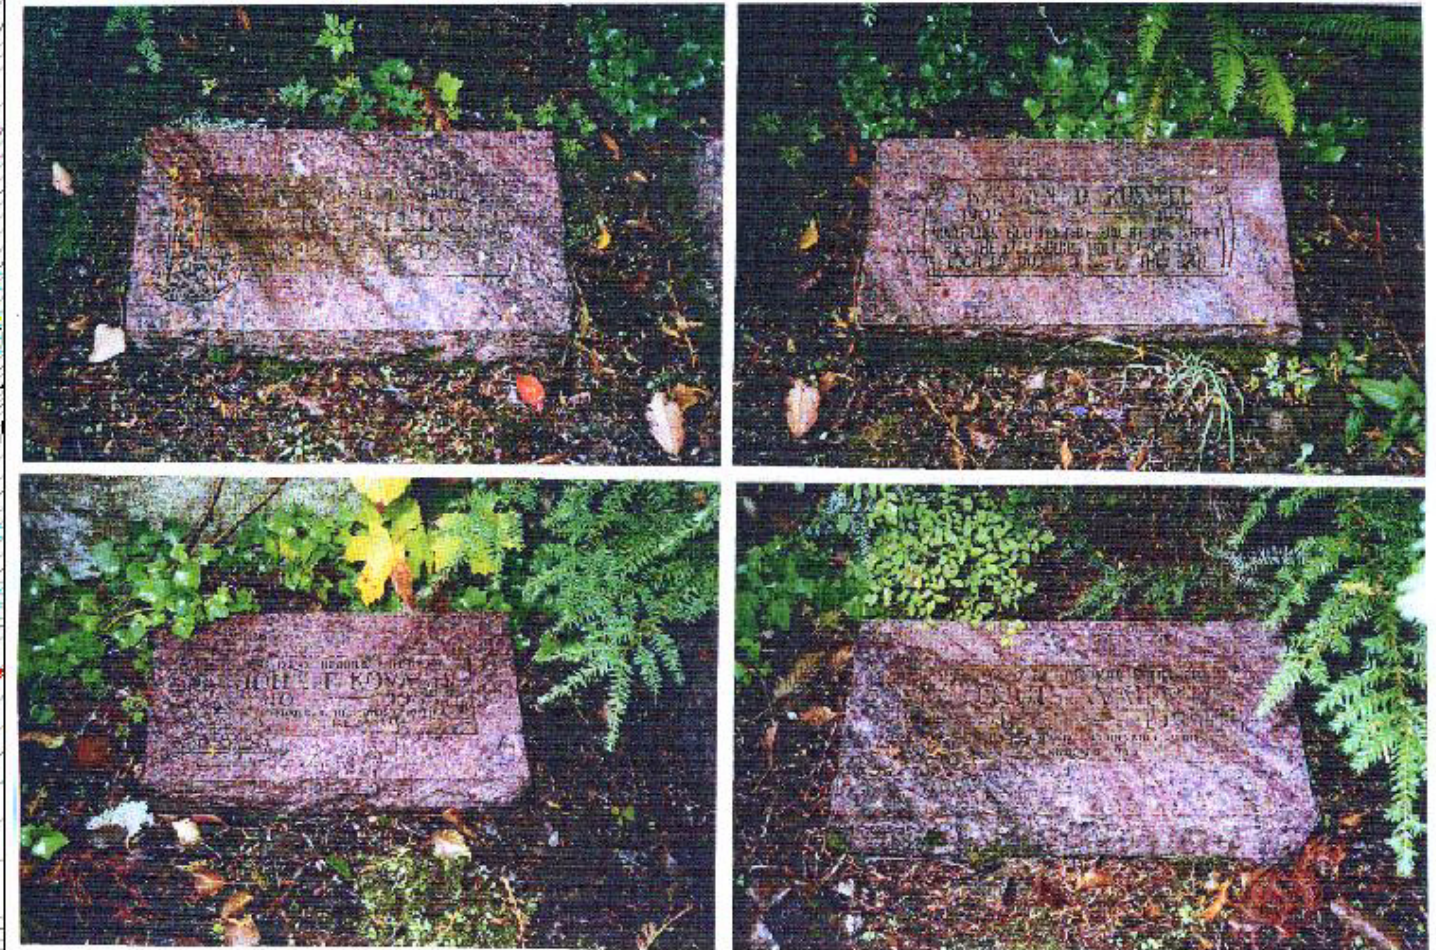
Figure 7
Landsburg Mines Memorial

- In the mean time, severe coal mine hazard areas may be utilized as suggested in Ordinance 21A.24.210 with the exception that structures should not be constructed above any areas that are judged to be prone to sinkhole type subsidence.
- The records indicate that a memorial was set up to commemorate the deaths of Frank Stebly, Louis Valenti, John Kovash, and Nathan Russel following the January, 1955 cave-in at the Landsburg Mine. This location and a picture of this memorial are shown in Figure 7.

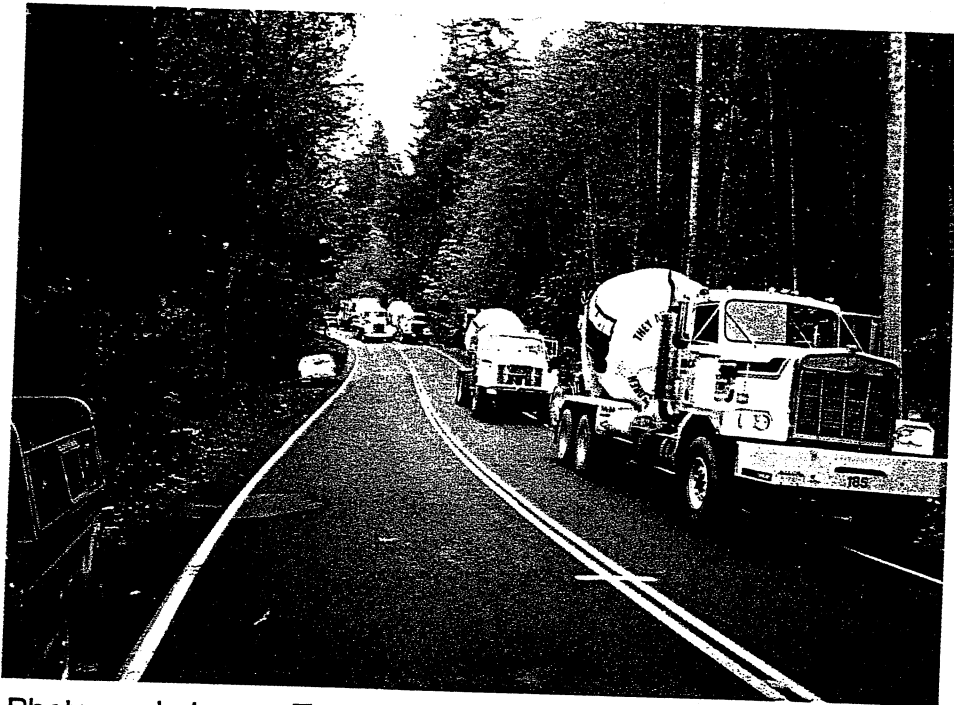
Photograph 1 - Trucks with CDF for L-01 backfilling.

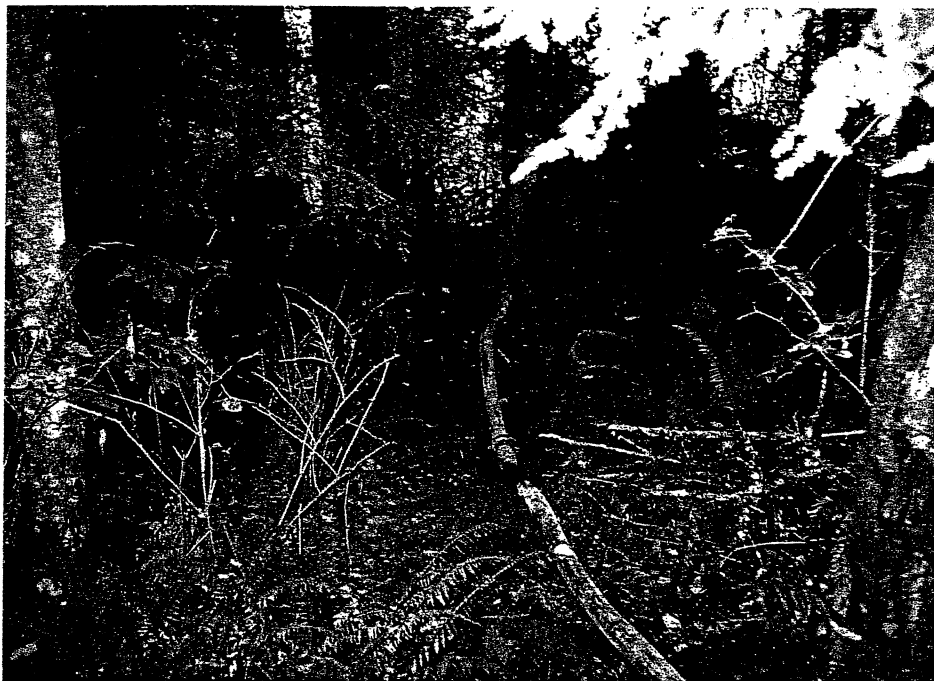
Photograph 3 - Hoses from pump through wooded area to L-01.

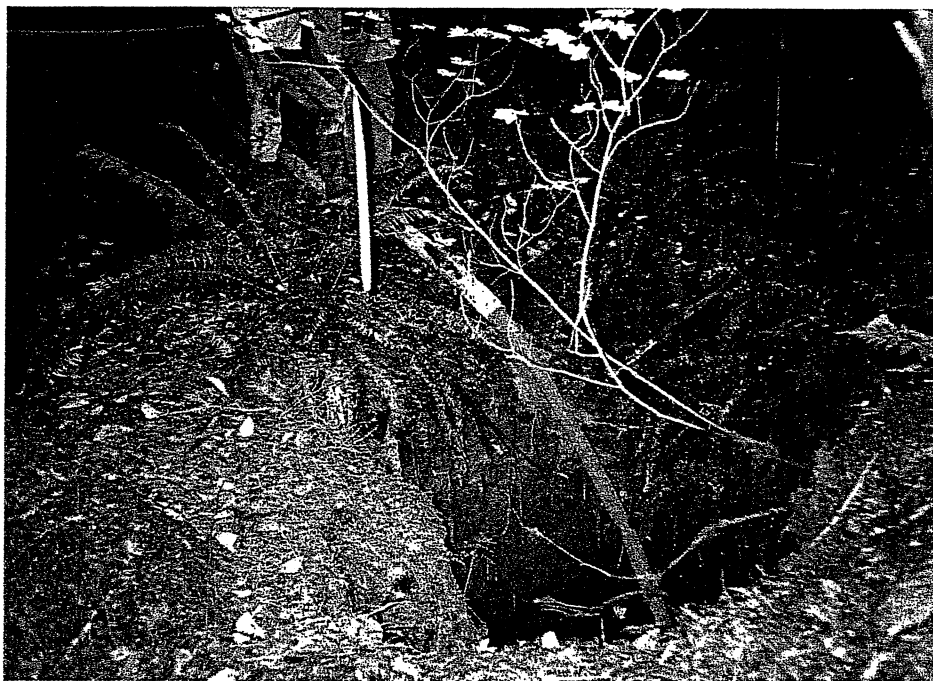
Photograph 4 - CDF placement into L-01.

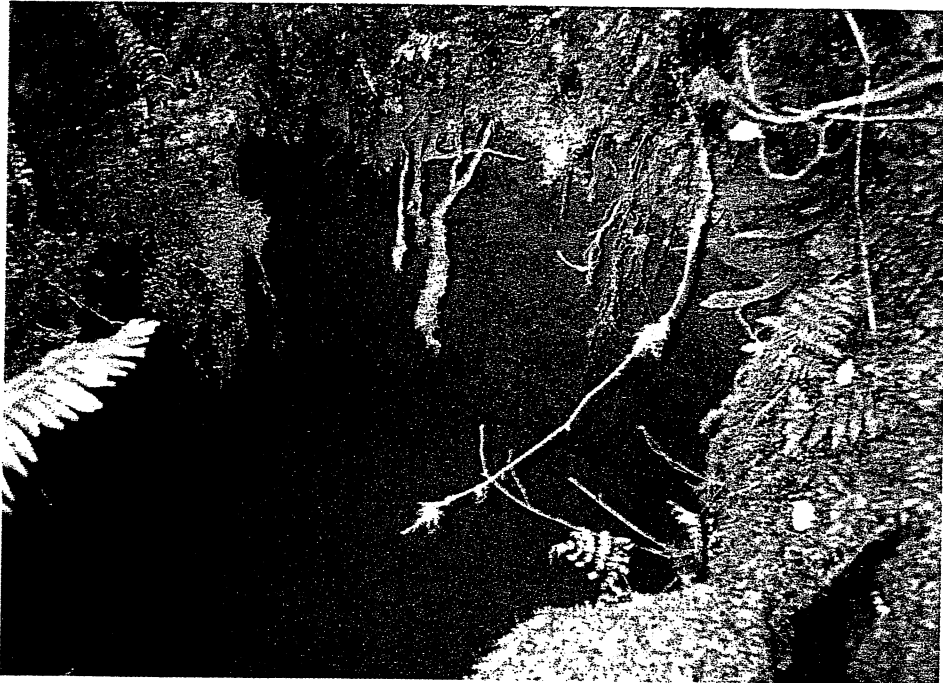
Photograph 5 - CDF in bottom of L-01.

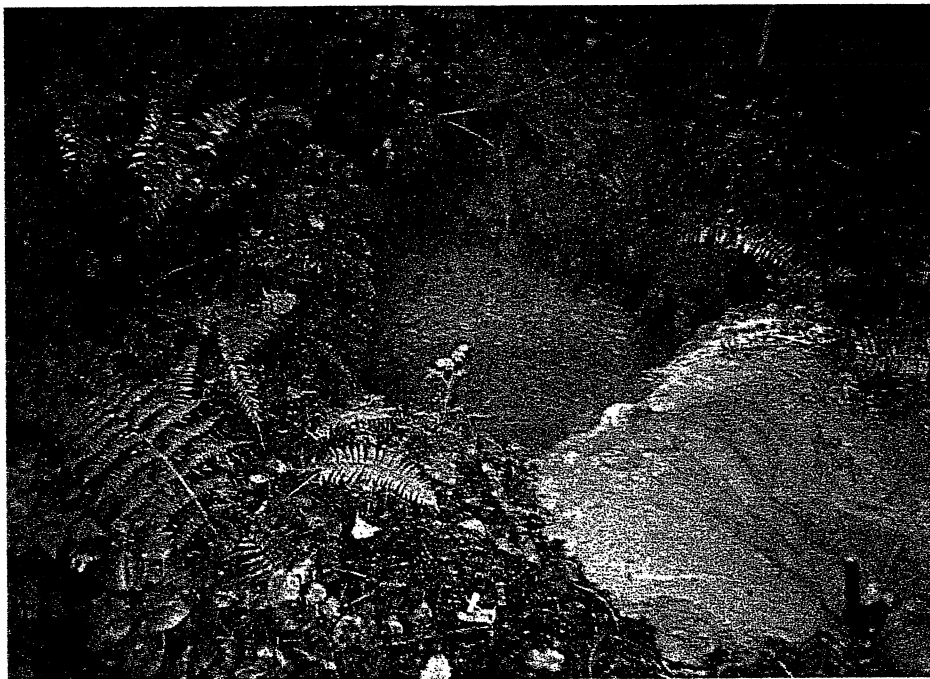
Photograph 6 - CDF placement in L-01 nearly complete.

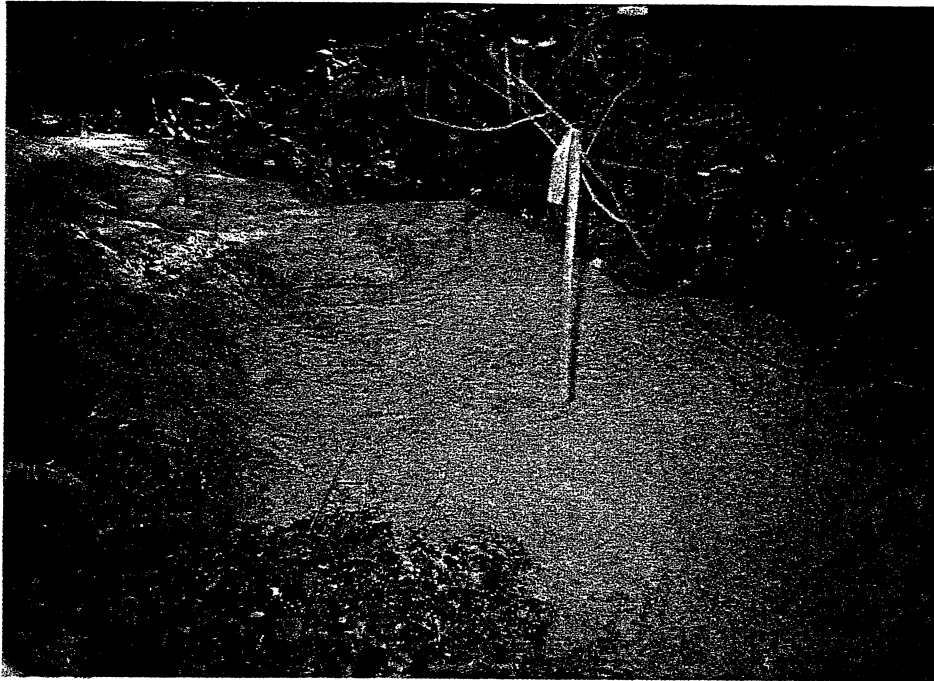
Photograph 7 - Completed CDF placement at L-01.

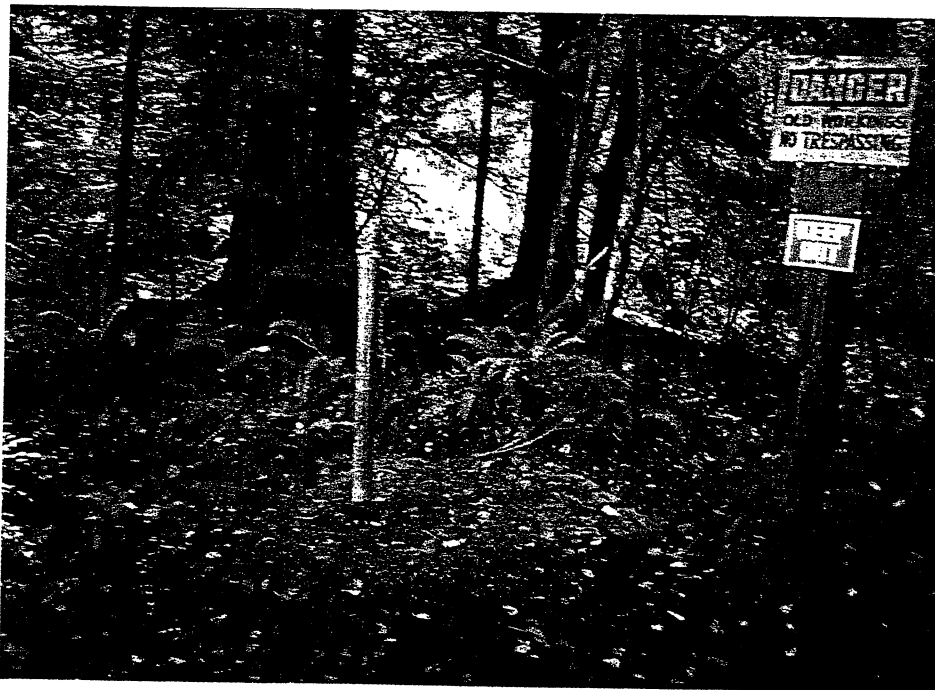
Photograph 8 - Monument at L-01. Site restoration complete.

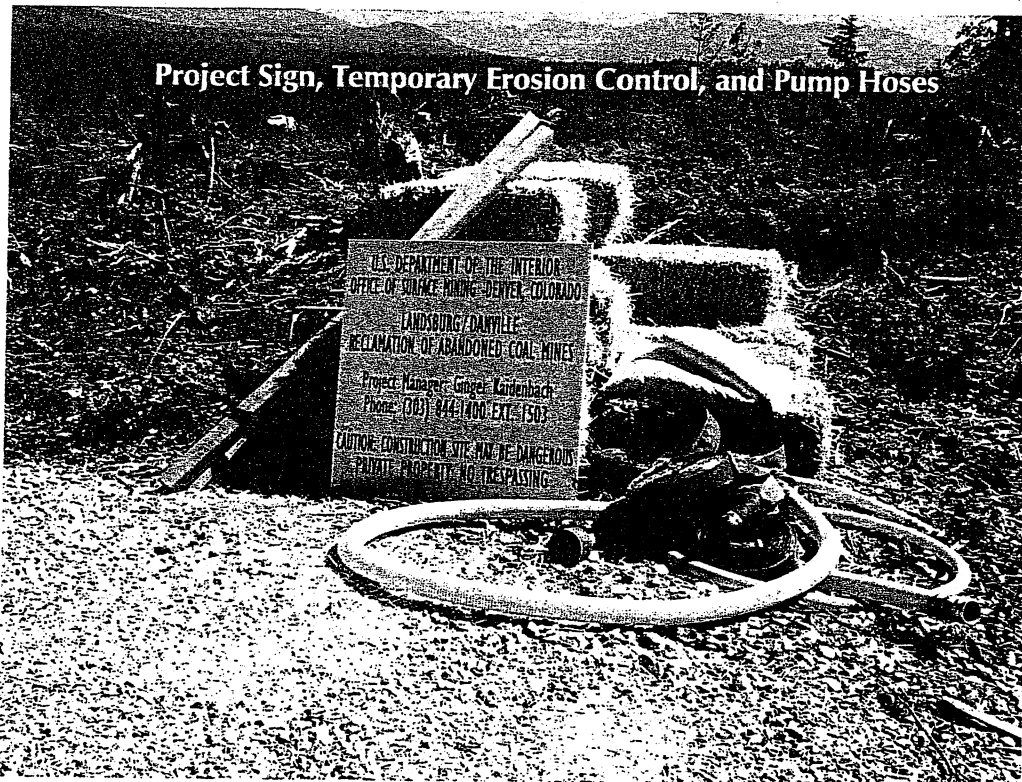
Photograph 1 Project sign, temporary erosion and sediment control, and dewatering hoses. Looking northeast.
(WA-009_RV-01_082503a_Misc Equipment.jpg)

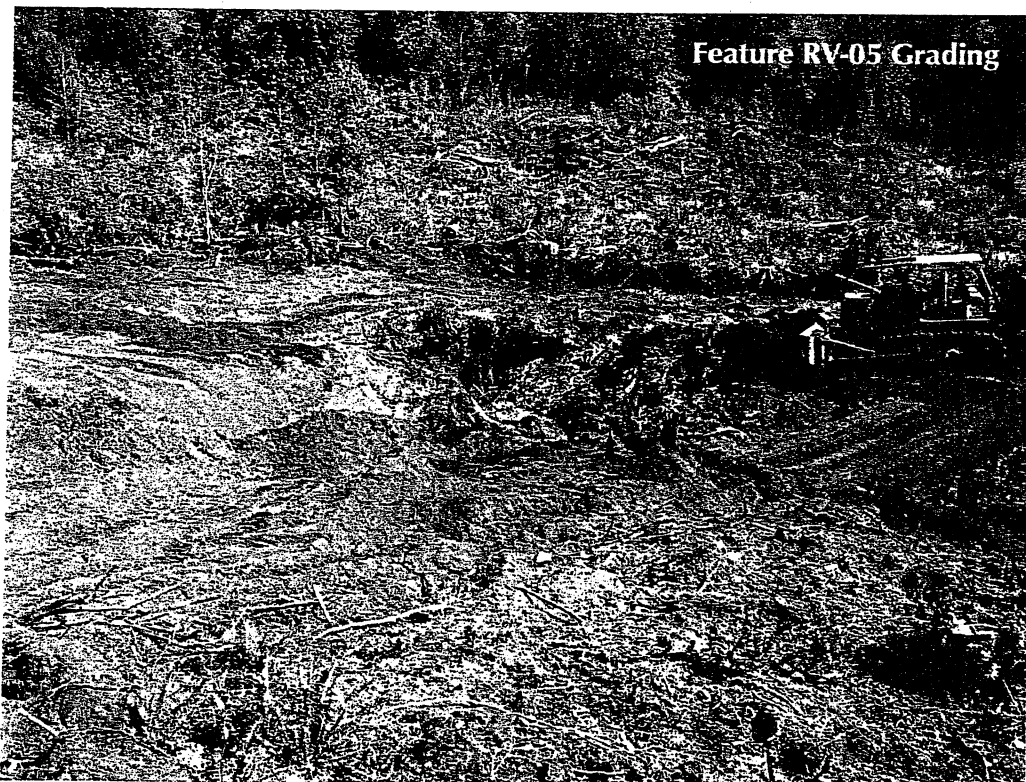
Photograph 4 Using Caterpillar D-8 to grade Feature RV-05. Looking northeast.
(WA-009_RV-05_082503a_Grading.jpg)

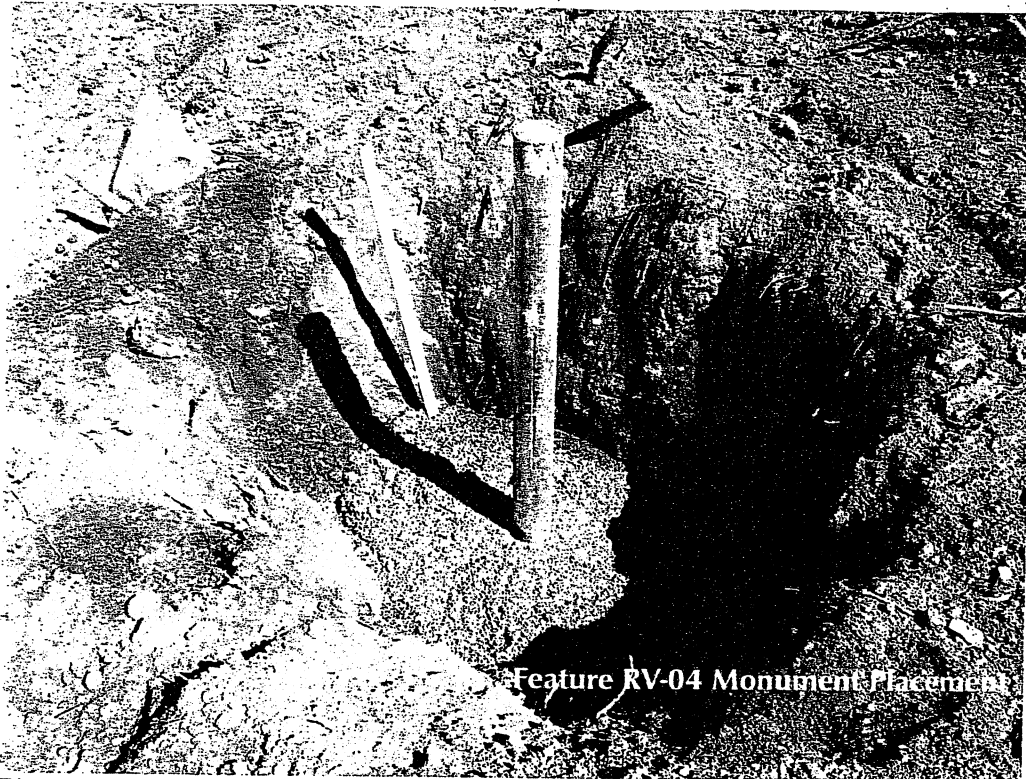
Photograph 5 Feature RV-04 and associated monument marker.
(WA-009_RV-04_082803b_MonumentPlacement.jpg)
