North Boeing Field/ Georgetown Steam Plant Site Remedial Investigation/Feasibility Study

Assessment of Infiltration and Inflow to North Boeing Field Storm Drain System

February 2011

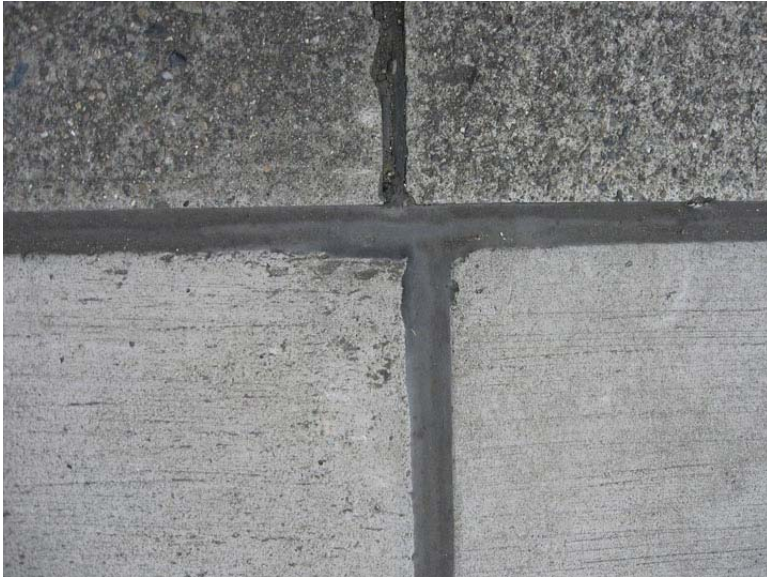
Photo 1. Comparison of New Caulk and Old Caulk between Buildings 3-369 and 3-380

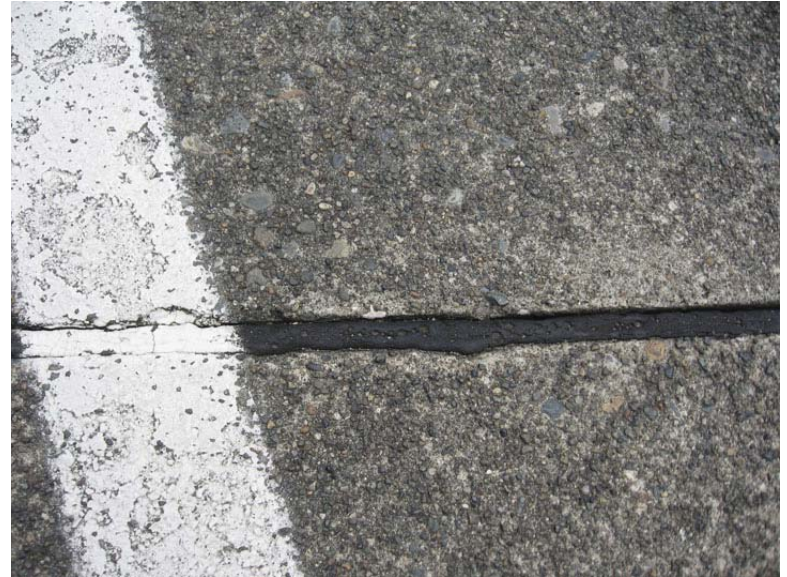
Photo 2. New Caulk with Residual Caulk on Concrete on the Flight Line

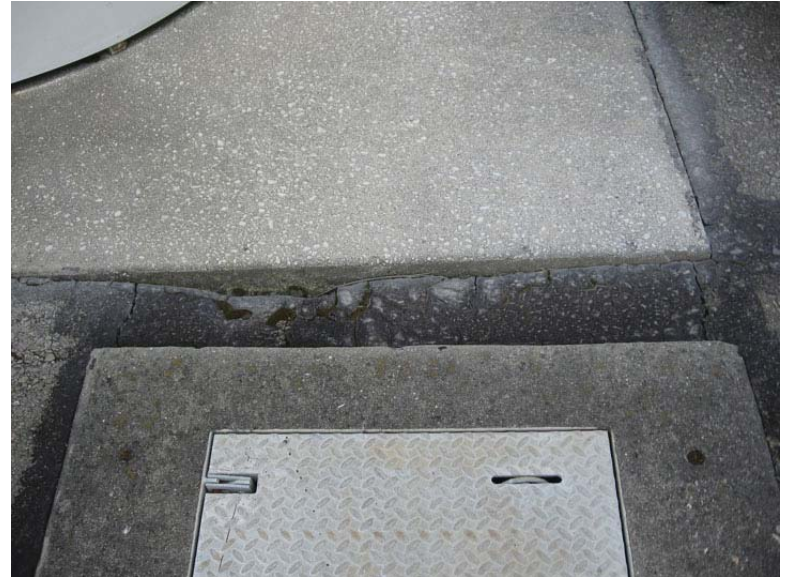
Photo 6. "Hot Patch" Asphalt used as CJM at Building 3-368

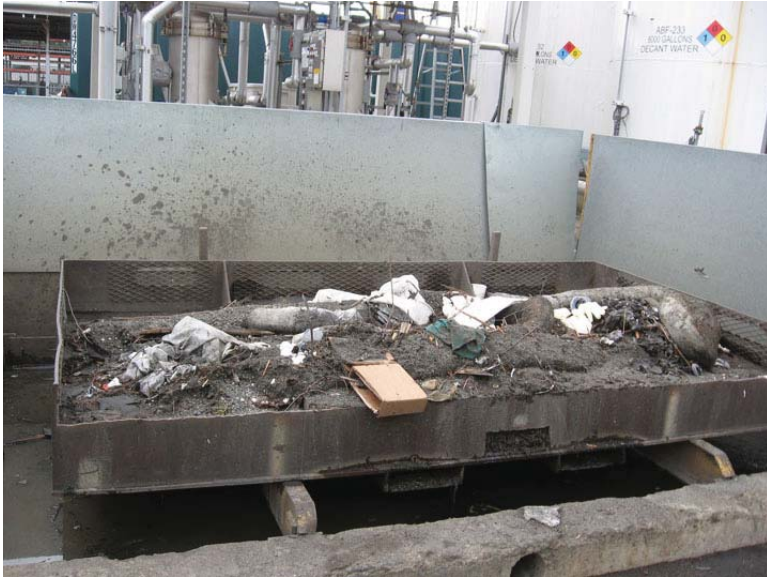
Photo 9. Sweeper Decant Station (April 15, 2010)

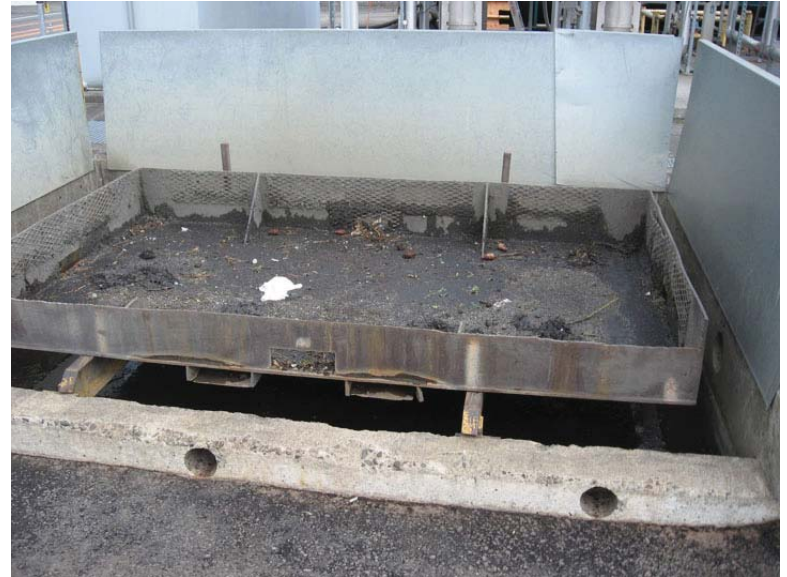
Photo 10. Sweeper Decant Station (June 17, 2010)

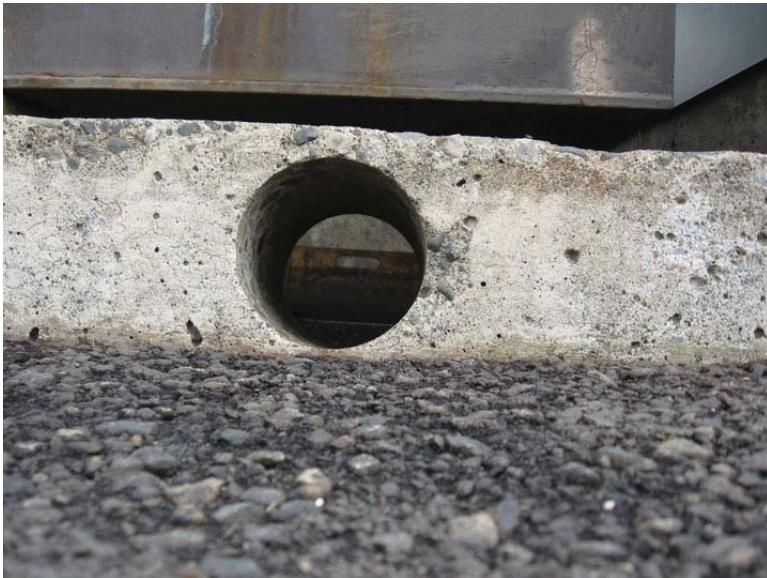
Photo 11. Detail of Drain from the Sweeper Decant Station

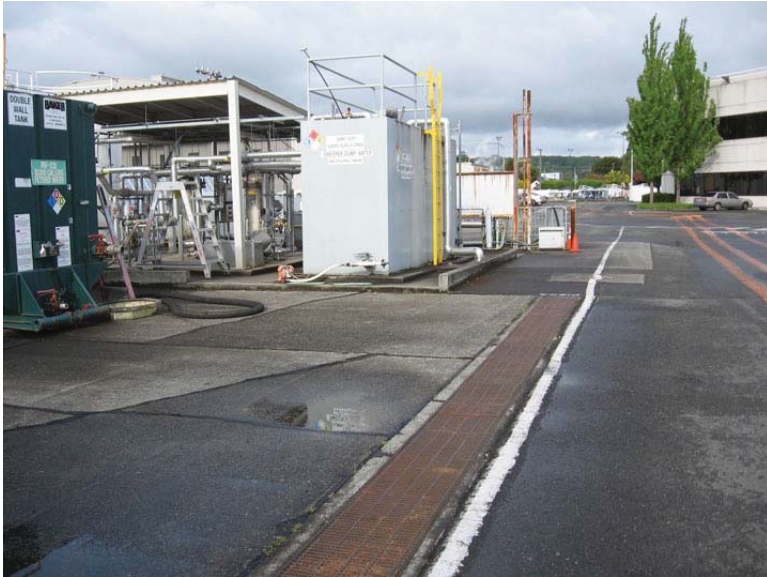
Photo 13. Sweeper Decant Station - Settling Tank

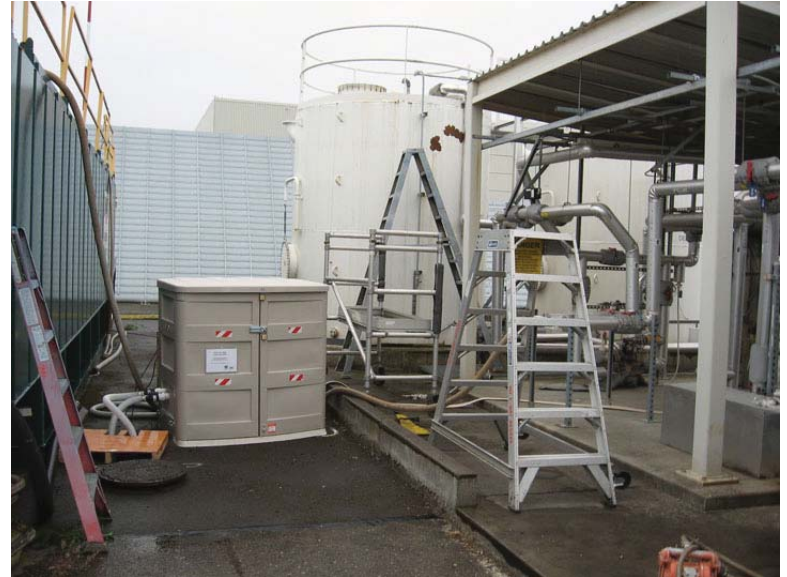
Photo 14. Sweeper Decant Station & Treatment System (note concrete berm around treatment system is not continuous)

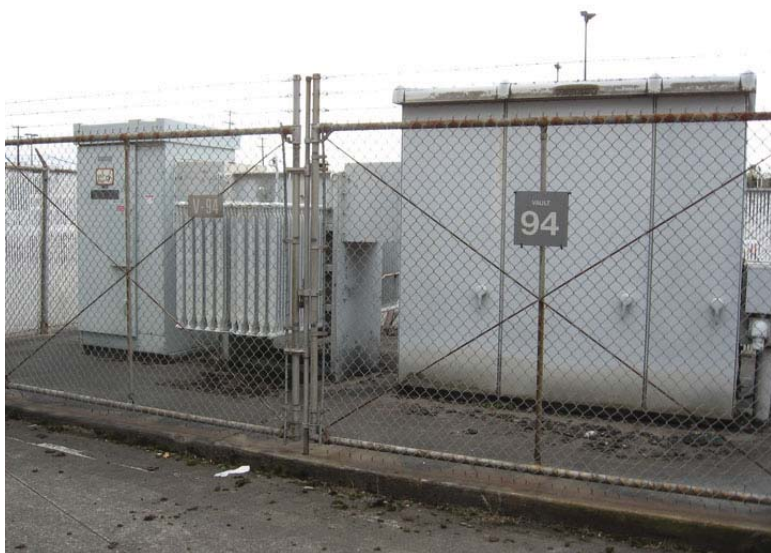
Photo 21. Vault 94 near Building 3-818

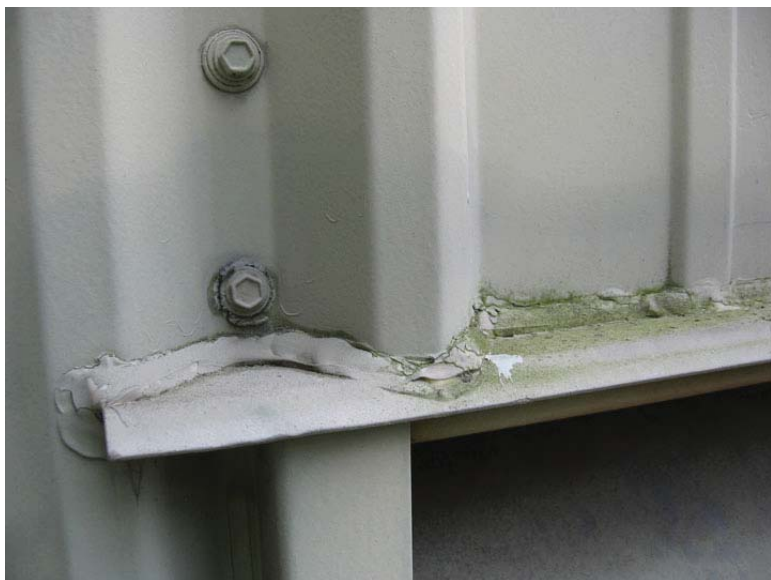
Photo 23. Vent Caulk at Building 3-323

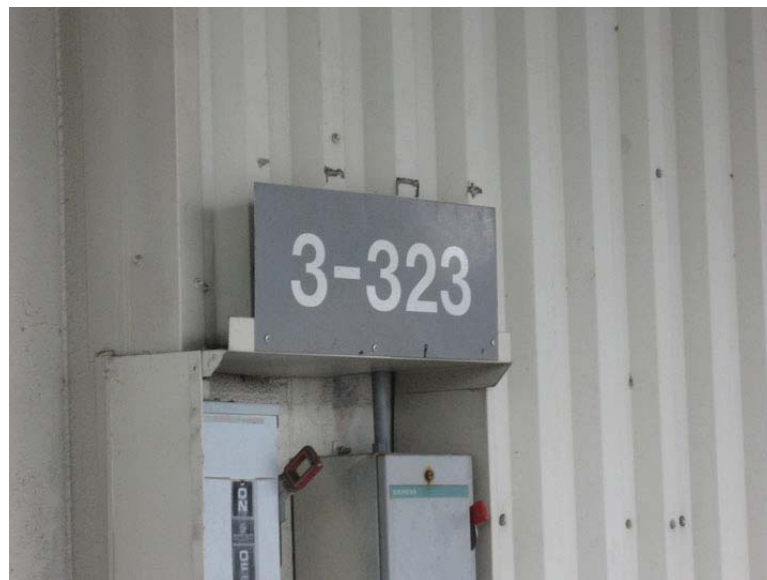
Photo 24. Seam Caulk between Differing Building materials at Building 3-323

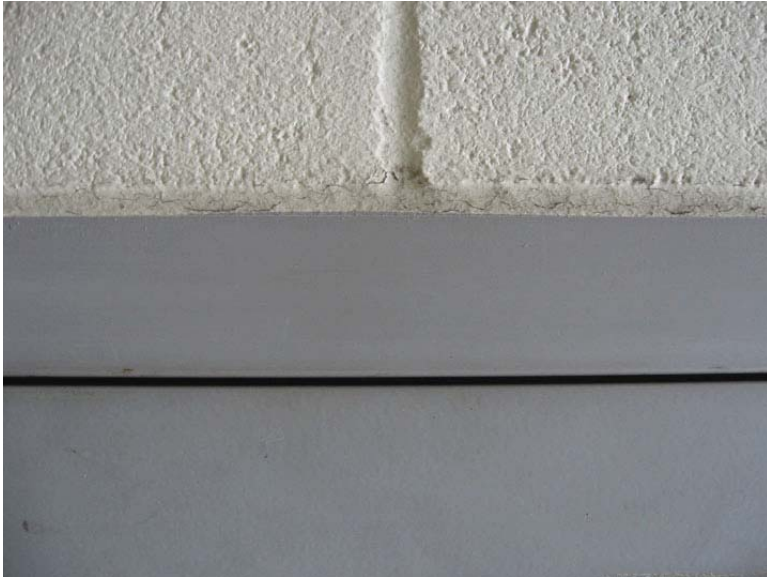
Photo 25. Door Caulk at Building 3-334

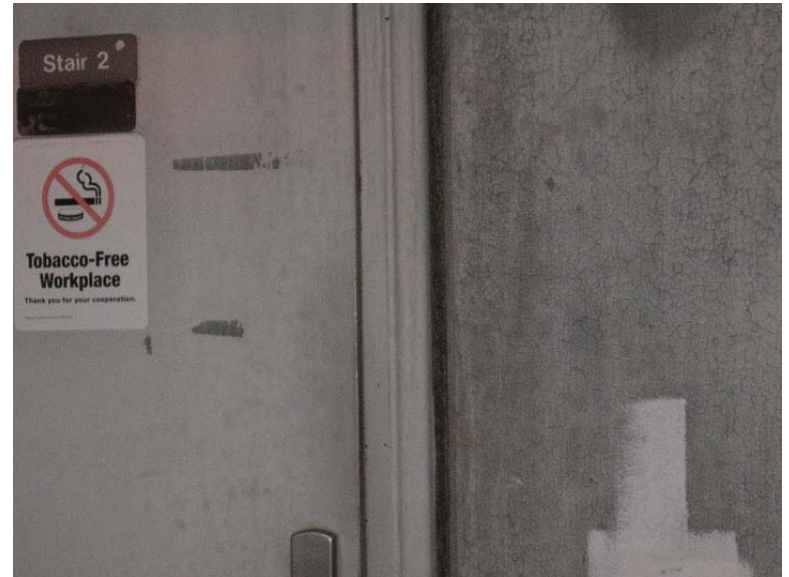
Photo 26. Door Caulk at Building 3-380

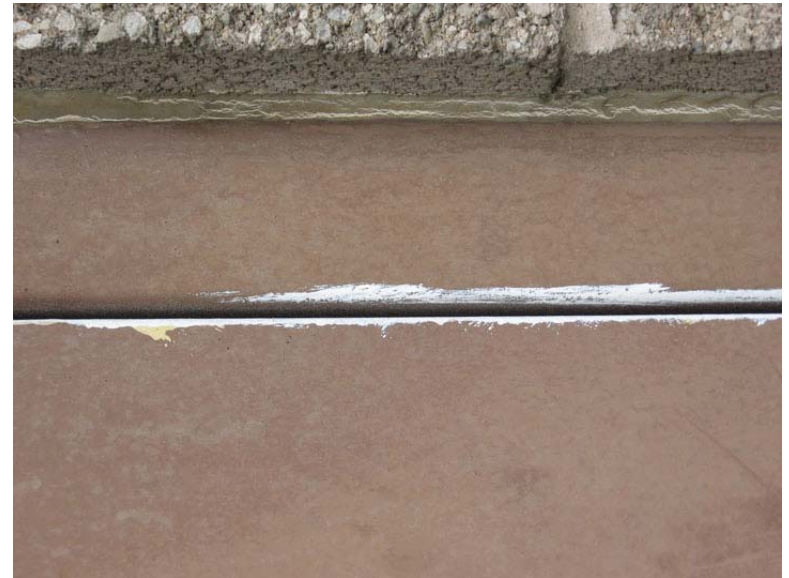
Building 3-369 was constructed in 1966. This building has concrete block and metal siding walls in good condition. Caulk material is present around the door jambs (Appendix E, Photos 27 and 28). Historical PCB concentrations in SD structures near Building 3-369 have exceeded the LAET (CB359) the 2LAET (MH361).

Photo 28. Door Caulk at Building 3-369 - Detail

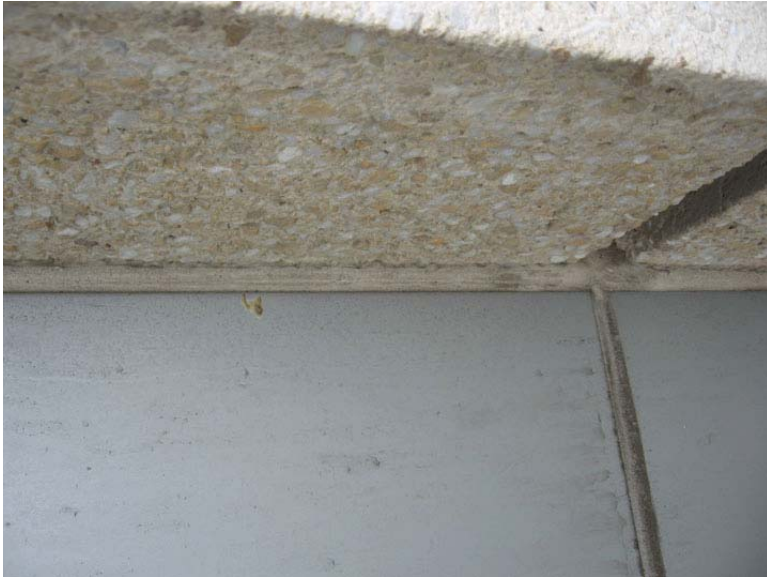
Photo 29. Door Caulk at Building 3-801

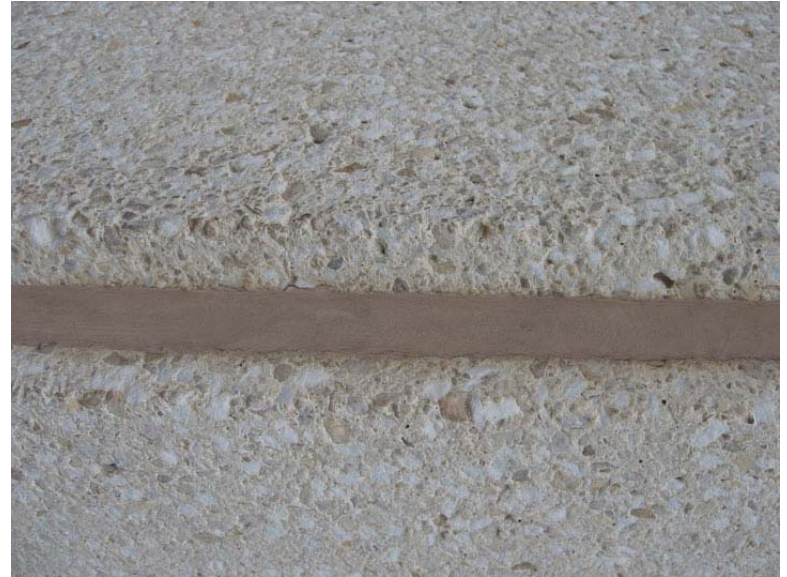
Building 3-800 was constructed in 1990. The building is constructed of unpainted concrete panels. Light-brown caulking material is present between the concrete panels (Appendix E, Photo 30). Black caulk or rubber is present around the door jambs and window frames. No downspouts were observed on the building; therefore, it is assumed that all stormwater discharge from the roof is conveyed directly to the SD system. Several exterior lights are present on the walls and air conditioning units are on the roof. No other exterior utilities were observed. SD structures near the building have not been sampled for metals, phthalates, or PAHs; however, PCB concentrations exceeding SQS and CSL have been observed in MH266A and CB266B, which are near the eastern and southern sides of the building.

Photo 30. Concrete Joint Material (Caulk) on Building 3-800

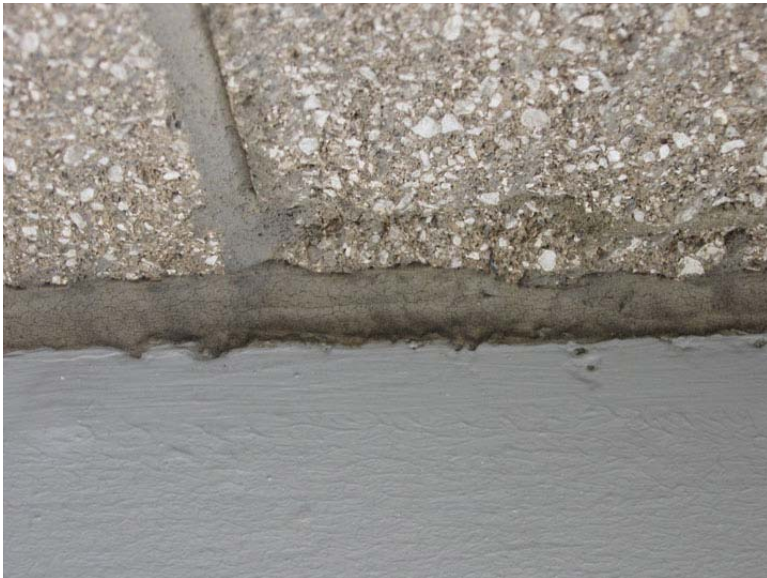
Building 3-818 has a concrete foundation and the walls are concrete brick and metal siding. The metal siding is in good condition (Appendix E, Photo 72). Dark and light brown caulk is present around the seams between building materials (Appendix E, Photo 31). Caulk is also present on door jambs and window frames. Peeling gray paint is present on some concrete surfaces. Roof downspouts appear to discharge only to the SD system. One of the roll-up doors is painted blue. Yellow-painted bollards connected by yellow-painted boards are present in the parking area associated with the building. Rubber gaskets are present on the roll-doors. Exterior utilities, including lights, vents and electrical outlets, are present. Cadmium and zinc concentrations exceeded the CSL in the SD solids sample collected from CB448, which is near the southwest corner of the building.

Photo 31. Concrete Joint Material (Caulk) on Building 3-818

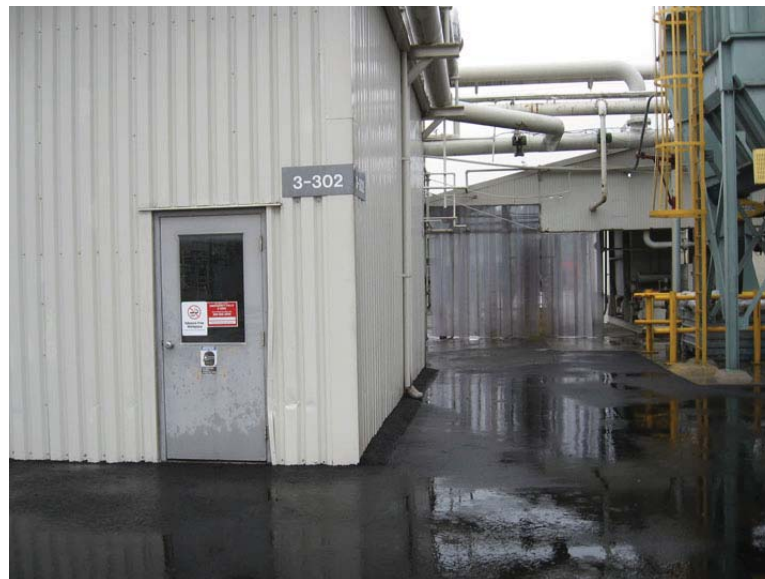
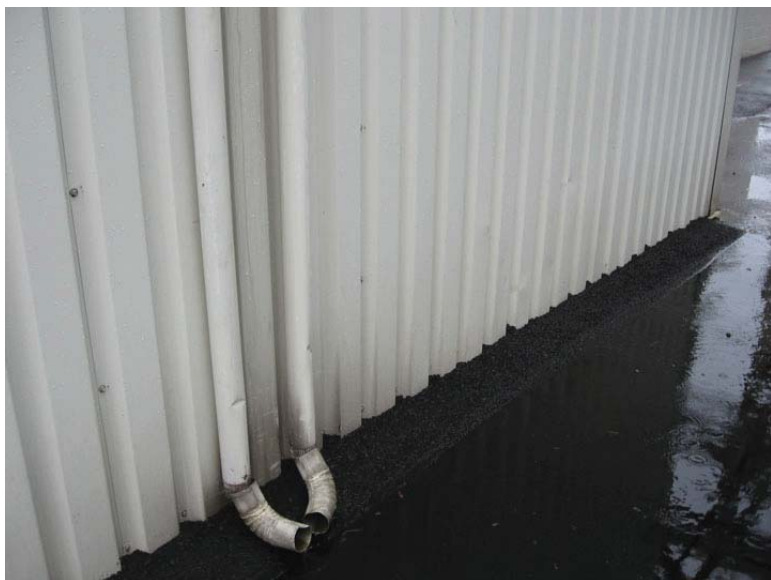
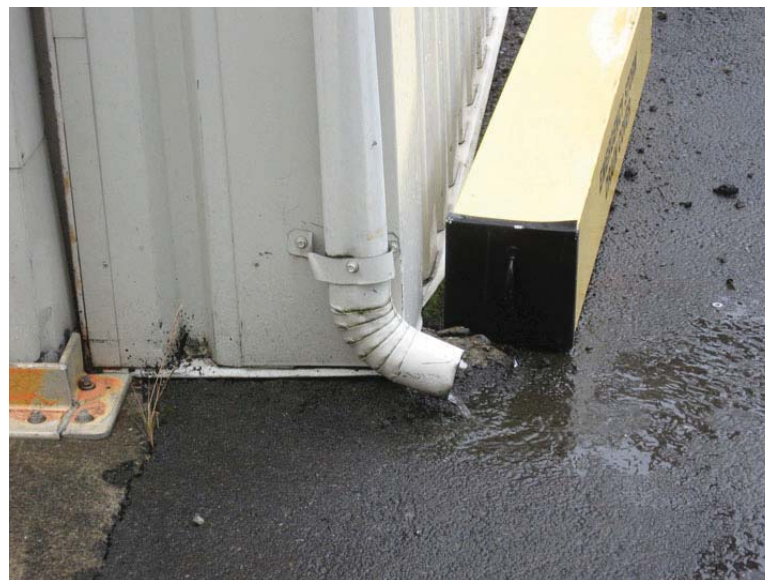
manhole. These downspouts appear to drain smaller rooftop areas, such as door awnings (Appendix E, Photos 50 through 56 and 58).

Photo 50. Roof Drain on Building 3-302

Photo 51. Roof Drain on Building 3-302 - Detail

Photo 52. Roof Drain on Building 3-302 - Detail

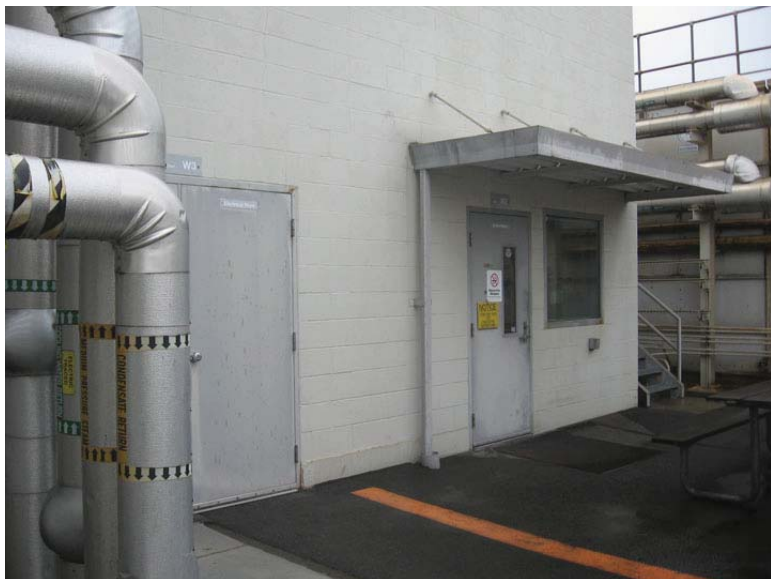
Photo 53. Roof Drain on Building 3-334

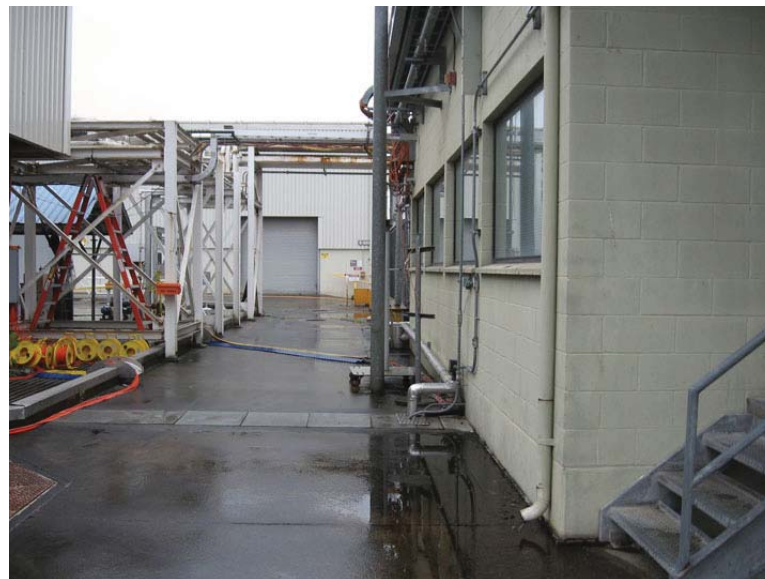
Photo 54. Roof Drain on Building 3-310

Photo 55. Roof Drain on Building 3-310 - Detail

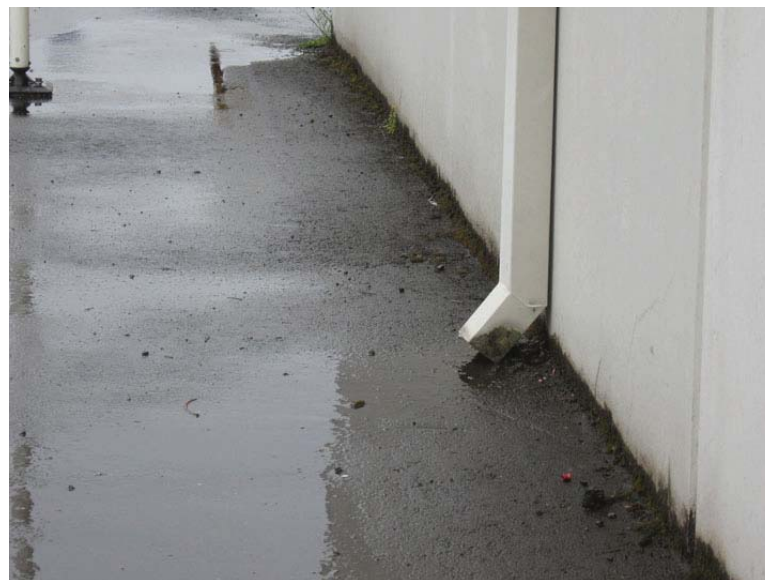
Photo 56. Roof Drain on Building 3-315

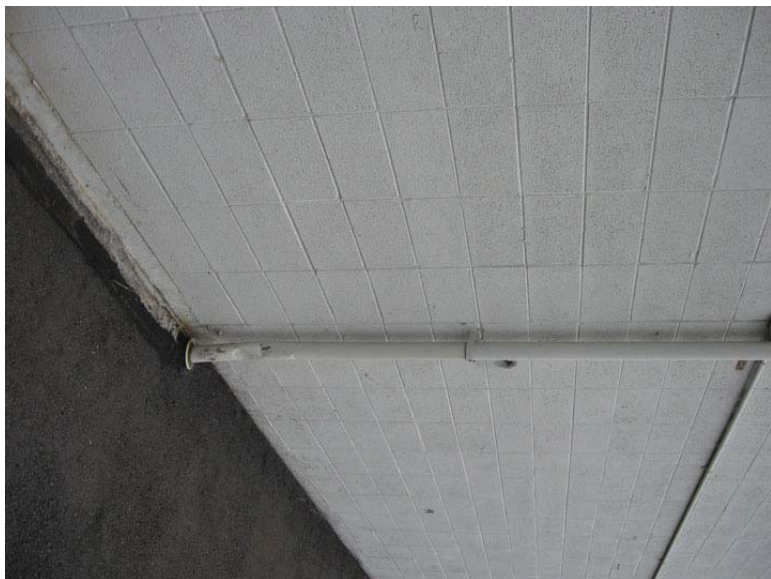
Photo 57. Roof Drain on Building 3-326 (note drain is connected to SD system)

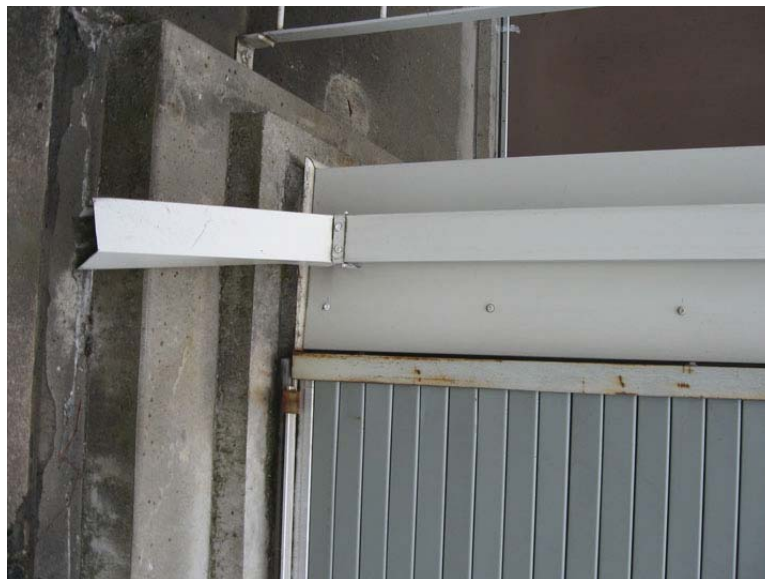
Building 3-369 has a concrete foundation and walls constructed of concrete blocks and metal siding. The metal siding is painted beige and appears to be in good condition, although some areas of damaged paint are observed on the hangar doors. Caulk material is present around the door jambs (Appendix E, Photos 27 and 28). ABF-205, which contains sludge water, is present on the southern side of the building. Yellow-painted bollards are present near the AST. Exterior utilities are present on the building, including an air-conditioning unit and electrical wiring. Rubber gaskets are present on the roll-up and hangar doors. Downspouts from the roof discharge to the SD system and to the ground (Appendix E, Photo 58).

Photo 58. Roof Drain on Building 3-369

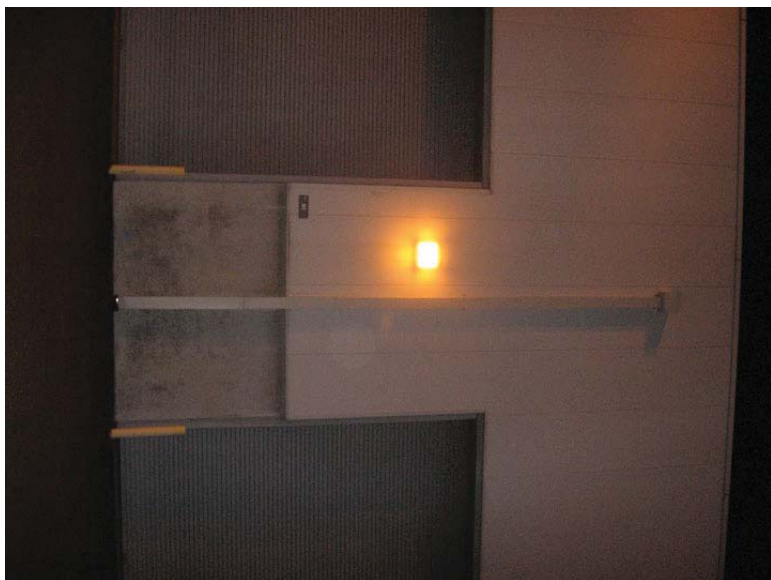
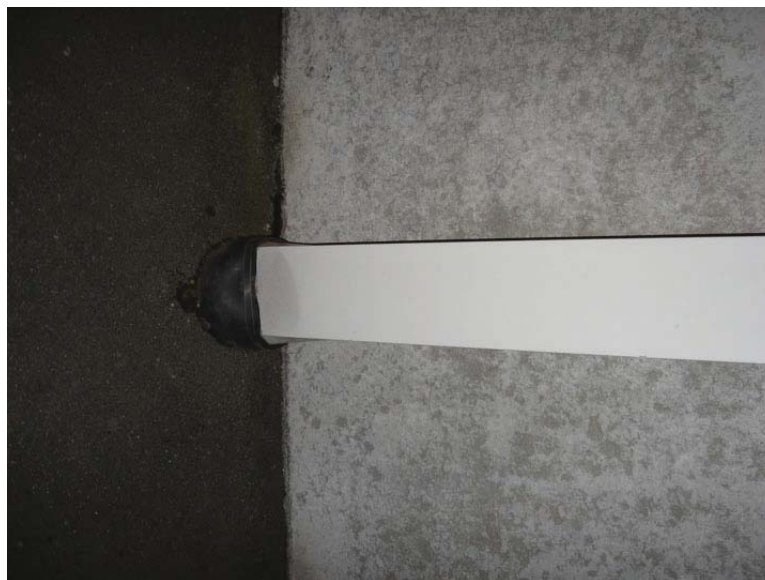
Building 3-370 has a concrete foundation and walls with metal siding. Beige paint on the concrete walls is in fair condition. Paint on the metal siding is in good condition. Downspouts from the roof discharge only to the SD system (Appendix E, Photos 59 and 60). Exterior utilities on the building include vents and lights on the walls and air conditioning units on the roof. Rubber gaskets are likely to be present on the roll-up doors. Cadmium, lead, and zinc concentrations exceeded the SQS and CSL in SD solids samples collected from one or more SD structures immediately adjacent to the building.

Photo 59. Roof Drain on Building 3-370

Photo 60. Roof Drain on Building 3-370 - Detail (note drain is connected to SD system)

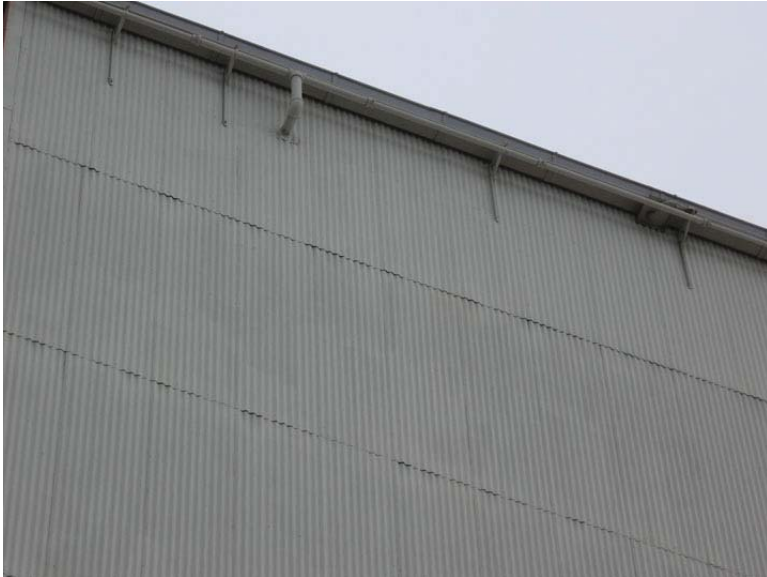
Building 3-390 is partially located within the south lateral drainage area. The western and southern footprint of the building is in this drainage area. Roof drains on the western side of the building discharge only to the SD system (Appendix E, Photo 61). Rubber gaskets may be present on the roll-up door at the southern end of the building. Exterior utilities are present on the building. Red and white radio towers, antennas, and other equipment are present on the roof. Mercury exceeded the SQS and cadmium, copper, and zinc concentrations exceeded the CSL in a SD solids sample collected from OWS1-C, which is immediately west of the building.

Photo 61. Roof Drain on Building 3-390

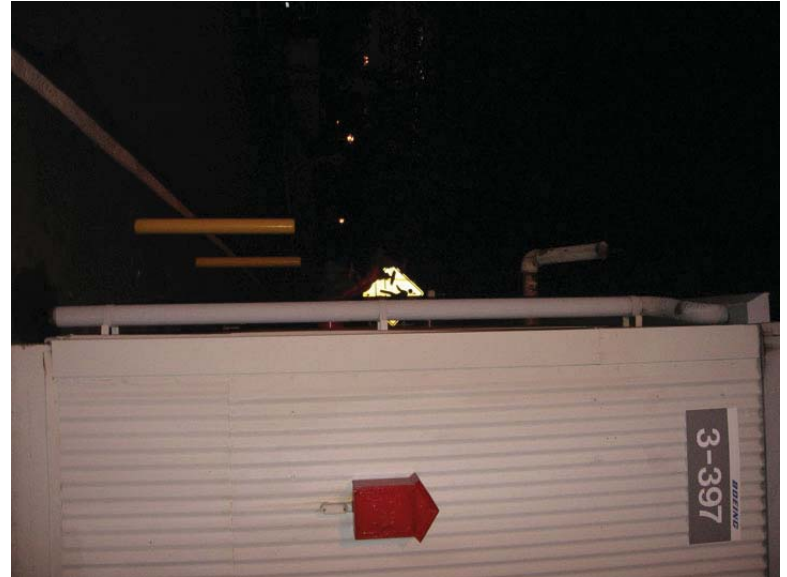
Building 3-397 has a concrete foundation and walls with metal siding. The paint on the building exterior is in fair to good condition while the gray paint on the doors is peeling and in poor condition. Downspouts from the roof discharge only to the SD system; however, damage to one connection was observed and stormwater was released to the surface (Appendix E, Photos 62 and 63). Caulk and window glazing may be present on the door jambs, window frames, and windows. Exterior utilities are present including an electrical line and vents. The SD structures adjacent to the building have not been sampled.

Photo 62. Roof Drain on Building 3-397

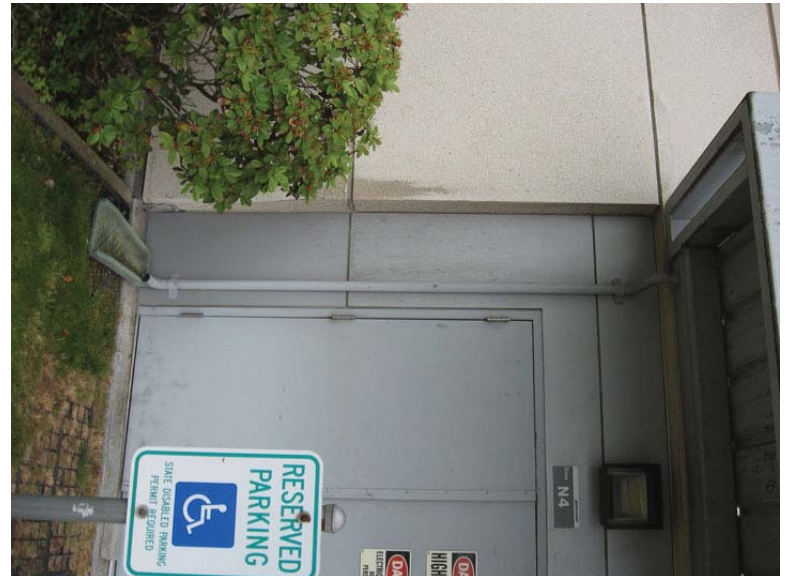
Photo 64. Roof Drain on Building 3-801

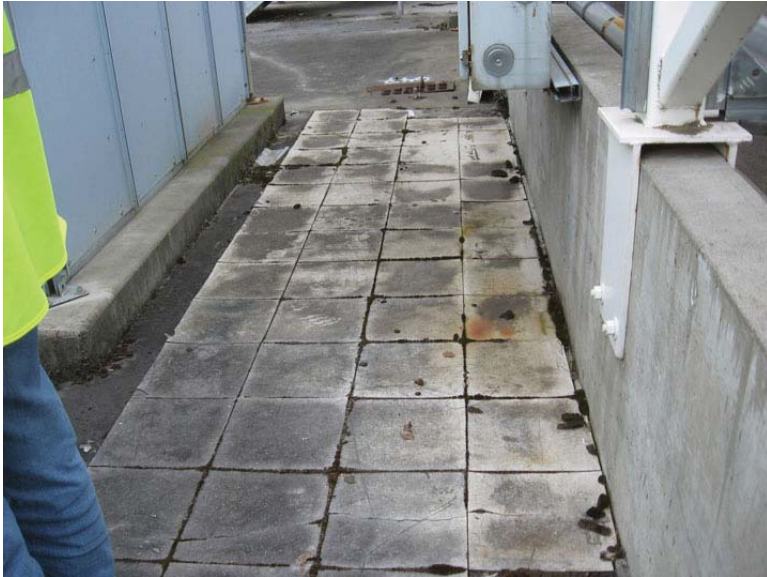
Photo 65. Interior Floor Tiles Used Outdoors near Building 3-310

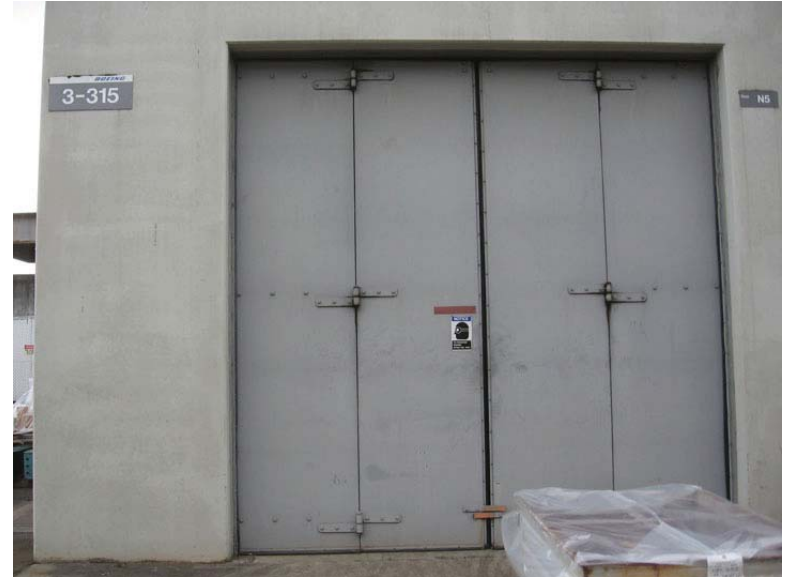
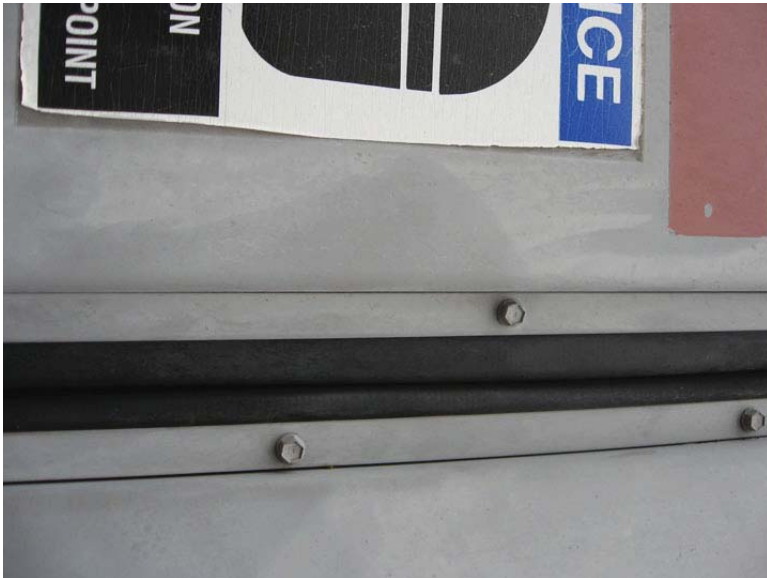
Photo 66. Rubber Gaskets on Doors at Building 3-315

Photo 67. Rubber Gaskets on Doors at Building 3-315 - Detail

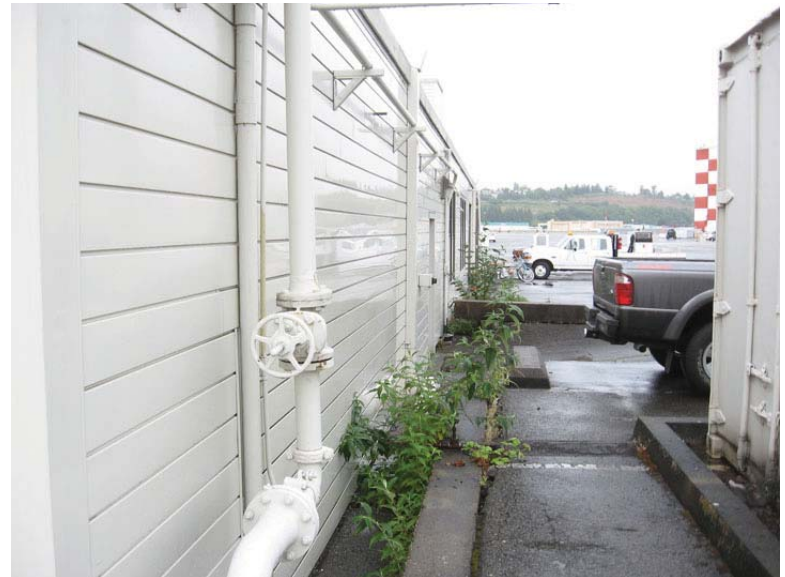
Photo 71. Concrete Block Construction and Metal Siding on Buildings 3-323 and 3-334

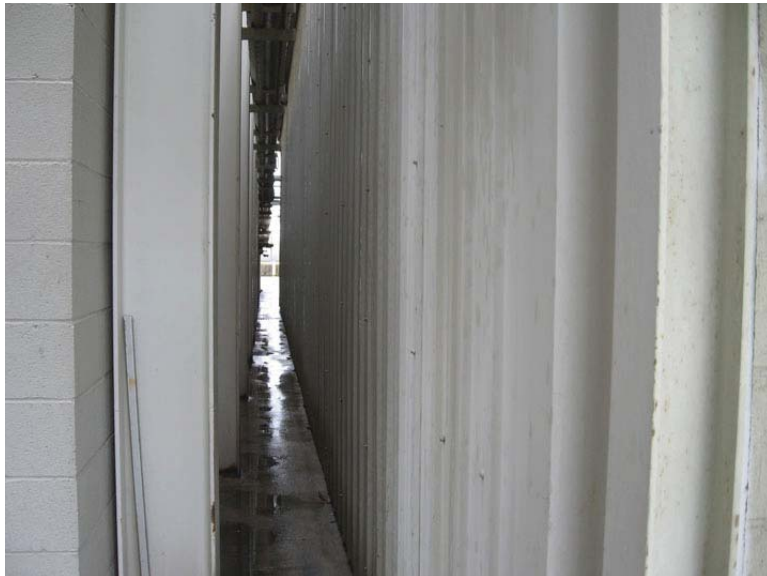
Photo 72. Concrete Block Construction and Metal Siding on Building 3-818

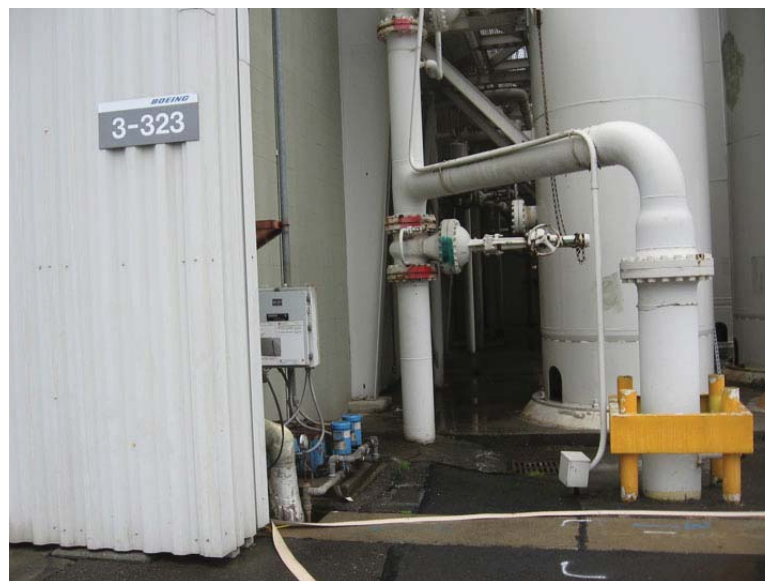
Photo 77. Piping and Flanges at Building 3-326

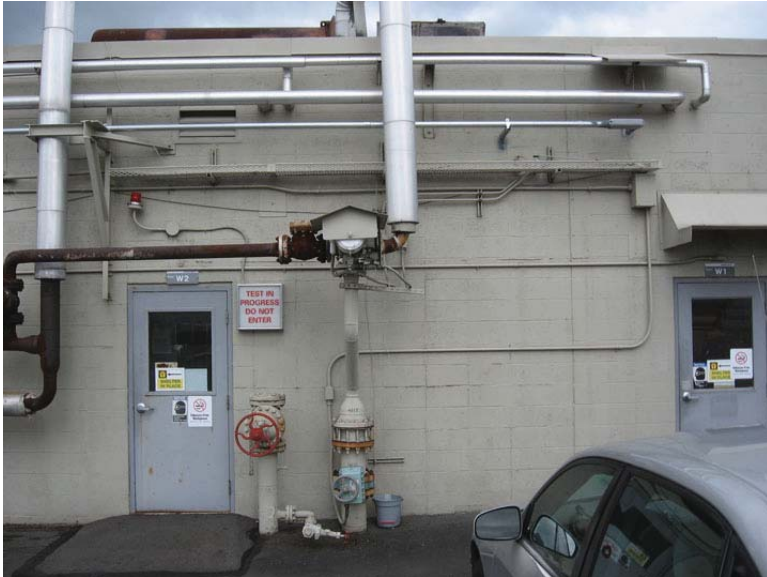
Photo 78. Piping and Flanges at Building 3-326

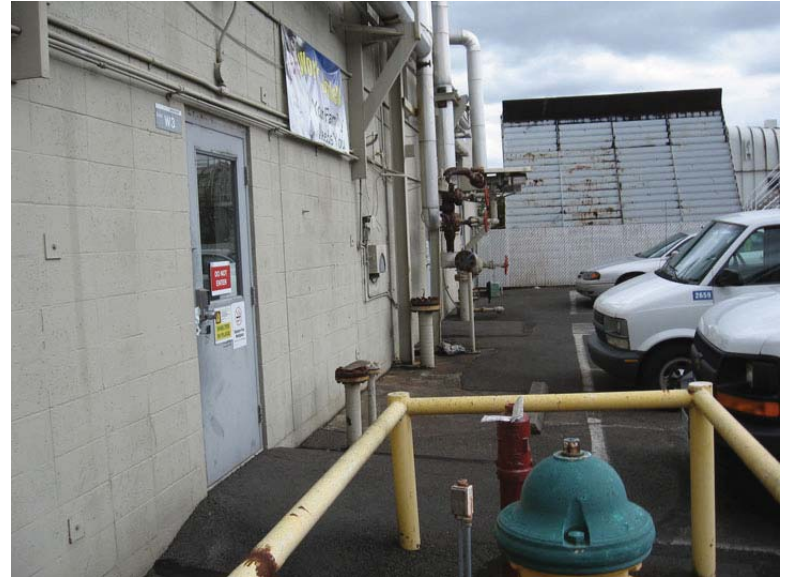
Photo 79. Piping Connecting Building 3-326 to 3-322

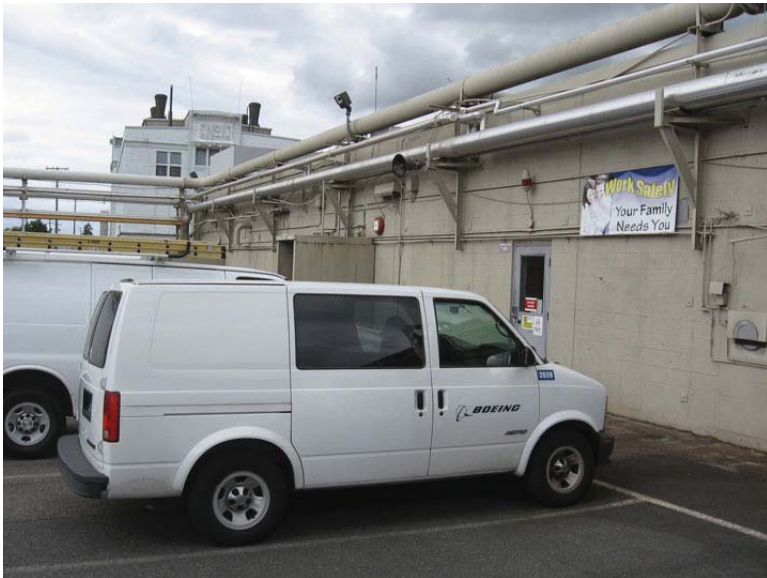
Photo 80. Piping and Flanges at Building 3-626

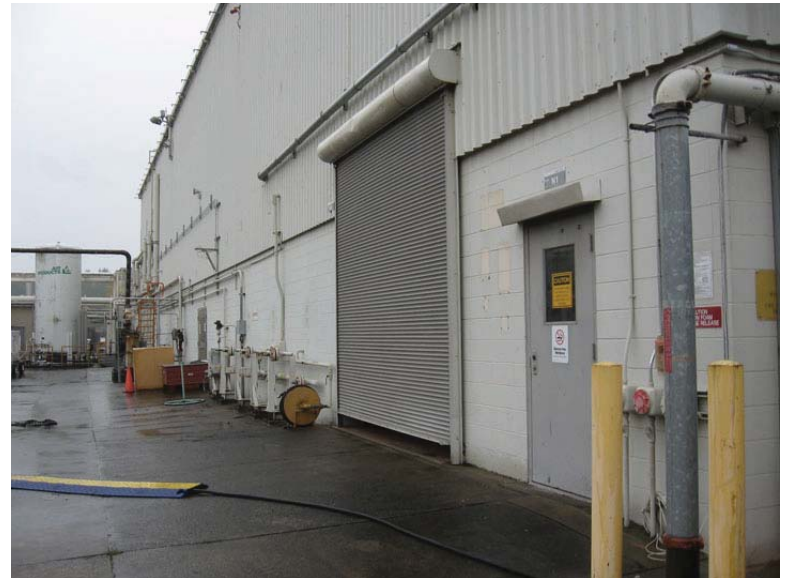
Photo 81. Flange at Building 3-354

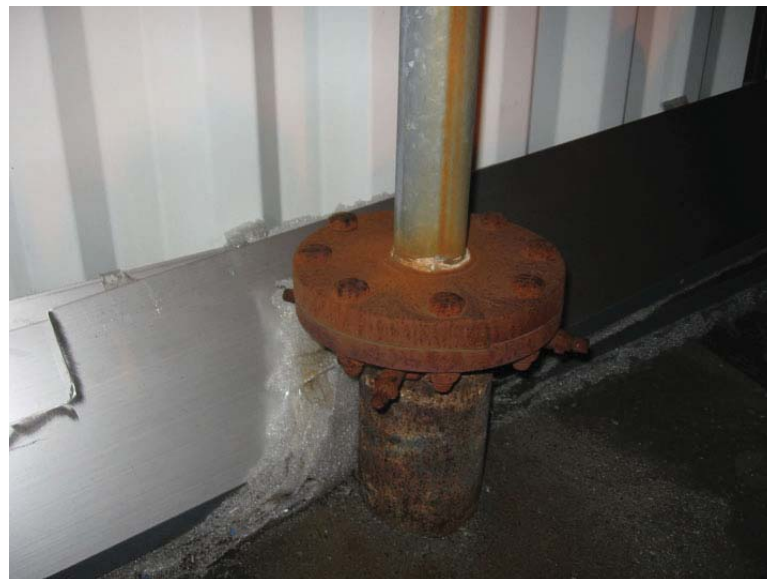
Building 3-356 is a barrel-storage building. The building is constructed with concrete walls covered with metal siding. Downspouts from the roof discharge to the ground. Exterior utilities are present. Caulk was observed on one exterior flange (Appendix E, Photo 82). Cadmium, mercury, and zinc concentrations exceeded the CSL in the SD solids sample collected from CB134, the catch basin that is closest to the building. This building is at the boundary of the north-central lateral drainage area; therefore, these building materials may be a potential source of COPCs to that drainage area.

Photo 82. Flange at Building 3-356 (note caulk around connection between the pipe and flange)

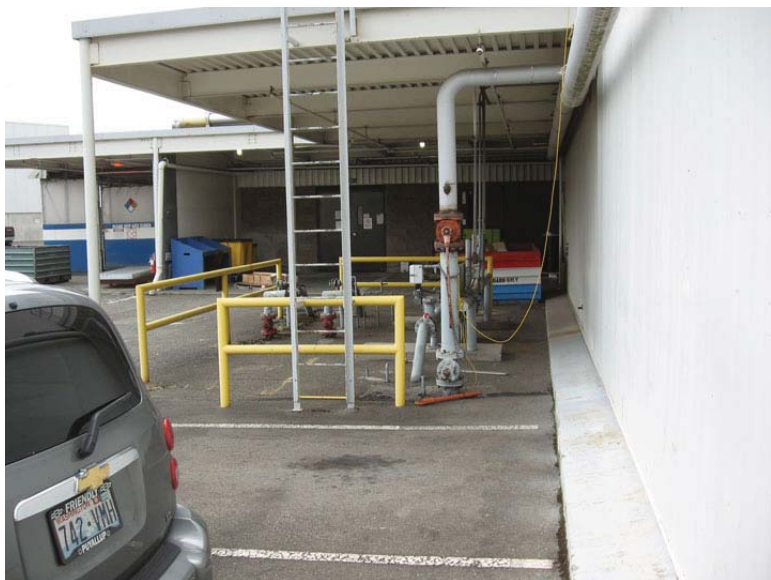
Photo 83. Piping and Flanges at Building 3-374
