Subject: As-Built Report
Shoreline Habitat Restoration
Irondale Iron and Steel Plant
Irondale, Washington
File No. 0504-042-02

Irondale Iron and Steel Plant
Shoreline Habitat Restoration
Jefferson County, Washington

File No. 0504-042-02

November 17, 2014

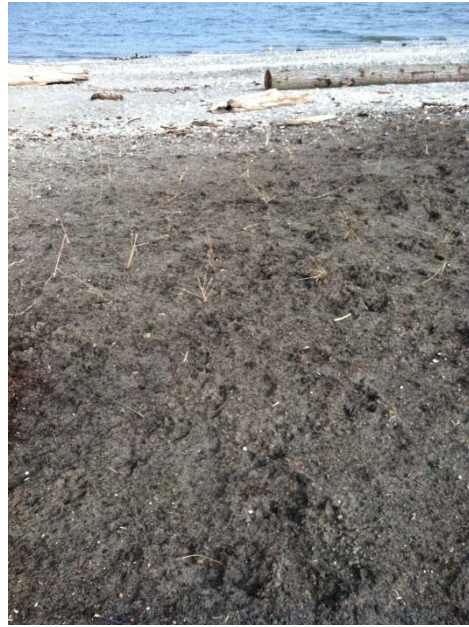
Photograph 29
Monitoring station 5 looking northeast.

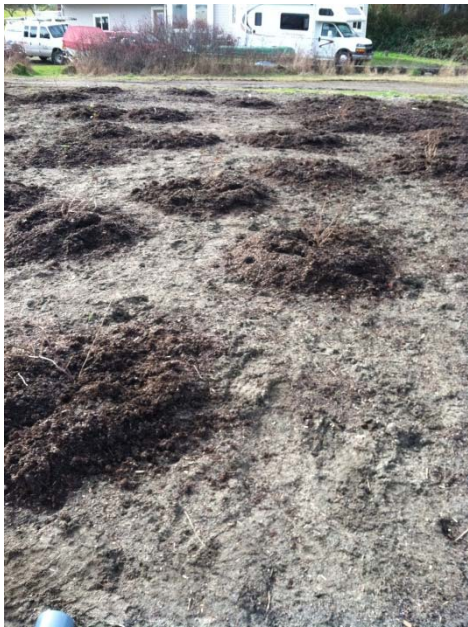
Photograph 30
Monitoring station 5 looking southwest.

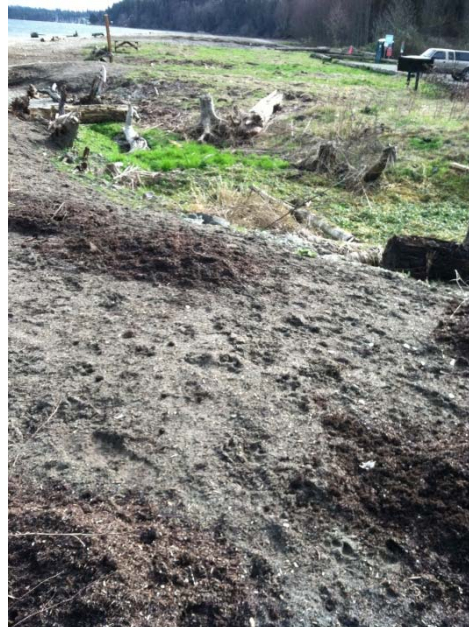
Photograph 31
Monitoring station 5 looking southeast.
