Construction Quality Assurance Certification Report for Sudbury Road Landfill Remedial Action Walla Walla, Washington

April 14, 2017

Construction Quality Assurance Certification Report Sudbury Road Landfill Remedial Action Walla Walla, Washington

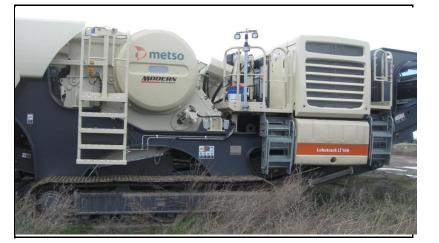
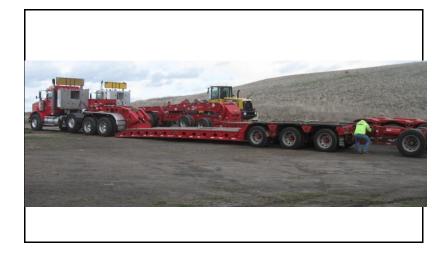
Photo # IMG-1470

Blief Beechpaeli
Metso - Lokotrack LT 1110 - delivery

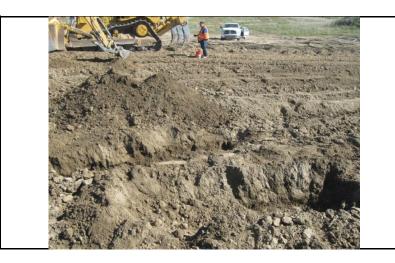
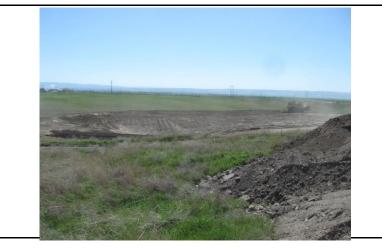
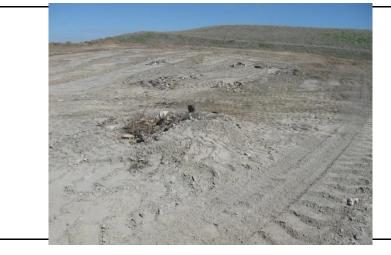
Test Pits Area 2 - Test Plot evaluation to determine effective compaction when using scrapers to dump cover material, then have D-8 Rip and track.

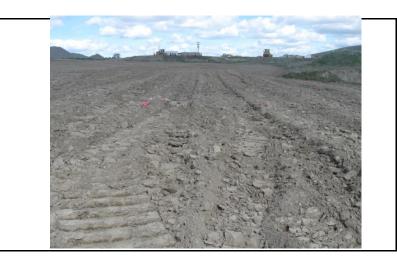
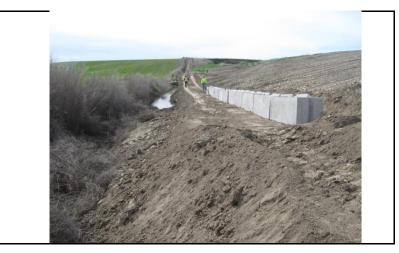
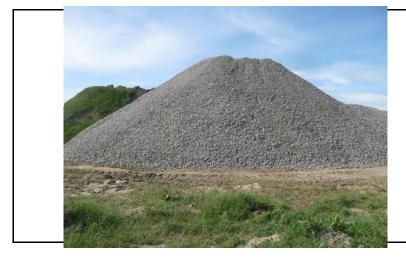
Photo # IMG-1868

Grade Check along South Slope Area 5

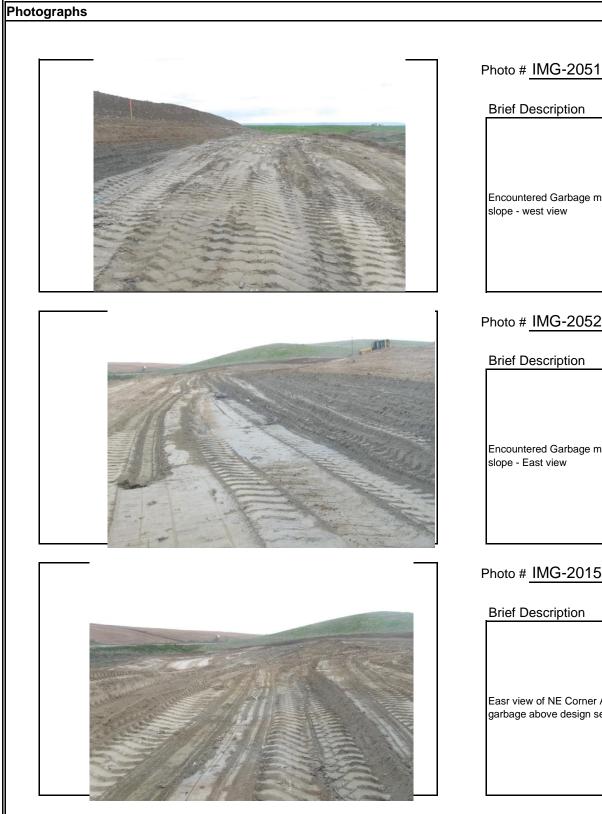
Photo # IMG-2052

Encountered Garbage midway along North

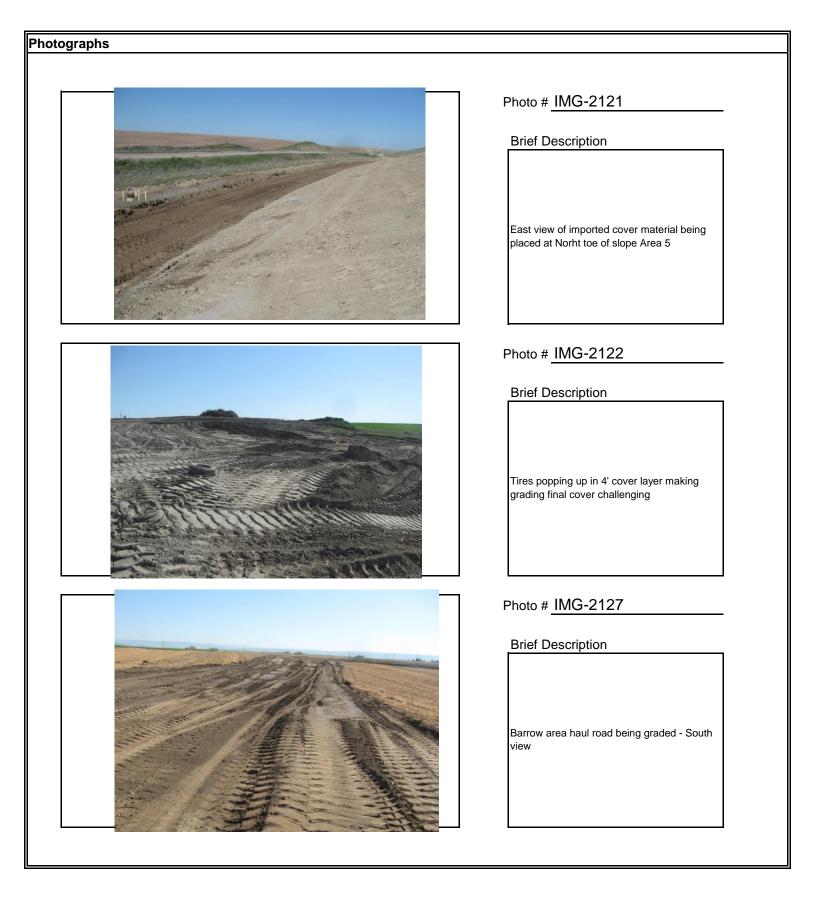
Subgrade on N Slope is to grade and topo completed, Hauling import cover material from barrow site in pm.

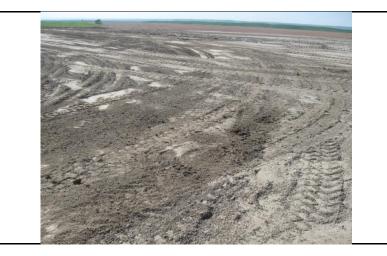
S view of grade transition. Top left is imported cover, middle portion is transition area to 3:1 north slope.

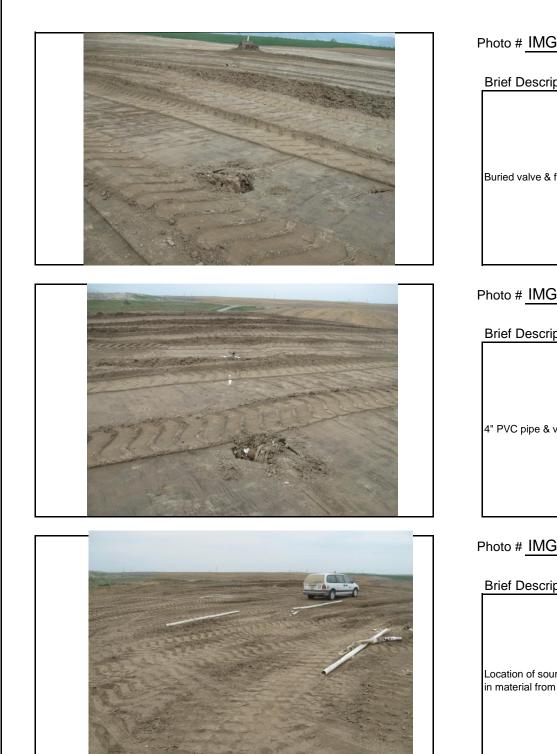
Bundle of 1" PVC pipe in same trench in borrow area, old irrigation system

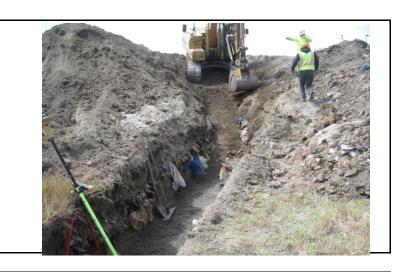
Trash encountered in trench above sump below EW-19 Area 2 (Note photo @11:15 am)

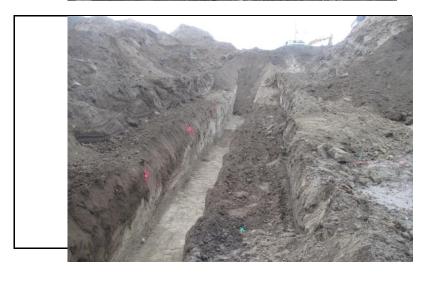
South view of Area 2 - trench near 2" minus concrete stockpile. Never found water main to dtermine adjusted grade. (3:40 pm)

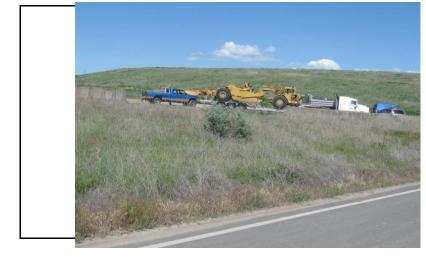
3rd Scraper being hauled off-site for repairs.

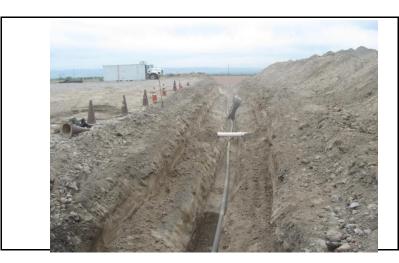
Grade break @ 40 If N of angle point @ barrier (will reduce depth of trench & increase production trenching).

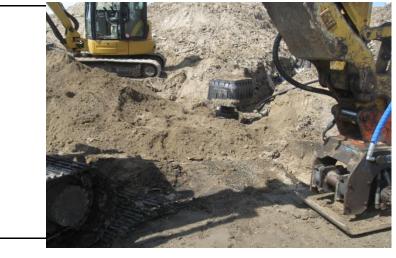
Photo # IMG-2404

Backfilling around LS east side of Area 2

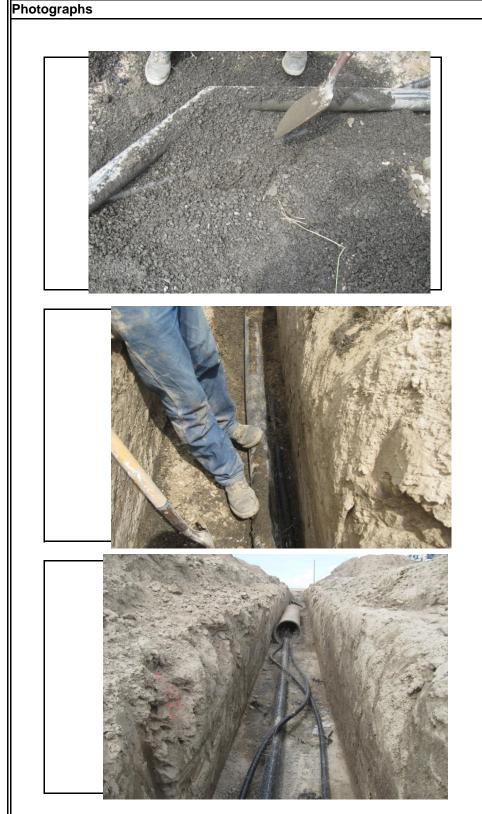
Photo # IMG-2443

HDPE pipe @ Haul Rd casing - partially full of rocks/concrete Slope < 1%

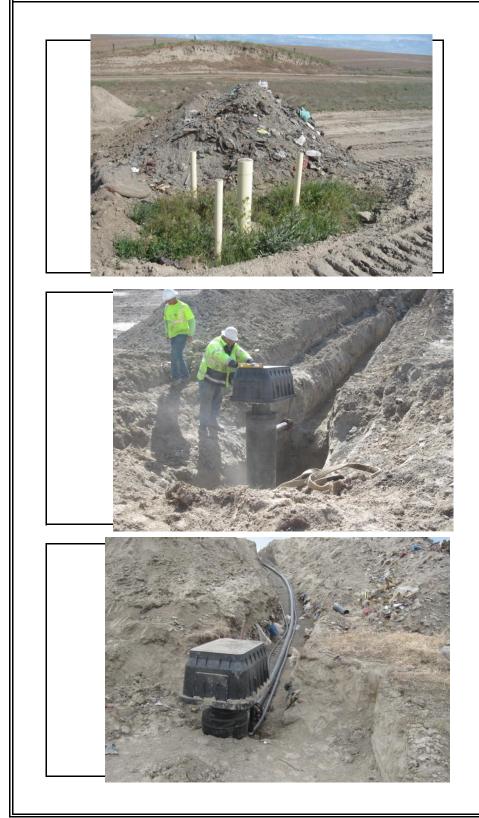
Photo # IMG-2456

W view 4" LFG main - 1.5" FM & air lines -Area 2 towards EW-19

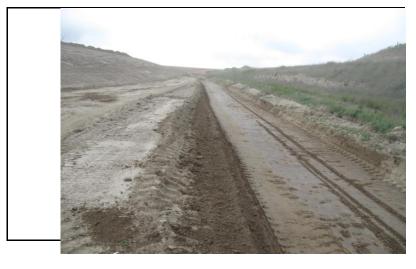
Photo # IMG-2464

W view of concrete ditch rough grading/excavating

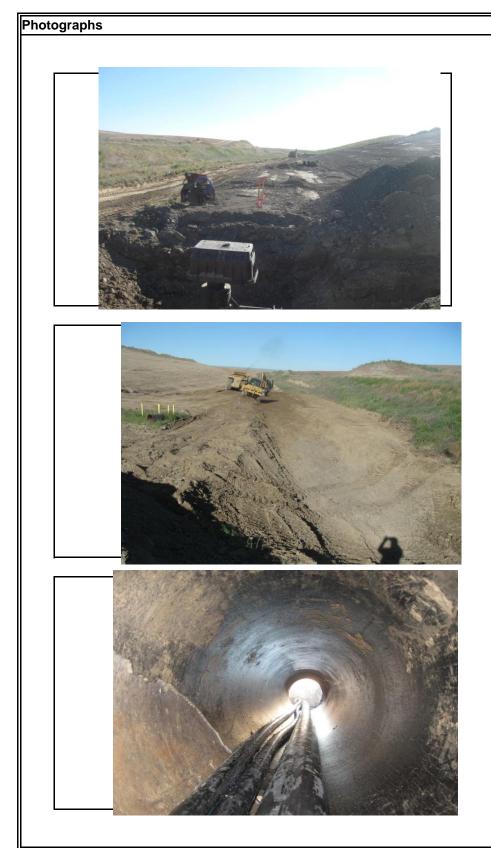
Photo # IMG-2479

View of cleaned out DI pipe under haul road Area 2

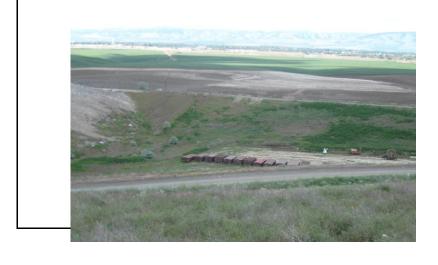
Photo # IMG-2496

Closeup - Easterly view of borrow site

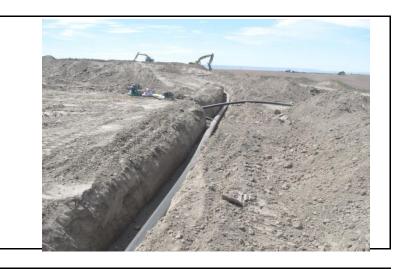
Photo # IMG-2543

N View of 4"LFG & 1.5" FM & air to sump/pump station

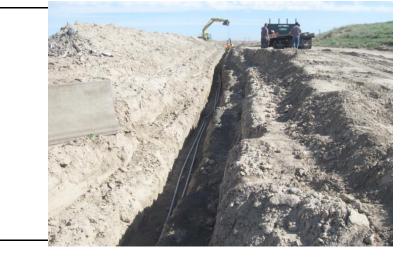
Photo # IMG-2563

No. view of Area 2 conduit to 2/5 meter vault by barrier to Compost Rd

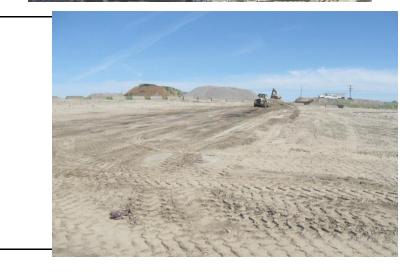
Photo # IMG-2572

No. view of 4" LFG main N Area 2 towards Compost Rd

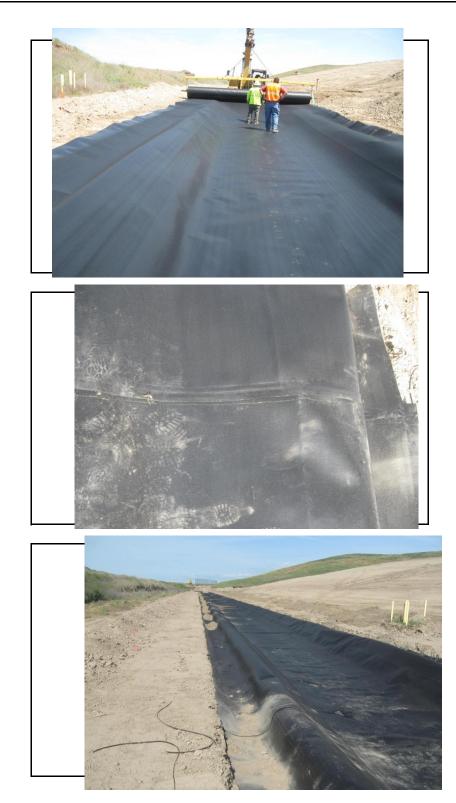
Photo # IMG-2673

moving roll of HDPE liner to west end of concrete ditch

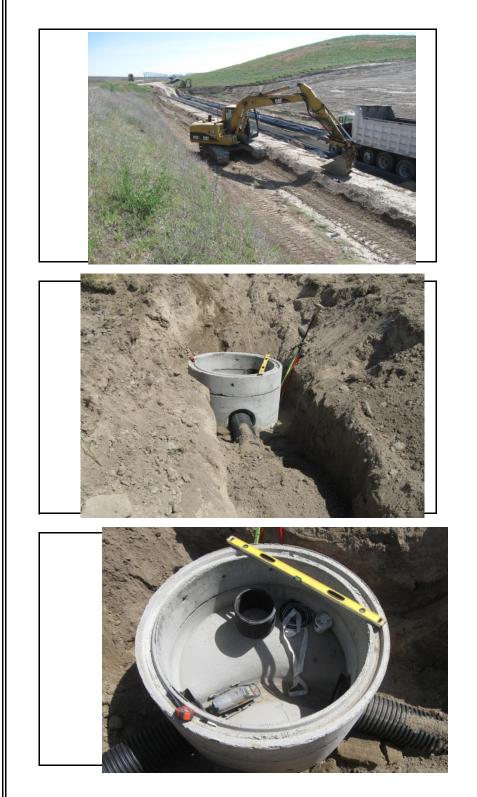
Photo # IMG-2703

10" HDPE outlet onto Compost pad

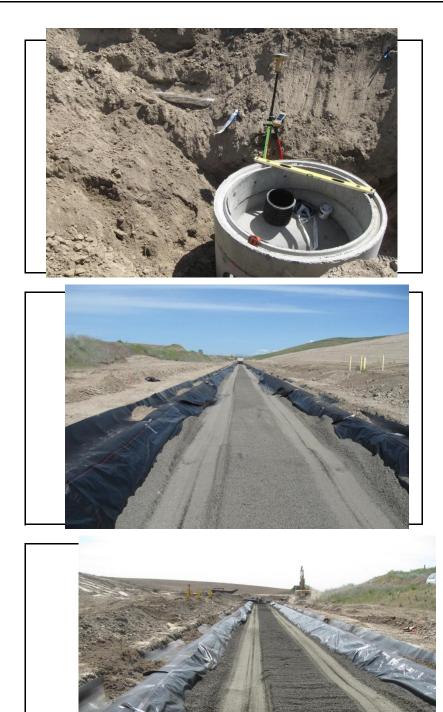
Photo # IMG-2706

Storm Drainage MH by shed - overview lazer

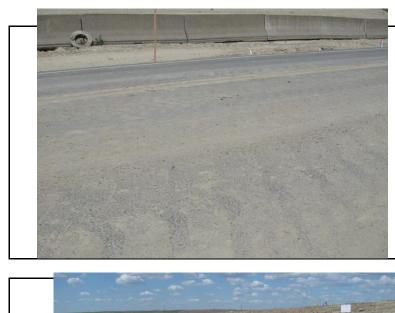
Photo # IMG-2842

Stringline - revised pavement grade to raise cover over 10" HDPE pipe

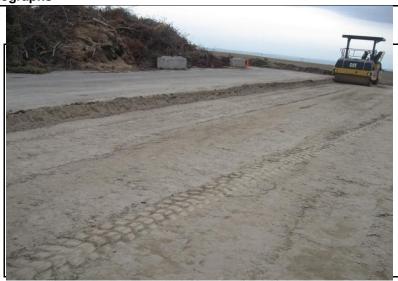
Photo # IMG-2903

Adding subbase to bring grade up to within 9" of existing pavement @ ang pt

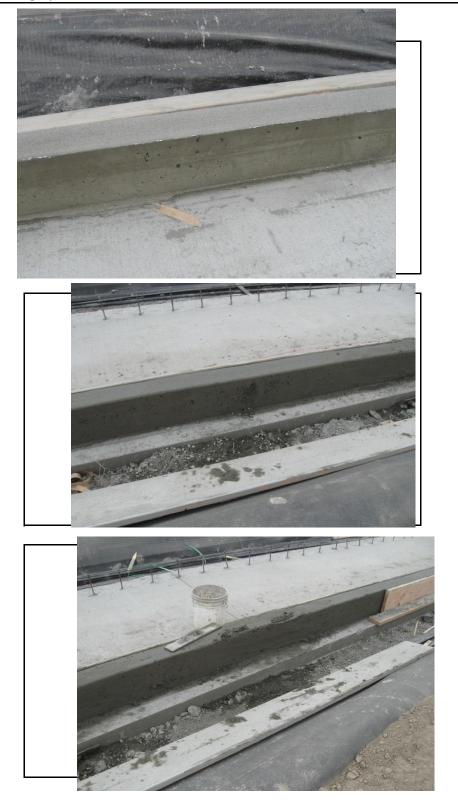
Photo # IMG-2931

Honey comb surface where concrete stuck to form - needs repaired

Repairing honey comb surface where concrete sticking to form

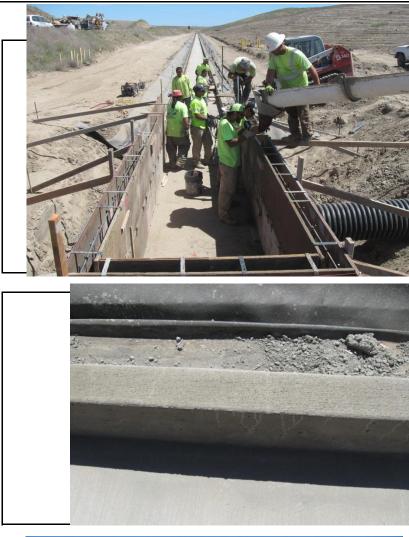
Photo # IMG-2972

Hairline cracks in S. wall approx 9 to 11 feet from saw cut joints

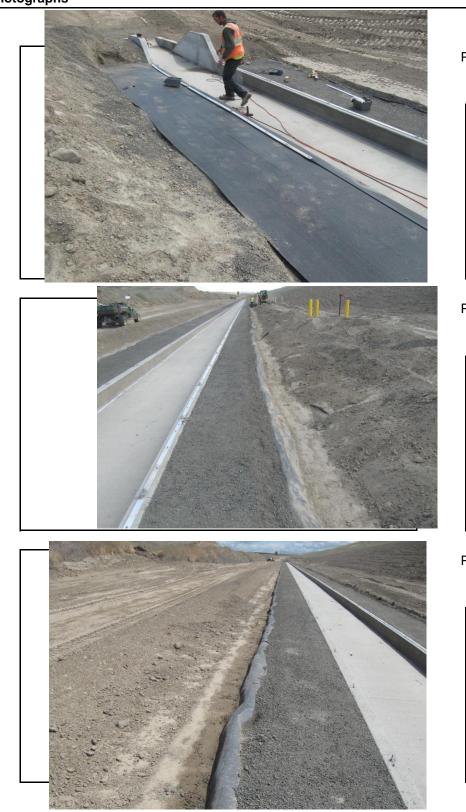
Photo # IMG-3155

East view - getting ready to repair tear in liner North side HDPE liner

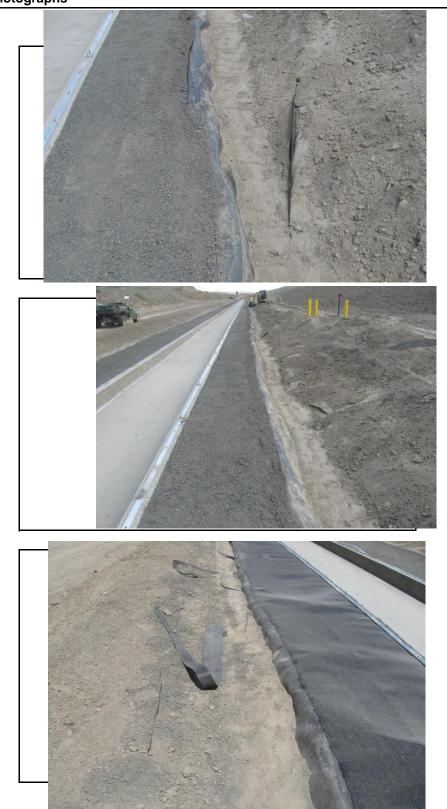
Exposed south liner - not per detail

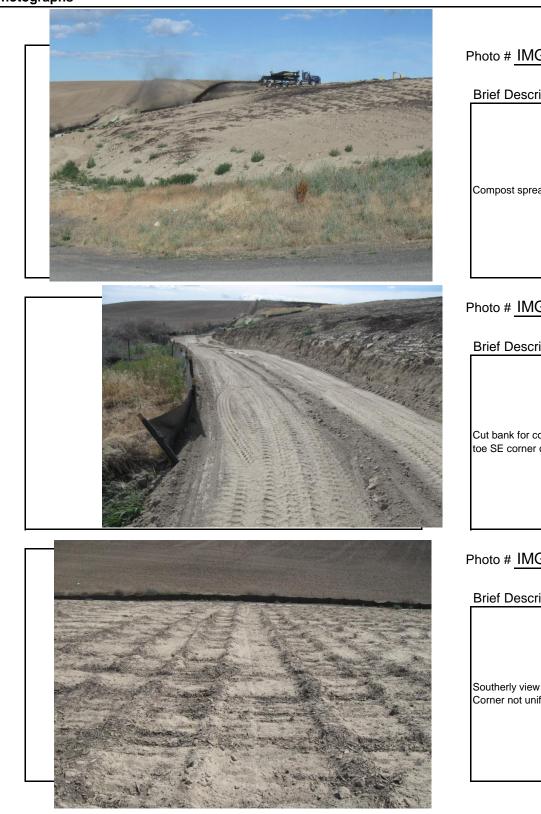
Southerly view Compost application by SW-Corner not uniform on Area 2 after tracking

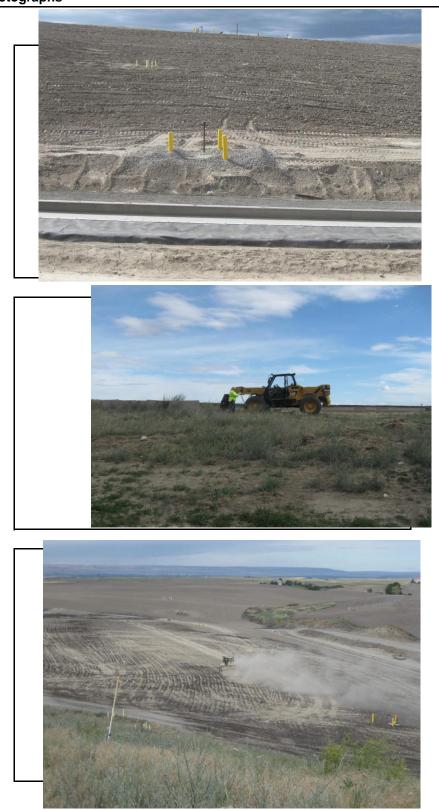
Photographs	
	Photo # <u>IMG-3208</u> Brief Description
	Grinding both surfaces to prep for weld
	Photo # IMG-3209
	Brief Description
	Grinding both surfaces to prep for weld - hard on the back
	Photo # IMG-3210
	Brief Description
	West view of haul road finish coarse by east gate

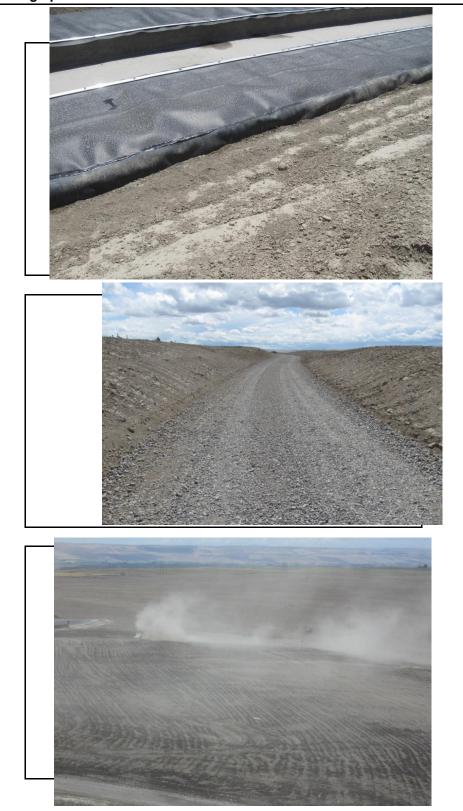
Photo # IMG-3220

Brief Description	
Patching holes in cover HDPE liner

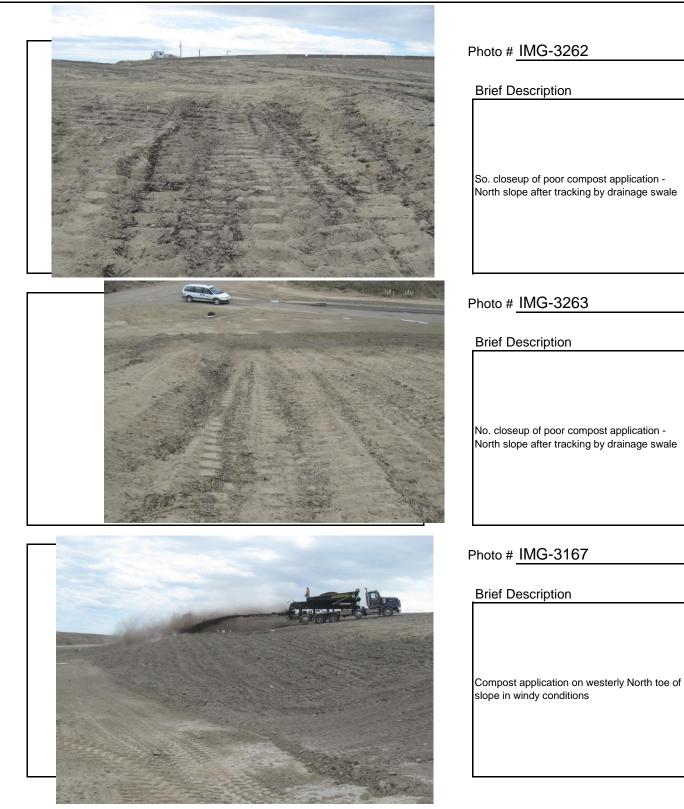
Photo # IMG-3260

Sporatic coverage of compost on North slope after tracking - heavy rut app shows up

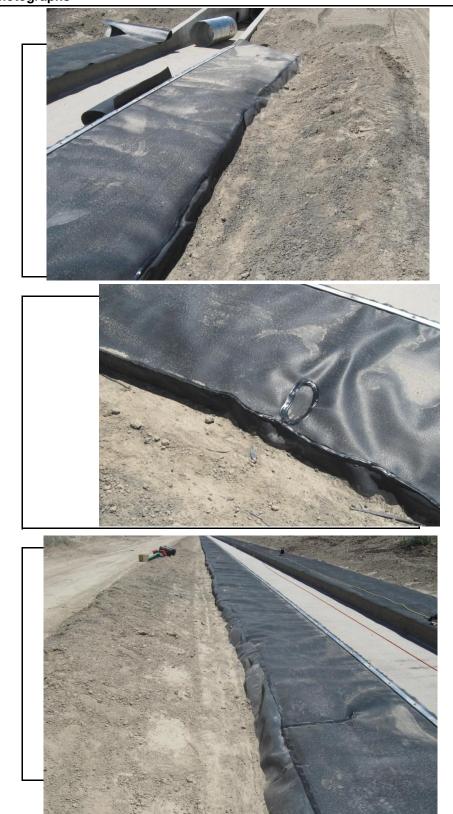
Photographs Photo # IMG-3291 **Brief Description** vertical HDPE liner weld south cover to botton liner - (not horizontal per detail) Photo # IMG-3292 **Brief Description** meandering vertical HDPE liner weld south cover to botton liner - (not straight per detail) Photo # IMG-3293 **Brief Description** West end meandering vertical HDPE liner weld south cover to botton liner

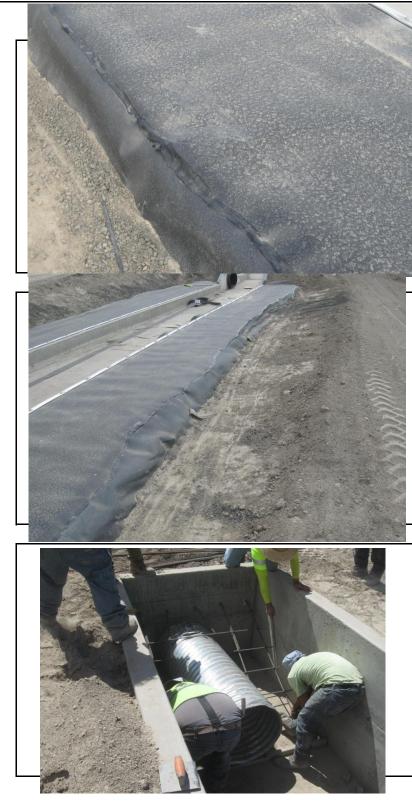
Ripples in HDPE liner - not flat per detail

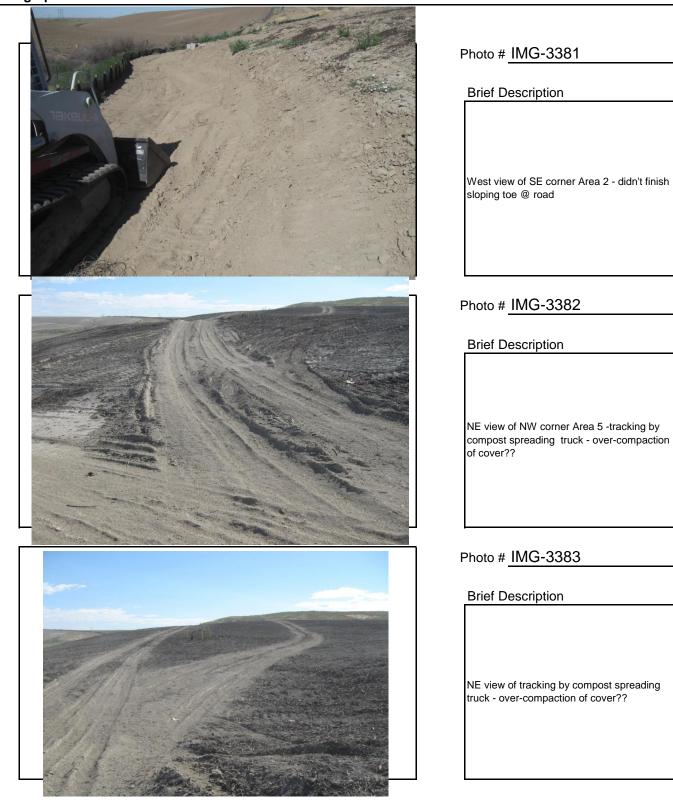
NW view of SE corner Area 2 - very light coverage and poor tracking

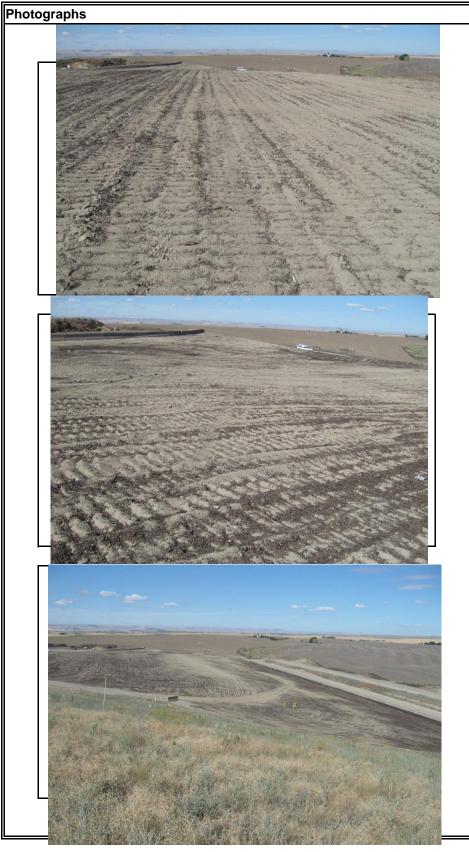
West view of light cover EW-16 towards EW-18 - truck - over-compaction of cover??

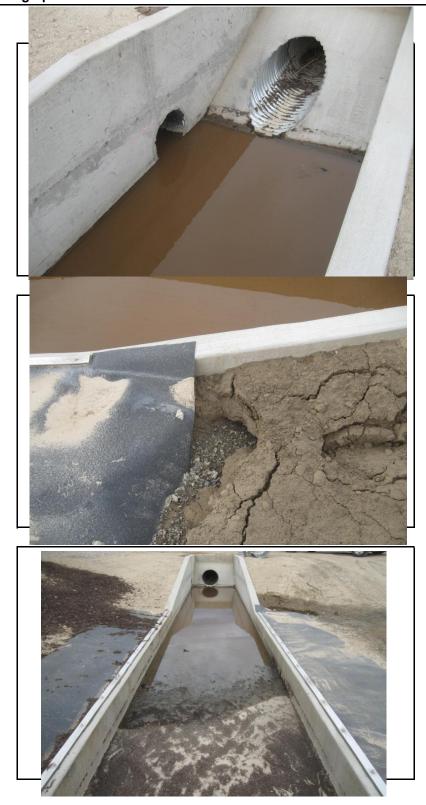
Note: Photos taken of North ditch outlet structure to forward to Culbert and J-U-B for corrective action. Water draining into percolation trench not into concrete ditch as designed.

Weekend rain-additional problems with runoff/ditch section-west view of

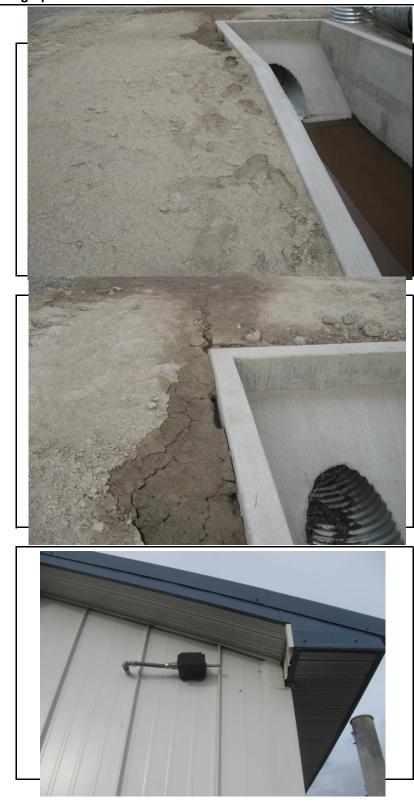
West view of outlet structure additional settlement due to rain event

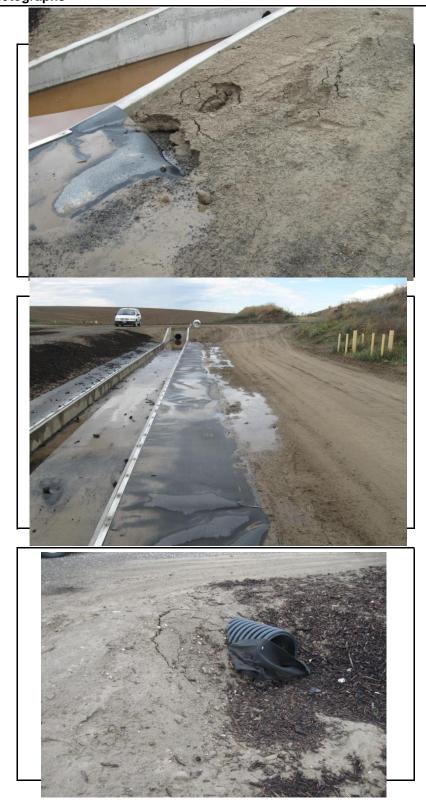
Note: Photos taken of North ditch outlet structure to forward to Culbert and J-U-B for corrective action. Water draining into percolation trench not into concrete ditch as designed.

East view of North ditch during rain event shows water flowing down liner not into ditch per design

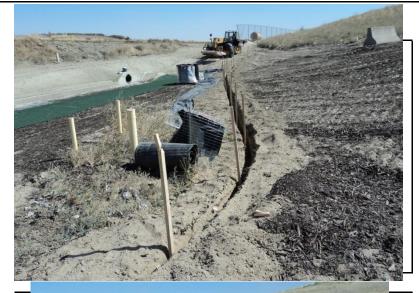
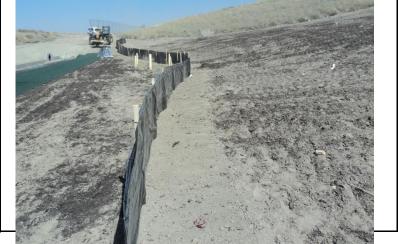
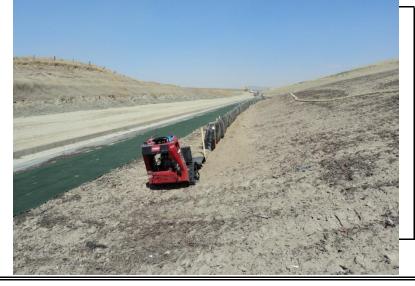
Photo # DSC09957
Brief Description

East view of Trenching for silt fence inlet structure towards the west
