**Re: Dangerous Waste Compliance Inspection on September 2, 2014 at Treoil Industries,
4242 Aldergrove, Ferndale, WA 98242 - RCRA Site ID: N/A Facility Site ID: 2919**

Washington State Department of Ecology Hazardous Waste and Toxics Reduction Program

NOTICE TO COMPLY

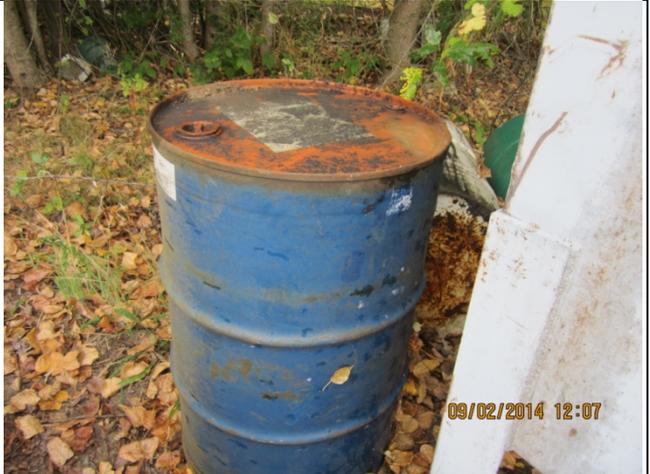
<p>#2</p> <p>Location: Eastern Facility Boundary</p> <p>This photograph depicts a 55-gallon drum of an unknown liquid.</p>

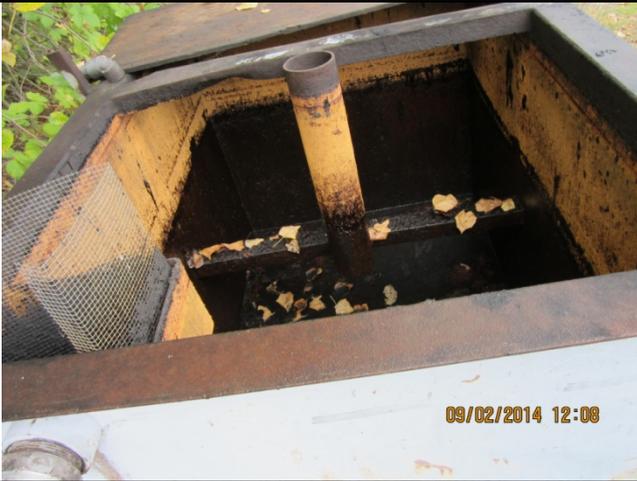
Area & Description	Photographs
<p>#3</p> <p>Location: Eastern Facility Boundary</p> <p>This tank in this photograph contains a residue of an unknown black liquid and rainwater. The side of the tank (not pictured) read "Thickener Tank" and "Caustic."</p>

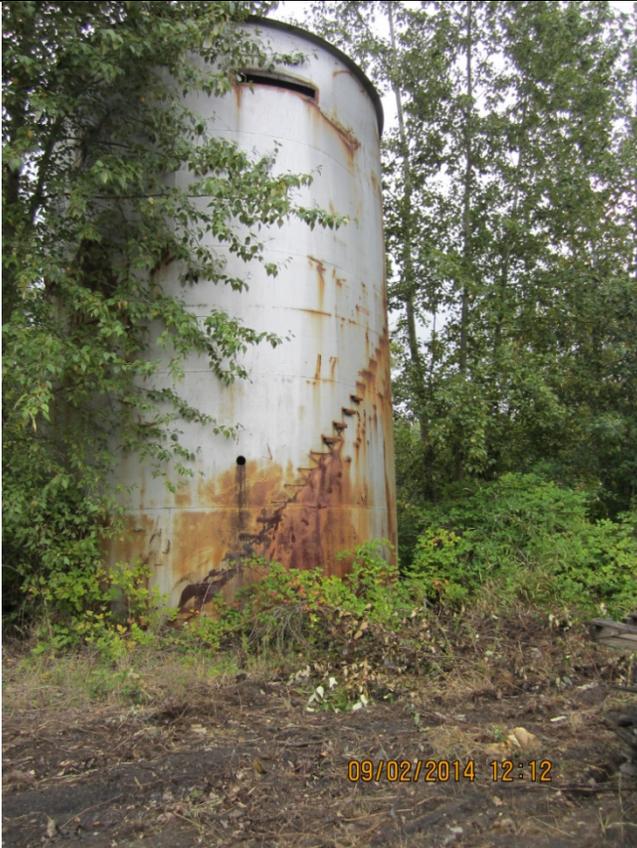
Along the eastern edge of the property was an approximately 20,000-gallon tank. Mr. Gill stated that this tank contained tall oil rosin. The tank was rusting and had an open vent on the top. This tank had no secondary containment.

<p>A photograph showing a rectangular, weathered metal tank. A vertical pipe extends from the top center into the tank. The interior is dark and contains some debris. A metal mesh screen is visible on the left side. A timestamp "09/02/2014 12:06" is visible in the bottom right corner.</p>
<p>#4</p> <p>Location: Eastern Facility Boundary</p> <p>This photograph a tank which Mr. Gill stated contained rosin.</p>

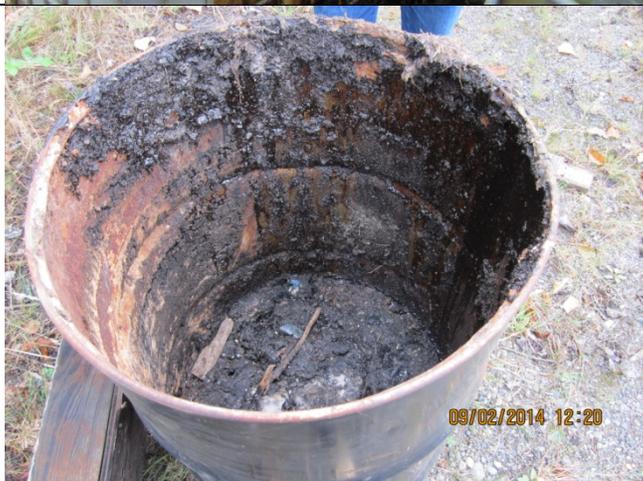
<p>A large, cylindrical metal tote with a blue and white painted section. The top is cut open, and dark, viscous waste is spilled over the top and onto the ground. The tote is surrounded by a metal cage. In the background, there are yellow construction vehicles and trees. A timestamp '09/02/2014 12:16' is visible in the bottom right corner of the photo.</p>
<p>#6</p> <p>Location: Eastern Facility Boundary</p> <p>This photograph shows a 55-gallon drum of waste suspected tall oil or tall oil distillates or spill cleanup debris.</p>

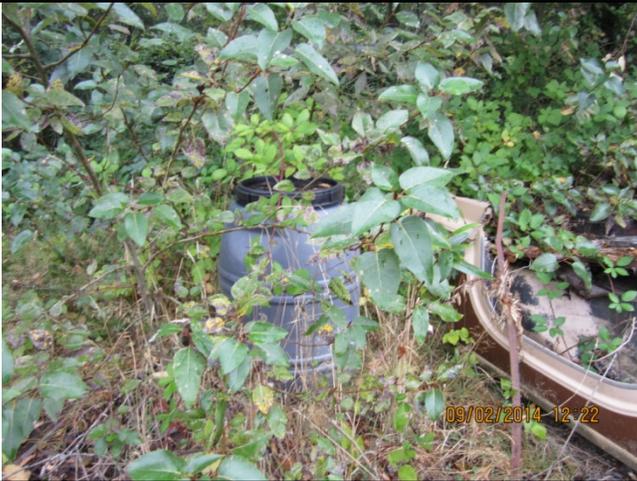
Area & Description	Photographs
<p>#7</p> <p>Location: Eastern Facility Boundary</p> <p>This photograph depicts a 55-gallon drum of an unknown liquid.</p>

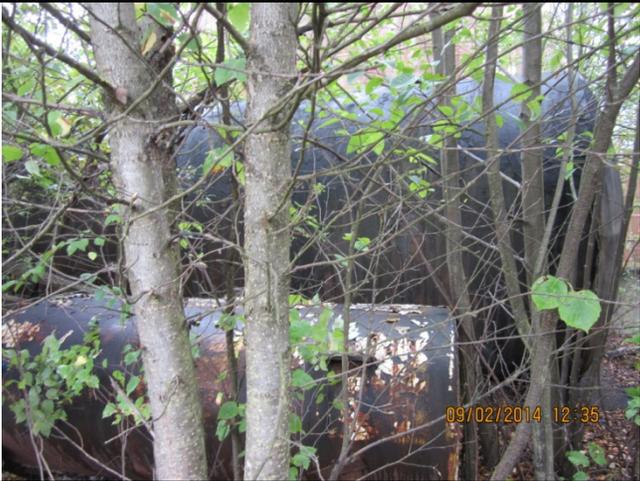
Area & Description	Photographs
<p>#14</p> <p>Location: Plant Perimeter</p> <p>This photograph depicts two more tanks with unknown contents.</p>

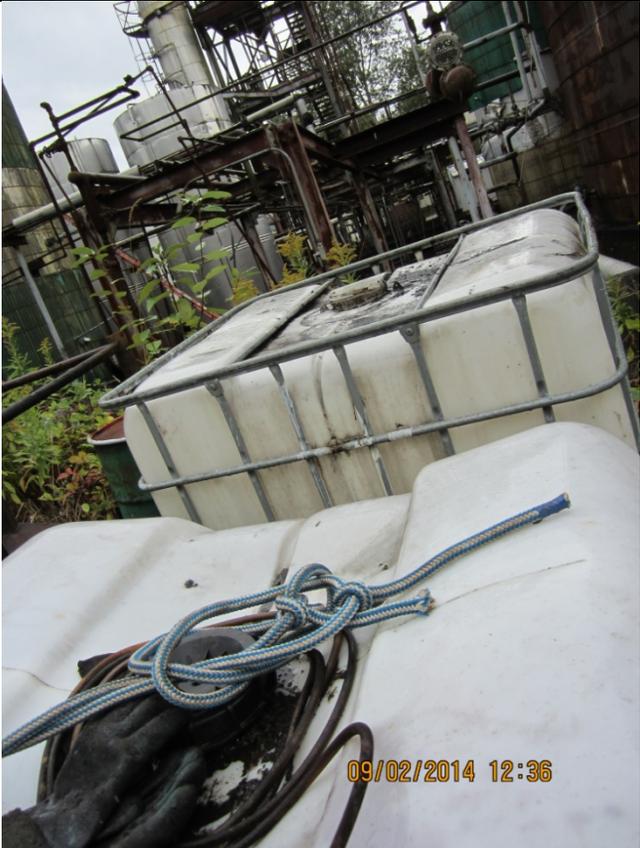
<p>A photograph showing two large, dark-colored tanks partially obscured by a dense thicket of trees and branches. The tanks are situated in a wooded area. A timestamp in the bottom right corner reads "09/02/2014 12:35".</p>
<p>#15</p> <p>Location: Plant Perimeter</p> <p>This photograph depicts two totes of suspected tall oil or tall oil derivatives.</p>

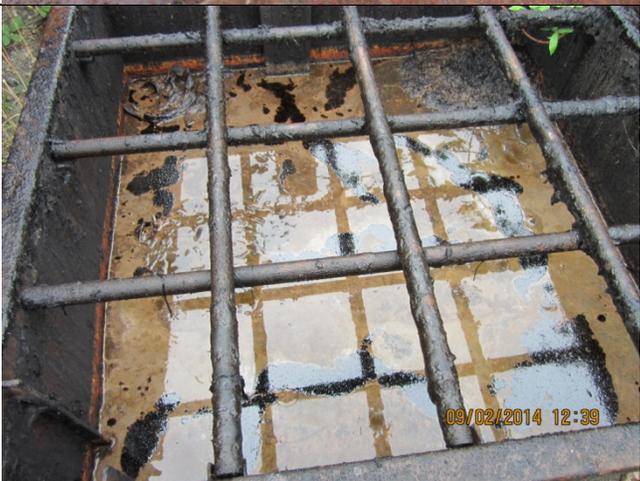
<p>#17</p> <p>Location: Plant Perimeter</p> <p>This photograph shows an open topped tank of suspected tall oil or tall oil distillates contaminated with rainwater.</p>

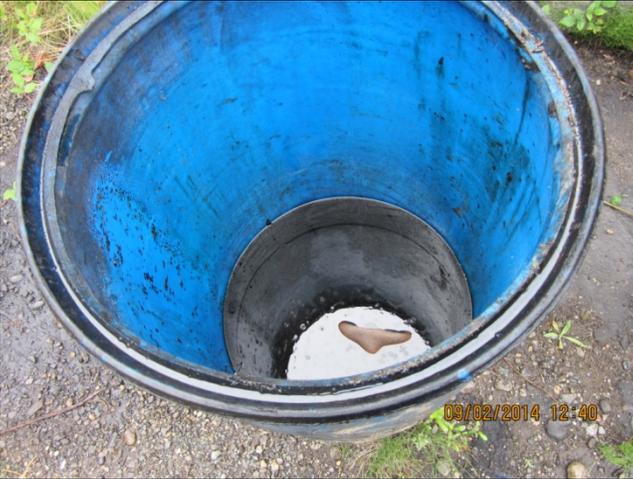
Area & Description	Photographs
<p>#18</p> <p>Location: Plant Perimeter</p> <p>This photograph depicts a 55-gallon drum of an unknown liquid.</p>

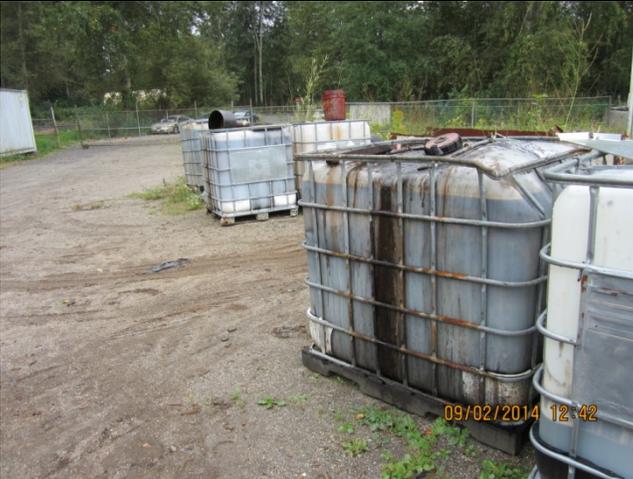
<p>09/02/2014 12:40</p>
<p>#19</p> <p>Location: Fabrication Building Exterior</p> <p>This photograph depicts five more totes of tall oil, tall oil distillates, or tall oil wastes.</p>

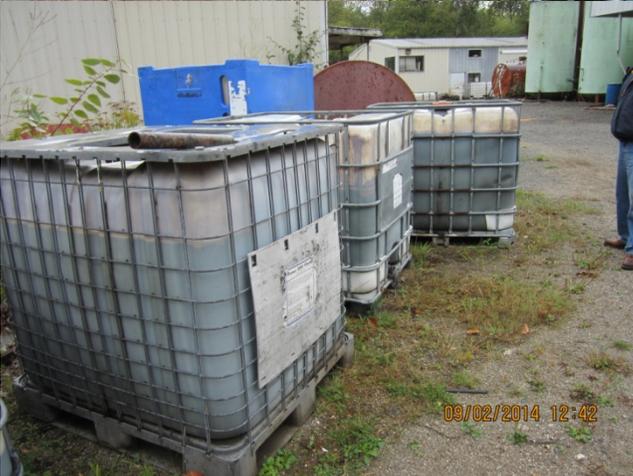
<p>09/02/2014 12:42</p>
<p>#20</p> <p>Location: Fabrication Building Exterior</p> <p>This photograph depicts three more totes of tall oil or tall oil distillates or tall oil wastes.</p>

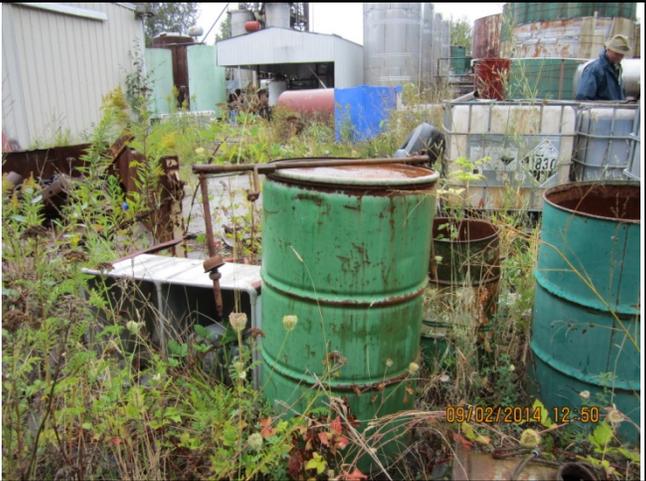
Area & Description	Photographs
<p>#21</p> <p>Location: Fabrication Building Exterior</p> <p>This photograph depicts a 55-gallon drum of an unknown liquid (center green drum). The open blue drum at the right of the frame contained black oil suspected as tall oil.</p>

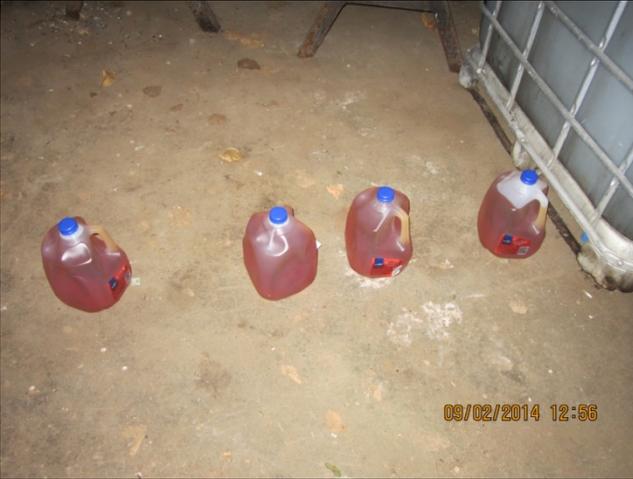
Area & Description	Photographs
<p>#23</p> <p>Location: Fabrication Building</p> <p>This photograph depicts four 1-gallon poly containers of an unknown liquid.</p>

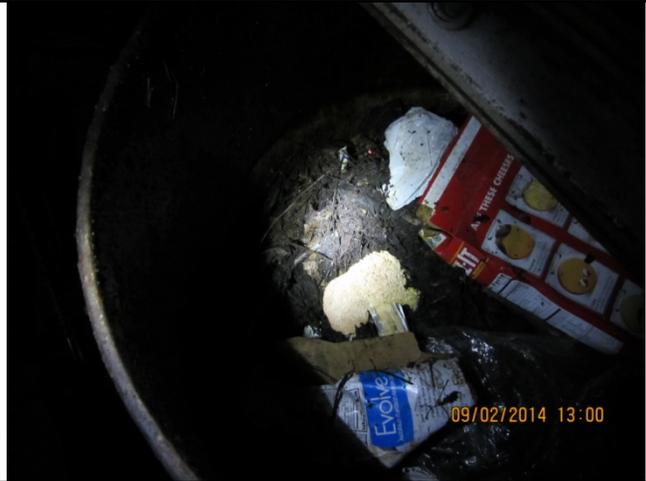
Area & Description	Photographs
<p>#26</p> <p>Location: Fabrication Building</p> <p>This photograph depicts the interior of one of the drums shown in photograph #25.</p>

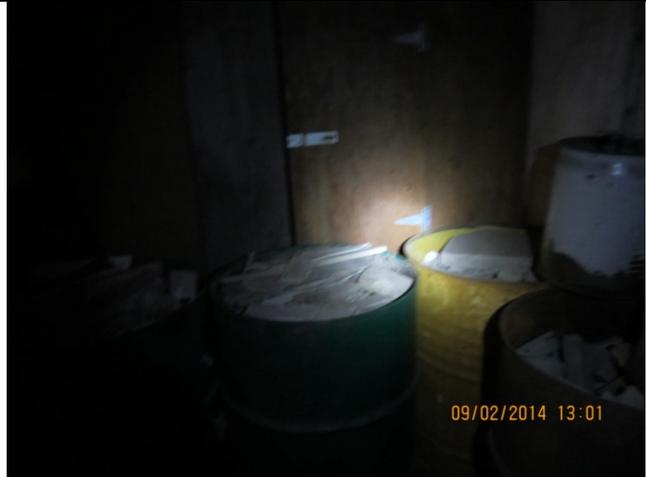
<p>A photograph showing the interior of a drum. The drum is dark and contains various pieces of debris, including a yellow foam object, a blue box labeled 'Evolve', and a red and white box. A timestamp '09/02/2014 13:00' is visible in the bottom right corner.</p>
<p>#27</p> <p>Location: Fabrication Building</p> <p>This photograph depicts four 55-gallon drum of refractory insulation waste.</p>

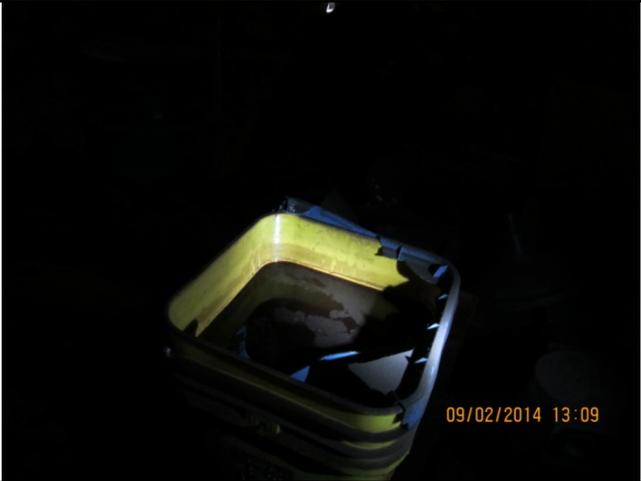
Area & Description	Photographs
<p>#30</p> <p>Location: Fabrication Building</p> <p>This photograph depicts a 5-gallon poly container of an unknown black liquid.</p>

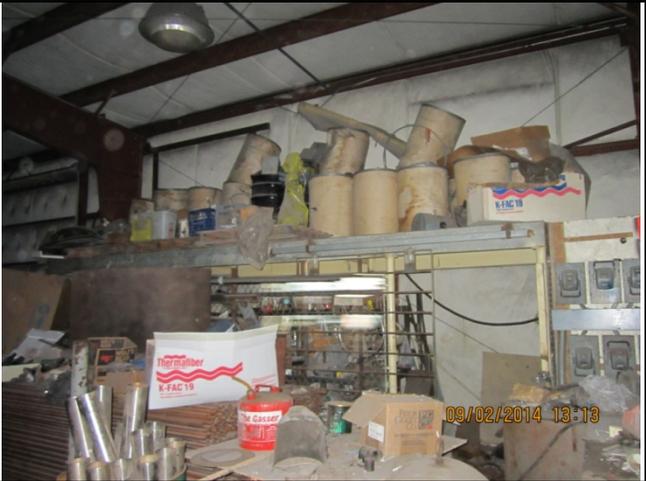
Area & Description	Photographs
<p>#32</p> <p>Location: Fabrication Building</p> <p>The numerous containers in the mezzanine area were not inspected directly due to safety concerns. Their contents are unknown.</p>

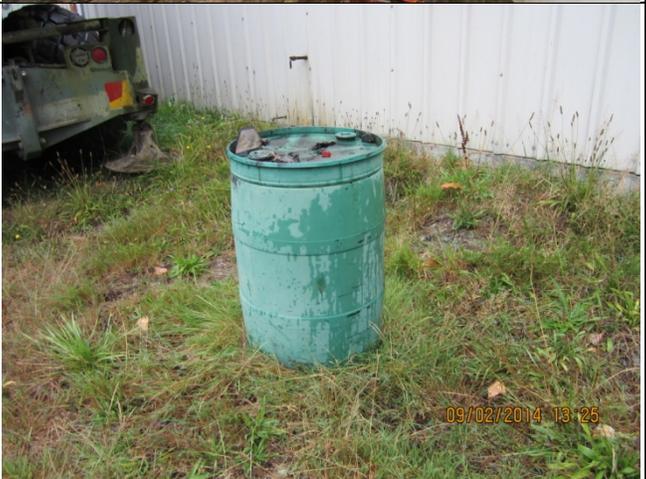
<p>A photograph showing three blue drums (two 30-gallon and one 55-gallon) and a white bucket containing a pink liquid. The drums are situated on a wooden floor against a white wall. A white brush and some debris are scattered on the floor in front of the drums. A timestamp '09/02/2014 13:23' is visible in the bottom right corner of the photo.</p>
<p>#39</p> <p>Location: Western Facility Boundary</p> <p>This photograph depicts a 55-gallon drum of an unknown liquid.</p>

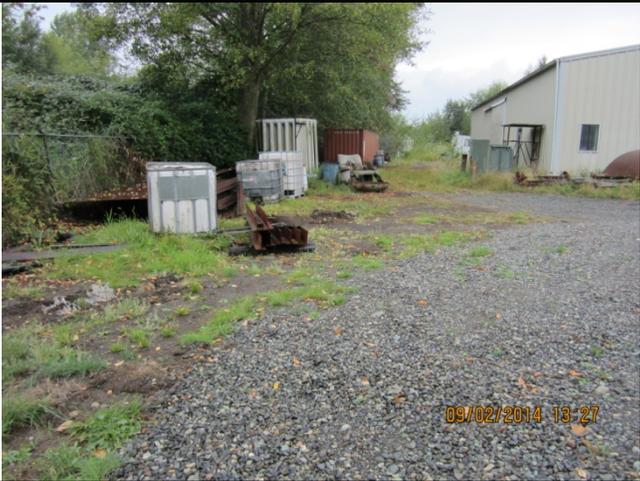
Area & Description	Photographs
<p>#40</p> <p>Location: Western Facility Boundary</p> <p>This photograph shows three more totes of tall oil or tall oil distillates.</p>

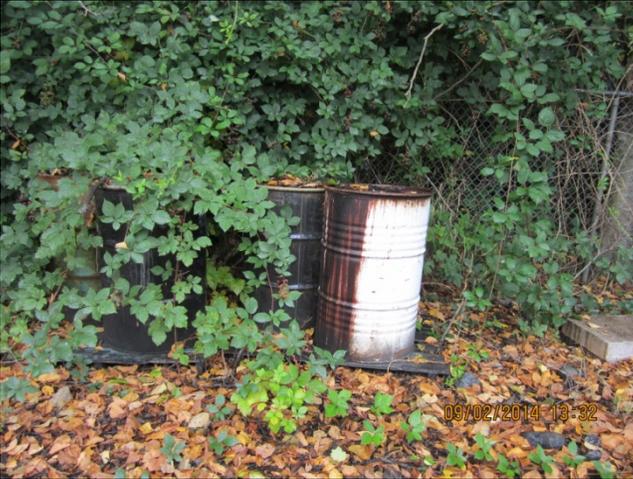
Area & Description	Photographs
<p>#42</p> <p>Location: Western Facility Boundary</p> <p>This photograph shows three 55-gallon drums of tall oil spill cleanup debris.</p>

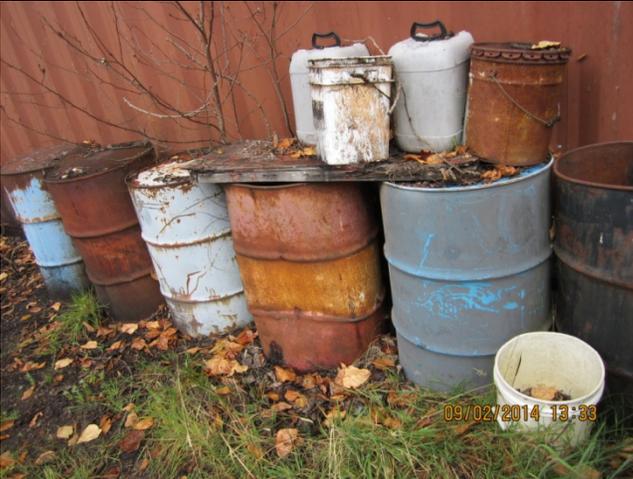
A photograph showing three 55-gallon drums (two black, one silver) partially obscured by dense green foliage and a chain-link fence. The ground is covered with fallen leaves. A timestamp '09/02/2014 13:32' is visible in the bottom right corner.
<p>#43</p> <p>Location: Western Facility Boundary</p> <p>The six 55-gallon drums in this photograph contain tall pitch spill cleanup debris. The five smaller containers contain unknown wastes. The cargo container in the background reportedly contains biological oils stored here since at least 2006.</p>

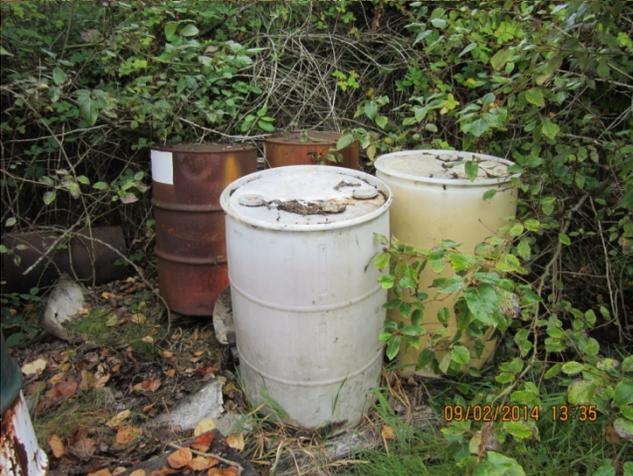
<p>#44</p> <p>Location: Western Facility Boundary</p> <p>This photograph depicts two 55-gallon poly containers of an unknown liquid and two 55-gallon steel containers of an unknown waste.</p>

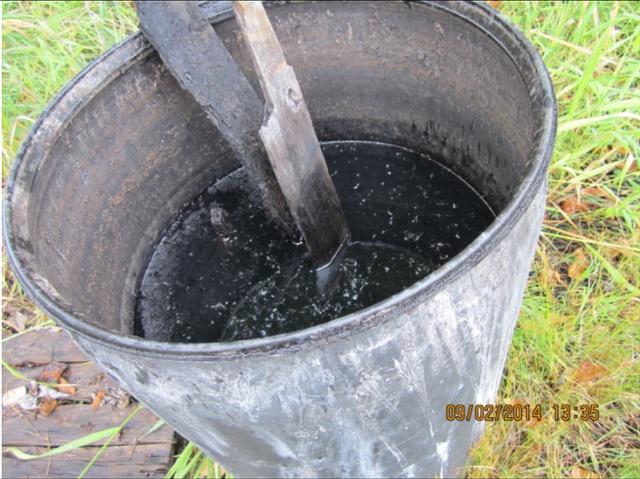
Area & Description	Photographs
<p>#45</p> <p>Location: Western Facility Boundary</p> <p>This photograph depicts an open topped drum of tall oil or tall oil derivatives.</p>

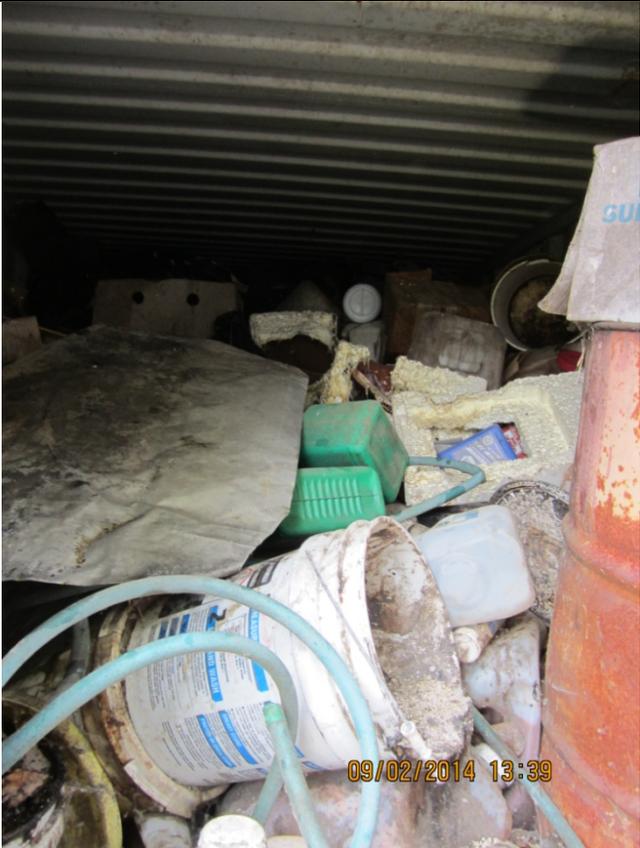
<p>A photograph showing a large, cylindrical metal drum with a dark, viscous liquid inside. A metal tool is inserted into the drum. The drum is situated outdoors on a wooden surface, with grass and leaves visible around it. A timestamp in the bottom right corner reads "09/02/2014 13:35".</p>
<p>#46</p> <p>Location: Western Boundary Shipping Container</p> <p>This photograph depicts the interior of the cargo container depicted in photograph #43. This container was very full which prohibited the close inspection of the contents interior.</p>

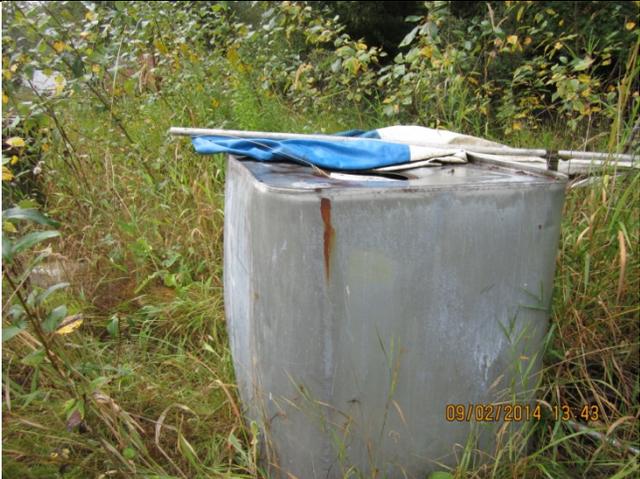
A photograph showing three drums of unknown wastes. On the left is a green drum, and on the right are two black drums. A person wearing a blue protective suit is partially visible on the right side of the frame. The drums are situated outdoors in a grassy area with some brush. A timestamp in the bottom right corner reads "09/02/2014 13:41".
<p>#48</p> <p>Location: Western Facility Boundary</p> <p>This photograph depicts a tote of an unknown liquid. The lid was closed with plastic sheeting rather than a manufactured cap (not pictured).</p>

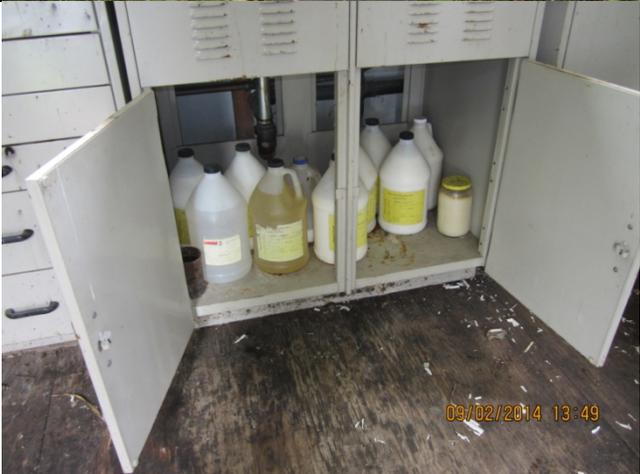
<p>#49</p> <p>Location: Laboratory</p> <p>The ten 1-gallon containers contain unspecified "specialty polymers" wastes left over from past product development. The 1-liter glass container (lower right) holds an unknown waste.</p>

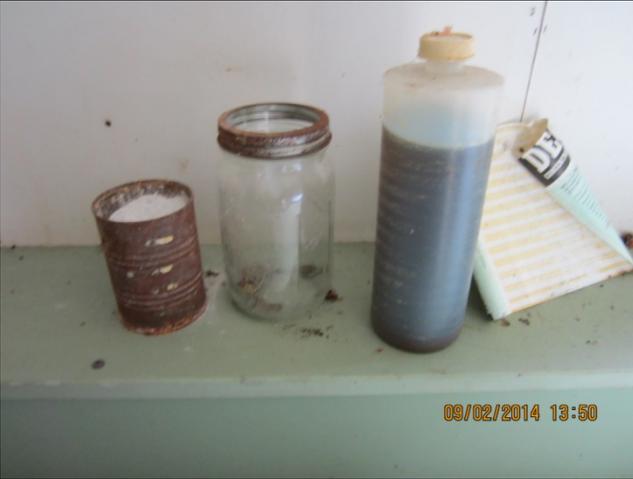
Area & Description	Photographs
<p>#50</p> <p>Location: Laboratory</p> <p>The metal container on the left contains an unknown white powder, the middle container is empty, and the right contains an unknown black liquid waste.</p>

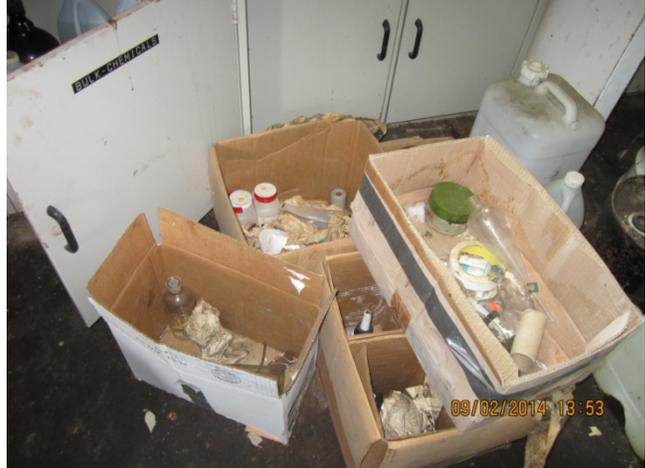
<p>#54</p> <p>Location: Laboratory</p> <p>This photograph depicts more cardboard boxes of waste laboratory chemicals, glassware and other laboratory debris.</p>

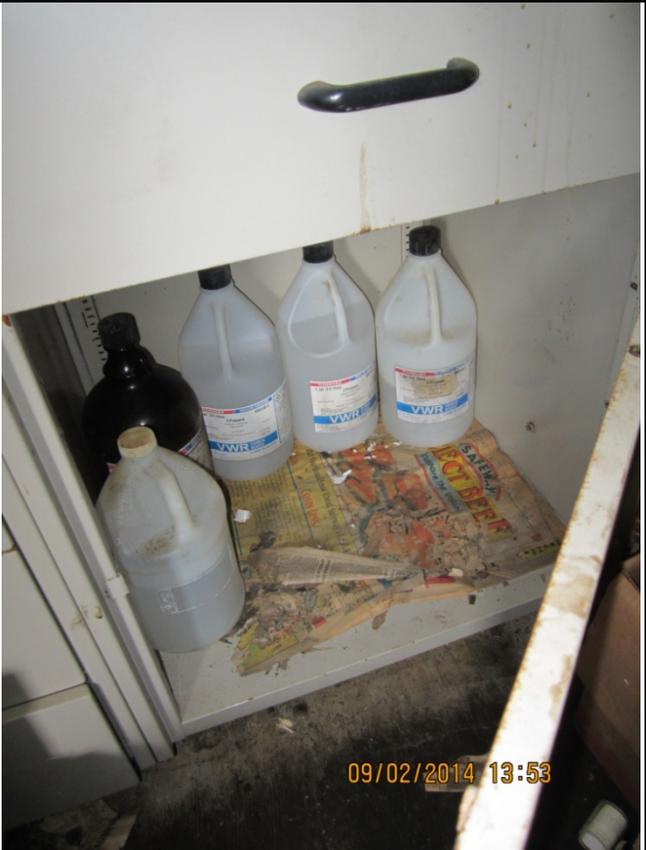
Area & Description	Photographs
<p>#55</p> <p>Location: Laboratory</p> <p>This photograph shows four 1-gallon poly containers of 2-propanol. The 1-gallon glass container on the left contains an unknown waste.</p>

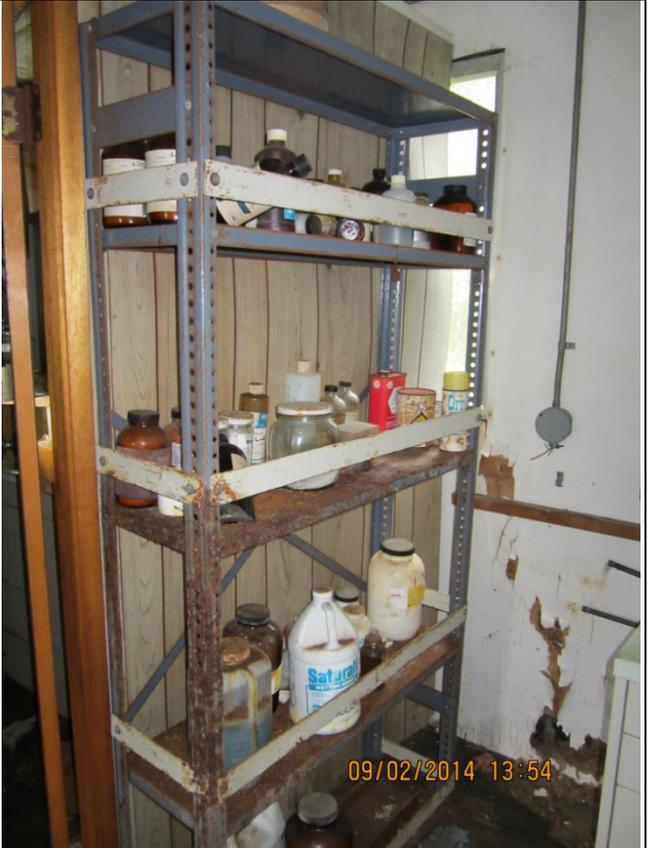
Area & Description	Photographs
<p>#56</p> <p>Location: Laboratory</p> <p>This shelf holds numerous containers of expired waste laboratory chemicals. Note that the shelf has begun to rust and deteriorate.</p>

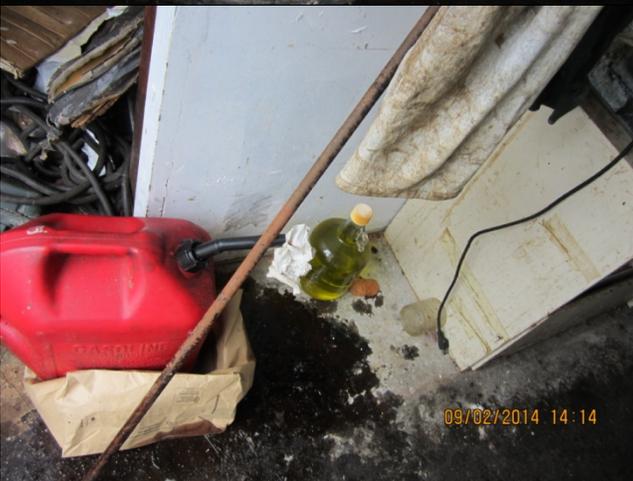
<p>#58</p> <p>Location: Control Building</p> <p>The red poly container on the left of frame contains old gasoline. Note a white rag is stuffed into the spout instead of a regular cap. The glass container on the right contains an unknown liquid waste.</p>

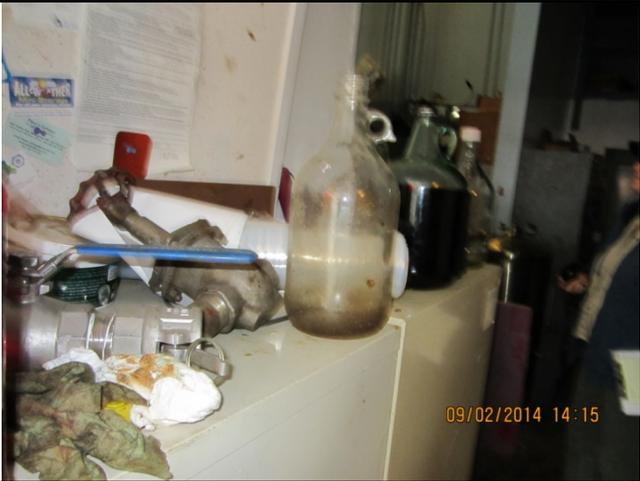
Area & Description	Photographs
<p>#59</p> <p>Location: Control Building</p> <p>This photograph shows three 1-gallon glass containers of unknown liquid waste.</p>

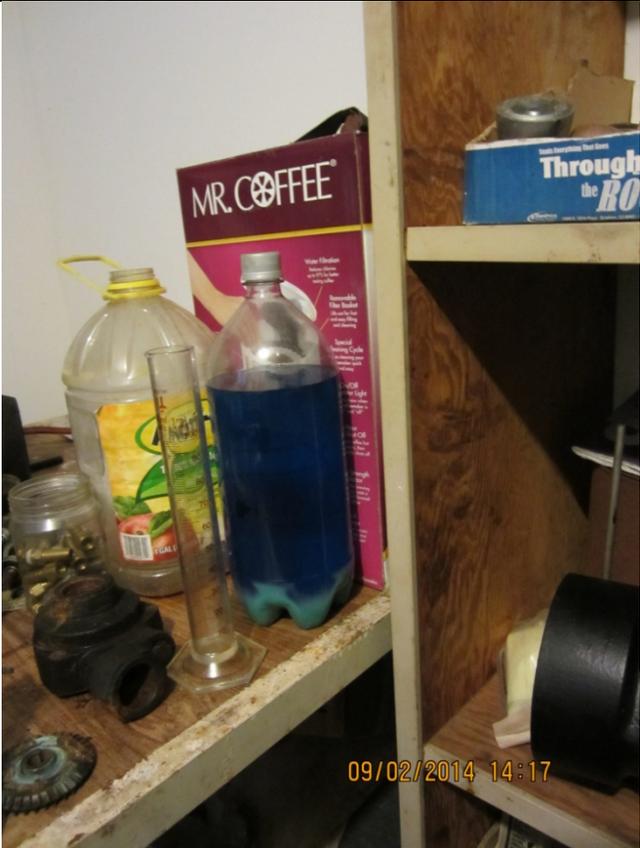
<p>A photograph showing three 1-gallon glass containers filled with a brown, opaque liquid. The containers are on a white surface, possibly a counter or table. There are other items on the surface, including a blue-handled tool and some papers. A timestamp in the bottom right corner reads "09/02/2014 14:15".</p>
<p>#60</p> <p>Location: Control Building</p> <p>This photograph depicts a 2-liter poly container of an unknown liquid waste.</p>

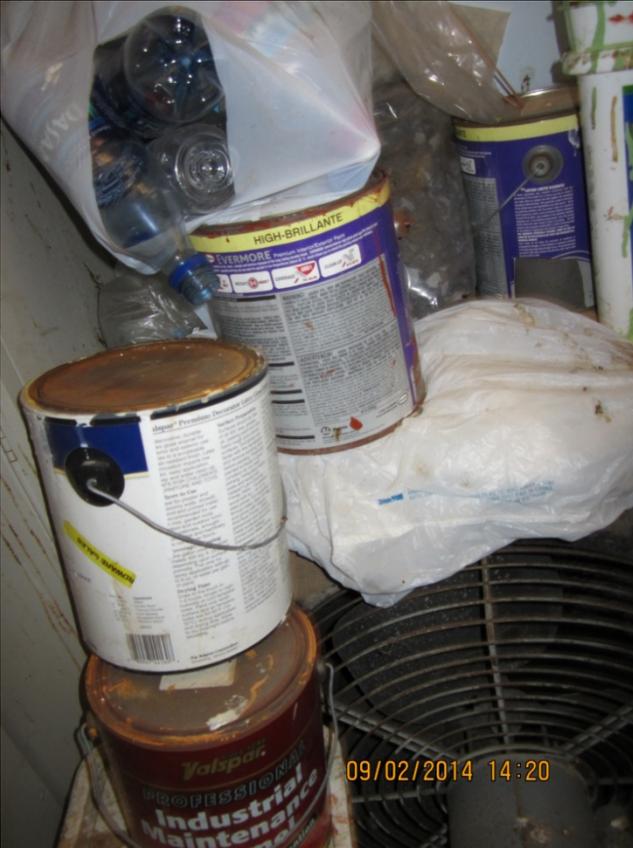
Area & Description	Photographs
<p>#62</p> <p>Location: Control Building</p> <p>This photograph shows four 1-gallon containers of waste flammable paint.</p>

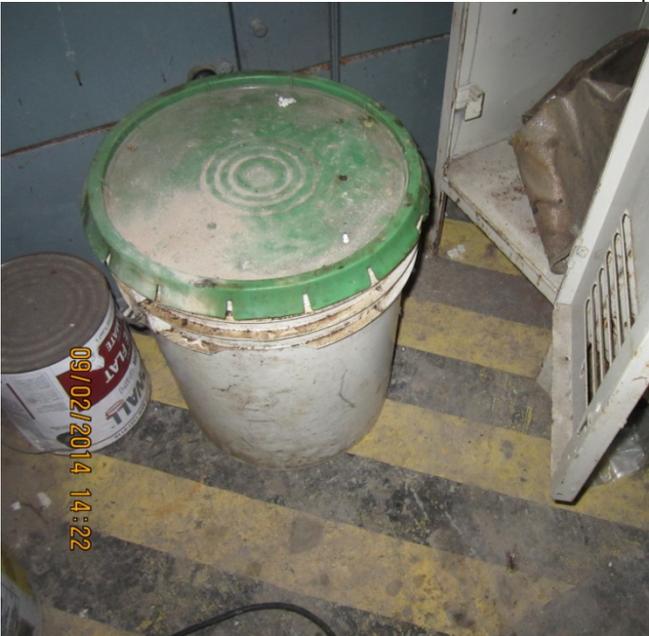
Location: Control Building

This photograph shows a 1-gallon container of flammable paint and a 5-gallon poly container of an unknown waste.

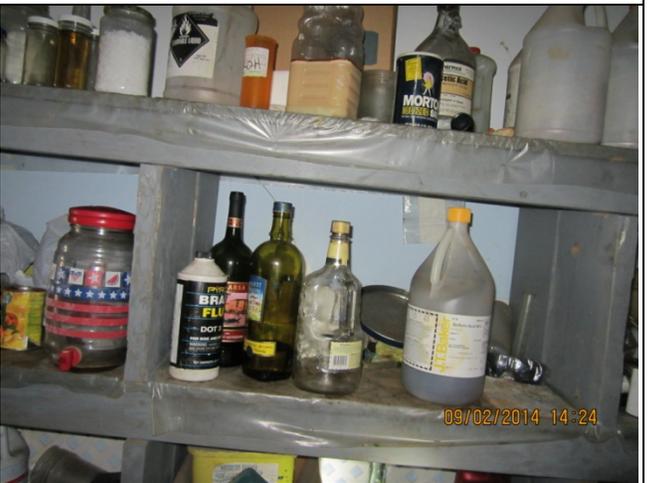
#64

This photograph shows a shelf with numerous small containers of waste. While many of these were unlabeled unknowns, a partial list of example wastes includes:

- Sulfuric acid
- Glacial acetic acid

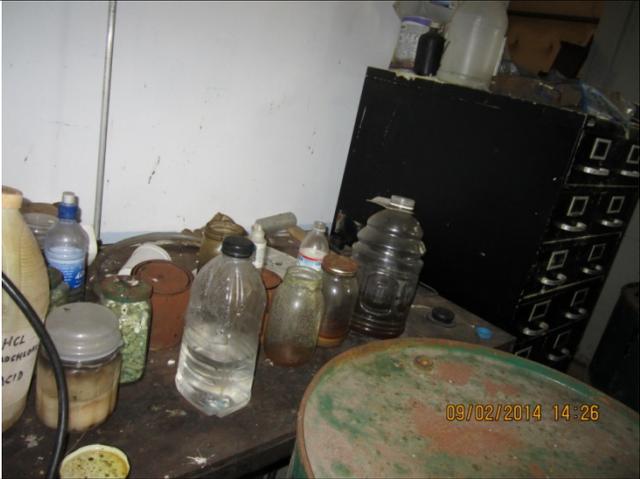
Area & Description	Photographs
<p>#65</p> <p>Location: Control Building</p> <p>This photograph shows a table laden with numerous small containers of unknown wastes.</p>

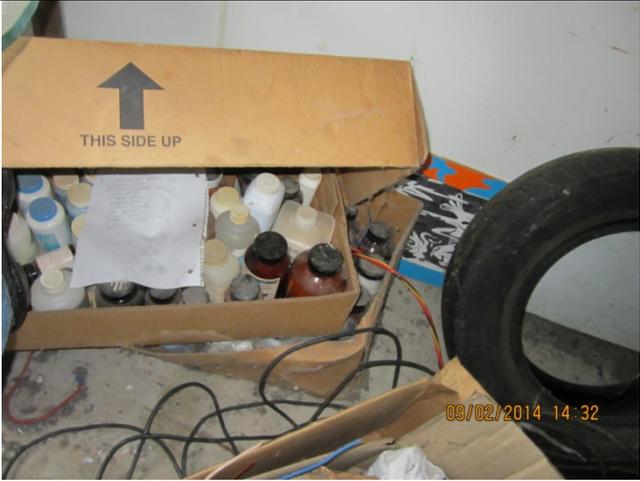
Area & Description	Photographs
<p>#68</p> <p>Location: Control Building</p> <p>This photograph shows two cardboard boxes of expired waste laboratory chemicals. A partial list of example chemicals included:</p> <ul style="list-style-type: none">• Copper Sulfate• Copper Chloride• Sodium Bromide

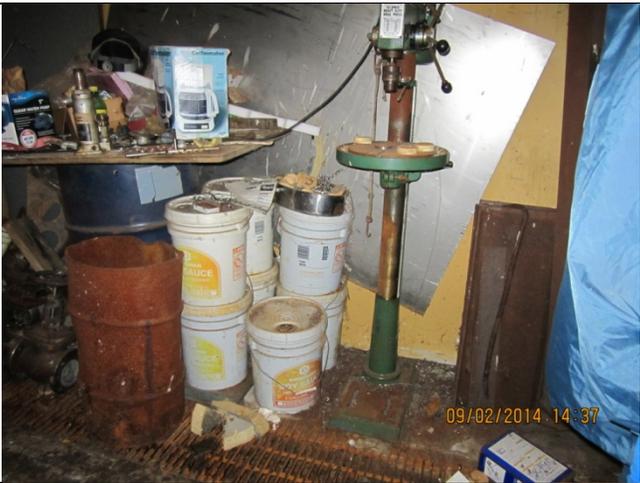
<p>#69</p> <p>Location: Control Building</p> <p>The seven white 5-gallon poly containers in this photograph contain an unknown waste. It is believed that the blue 55-gallon drum in the background being used as a table is empty.</p>

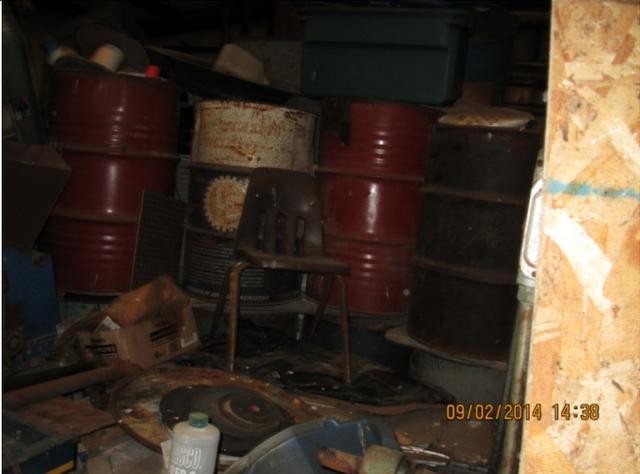
<p>#70</p> <p>Location: Control Building</p> <p>The drums in this photograph were difficult to access due to so much clutter and equipment. Their contents are unknown.</p>

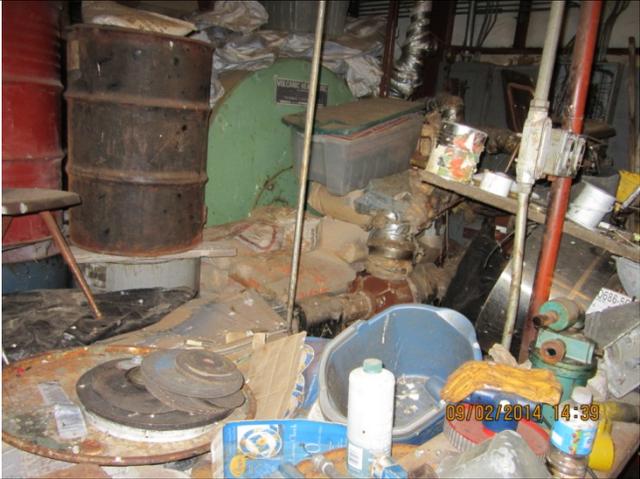
Area & Description	Photographs
<p>#71</p> <p>Location: Control Building</p> <p>This photograph shows more drums of unknown waste. The green piece of equipment in the background is reportedly an old boiler.</p>

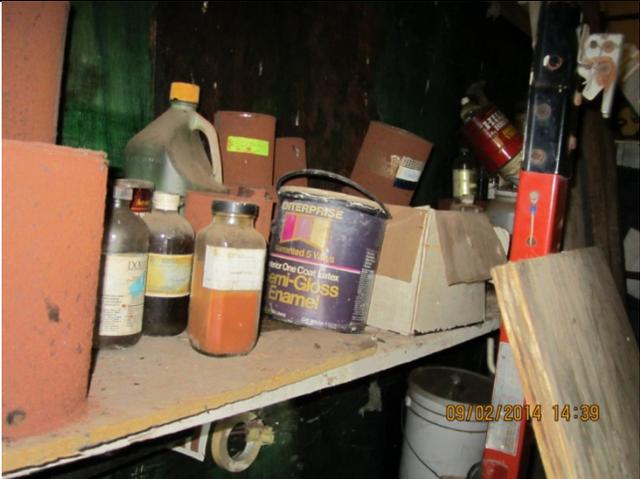
<p>A photograph showing a cluttered storage area. In the foreground, there are several drums and containers, some with labels. A green piece of equipment is visible in the background. The timestamp '09/02/2014 14:39' is visible in the bottom right corner.</p>
<p>#72</p> <p>Location: Control Building</p> <p>This photograph depicts a shelf of expired waste laboratory chemicals, paint, and unlabeled unknown wastes. An example chemical on this list was polydimethylsiloxane.</p>

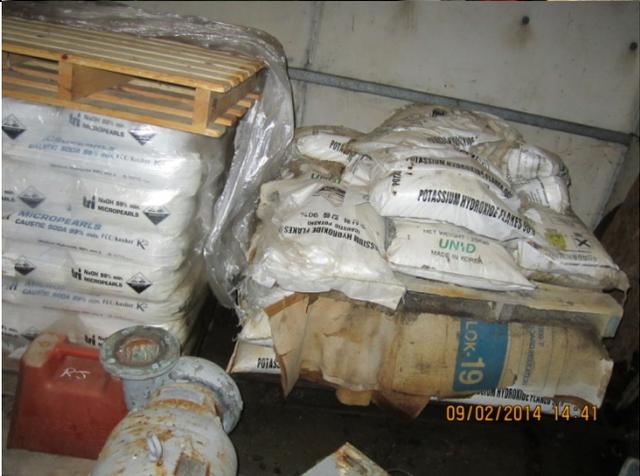
<p>#73</p> <p>Location: Control Building</p> <p>This photograph shows two pallets of solid caustic waste; the pallet on the left holds sodium hydroxide while the right contains potassium hydroxide.</p>

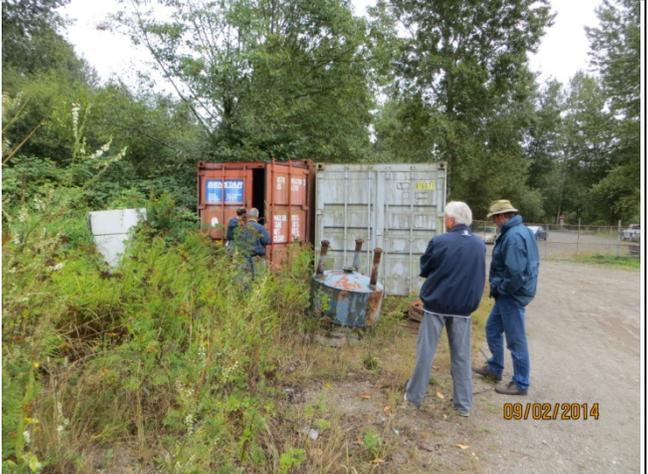
<p>A white trailer is parked on a gravel lot. A grey tarp covers a vehicle on the trailer. A date stamp '09/02/2014' is in the bottom right corner.</p>
<p>#503</p> <p>Location: Eastern Facility Boundary</p> <p>The two shipping containers in this photograph were reported by Mr. Gill to contain equipment owned by a Mr. Frank Kanderall.</p>

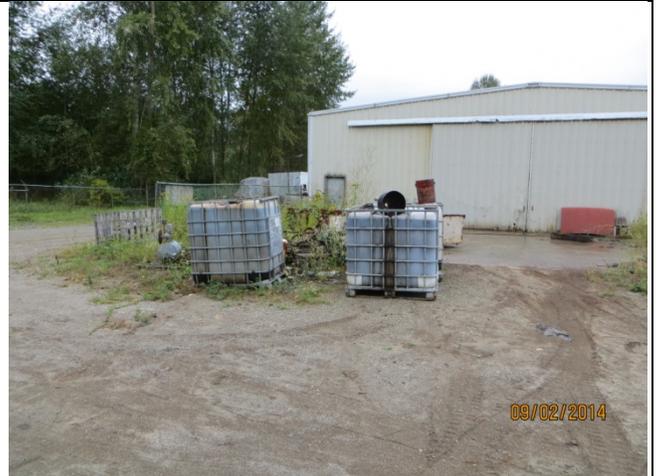
#504

The totes in this photograph reportedly contain tall oil or tall oil derivatives.

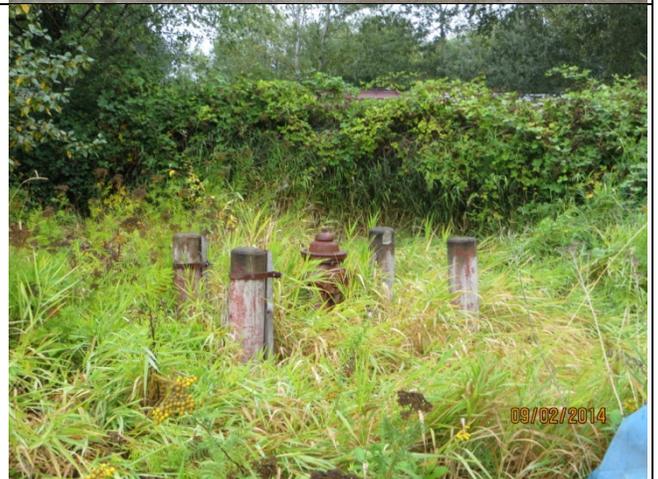
#505

This water hydrant is active and pressurized and the facility is served by the local water utility.

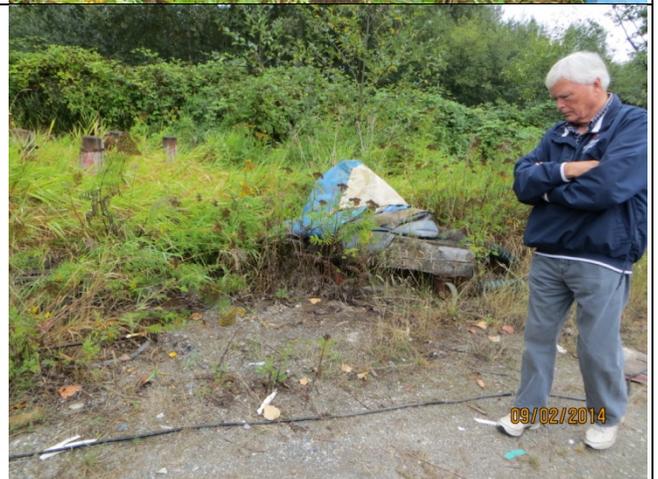
#506

The blue tarp in this photograph covered a pile of cable.

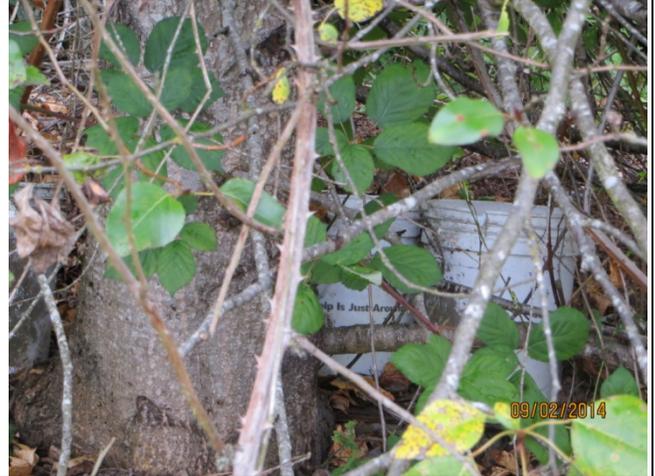
#507

closed and in fair condition but was unlabeled. Among the vegetation in this area were four 5-gallon poly buckets, which contained soil and pieces of metal equipment. We observed a water hydrant in this area and Mr. Gill stated that site is served by City of Bellingham water.

The white 5-gallon poly buckets in this photograph contained soil and pieces of metal equipment.

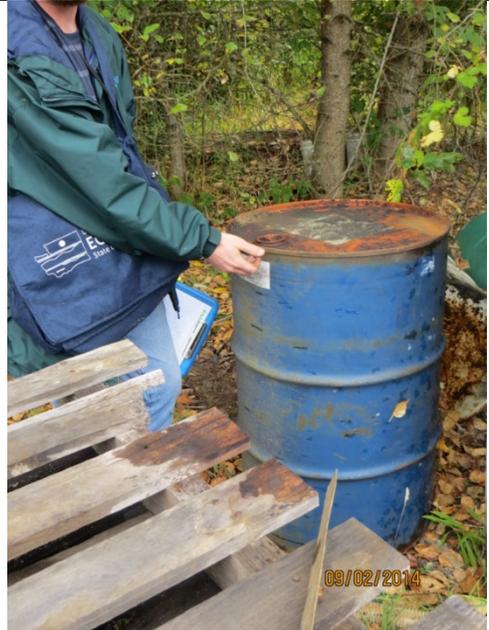
#510

The drum in this photograph contained an unknown waste.

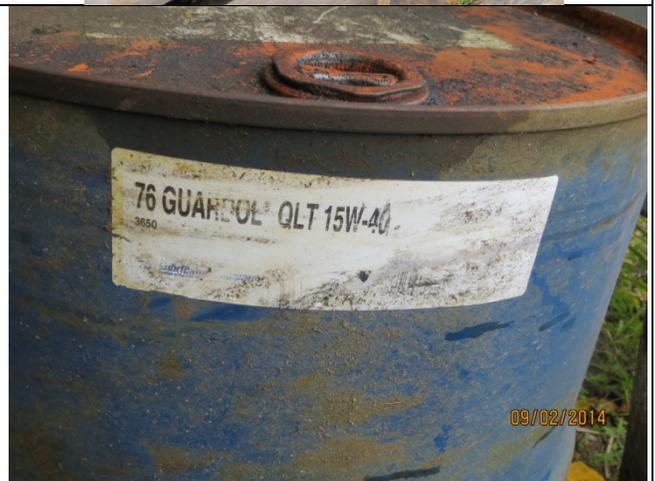
#511

This photograph shows a close-up of a product label on the drum from photograph #510.

Note: Mr. Gill reported that containers often were repurposed at the facility and that old product labels were not removed or updated.

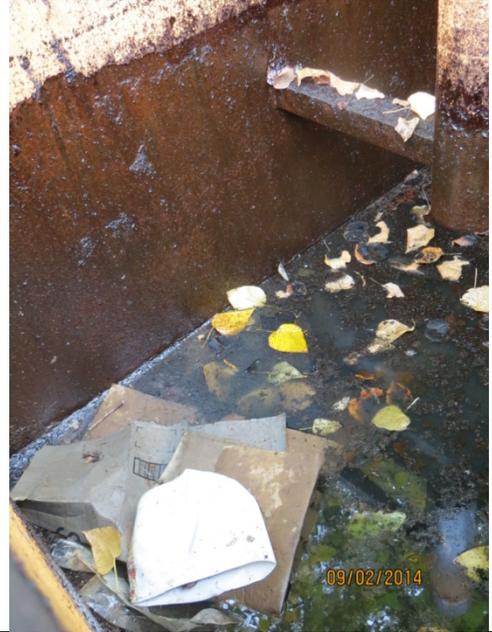
#512

This photograph shows the interior of an open topped metal tank. The liquid in the bottom appeared to be rainwater contaminated with tall oil.

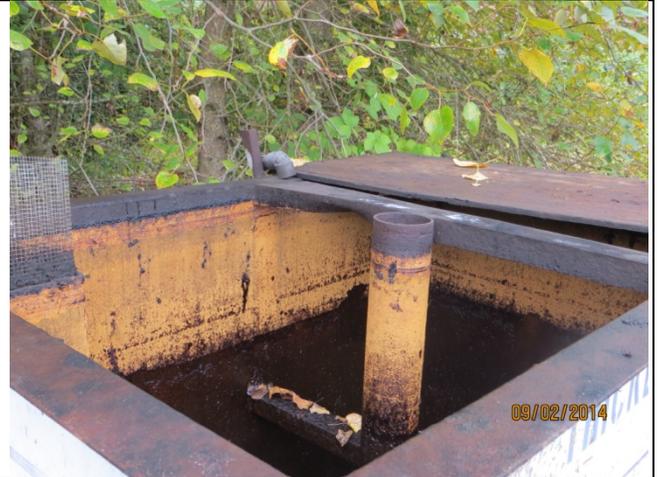
#513

This photograph shows the open top of the tank in photograph #512.

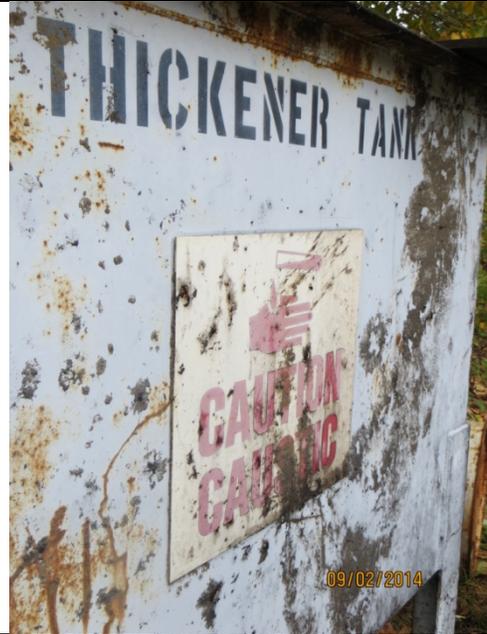
#514

The tank in #512 was labeled on the side as "THICKENER TANK" and "Caution Caustic." It is unknown if the waste inside was actually caustic.

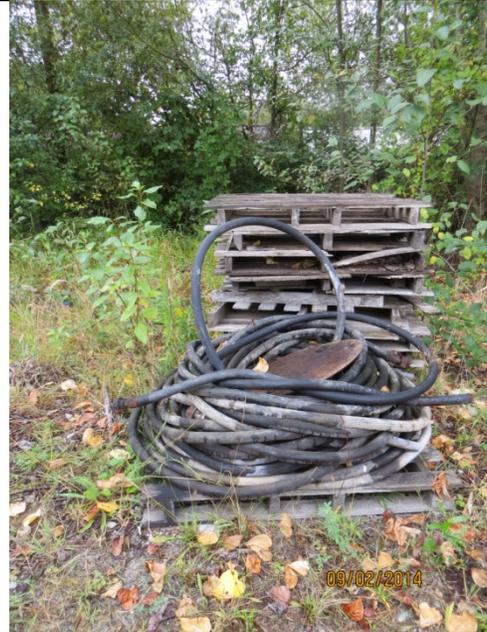
This photograph depicts another pile of discarded cable.

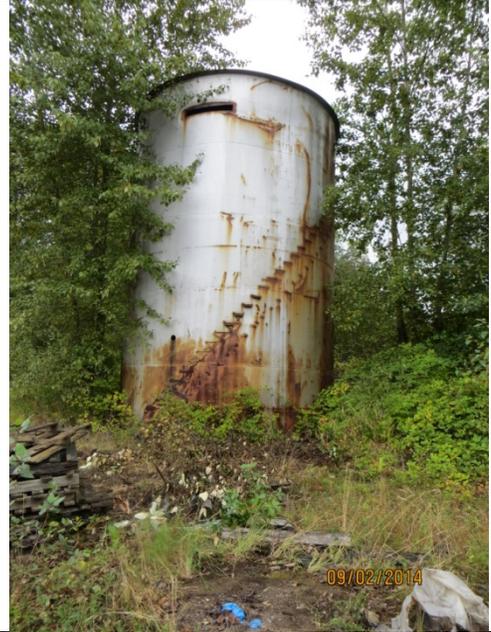
#518

This tank reportedly holds tall oil rosin.

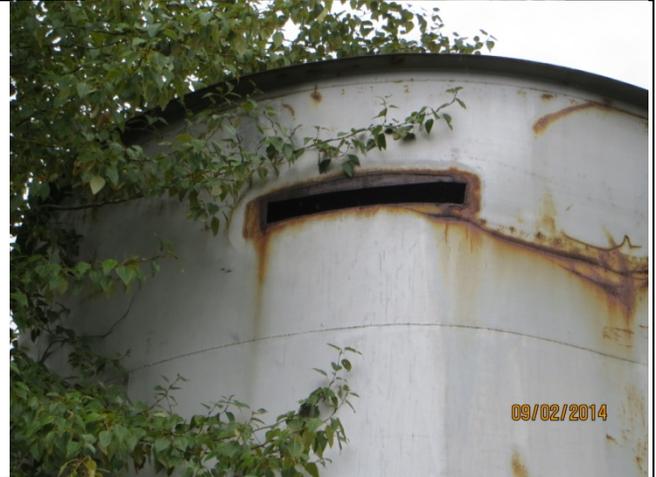
#519

This photograph shows a hole near the top of the tank shown in photograph #518.
