**Re: Dangerous Waste Compliance Inspection on September 2, 2014 at Treoil Industries,
4242 Aldergrove, Ferndale, WA 98242 - RCRA Site ID: N/A Facility Site ID: 2919**

Washington State Department of Ecology Hazardous Waste and Toxics Reduction Program

NOTICE TO COMPLY

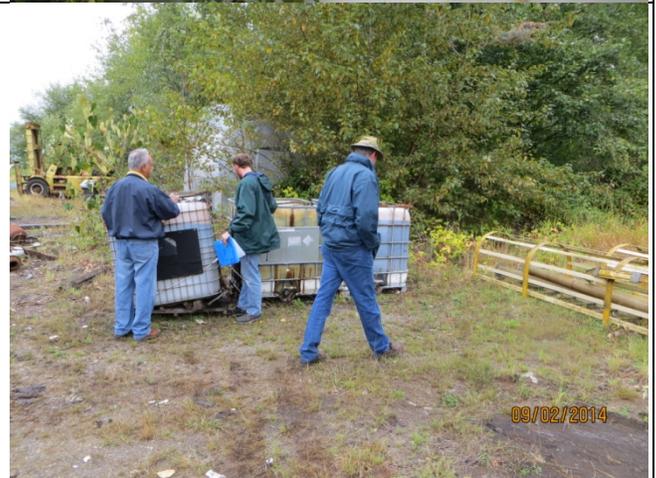
#520

The three totes in this photograph reportedly contain tall oil or tall oil derivatives.

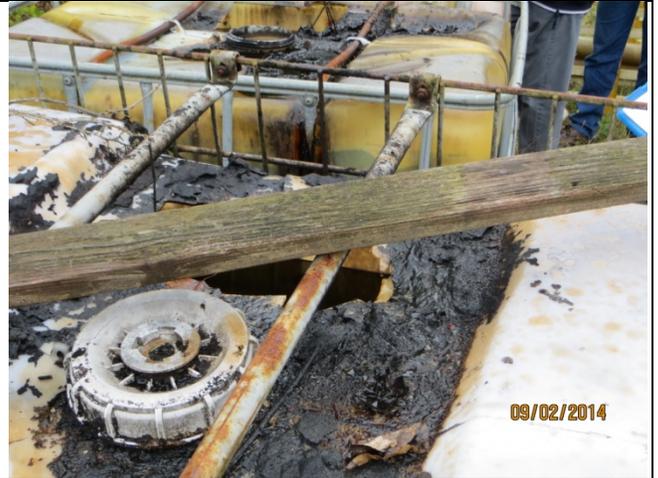
#521

The top of the totes in photograph #520 had holes cut into the top of the tote.

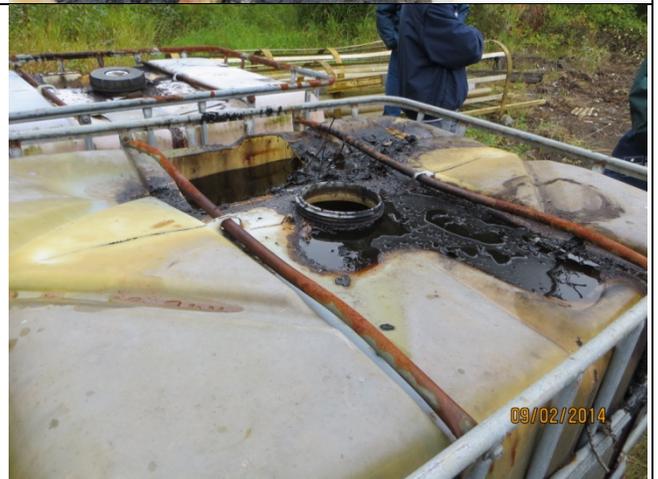
#522

Another view of the top of the totes shown in photograph #520.

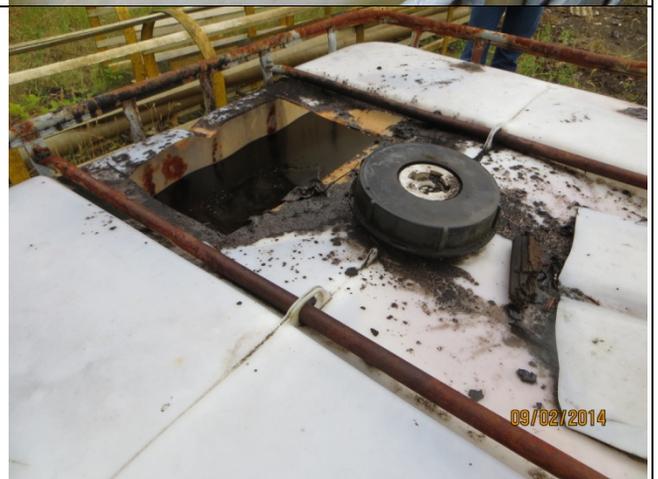
#523

A third view of the top of the totes shown in photograph #520.

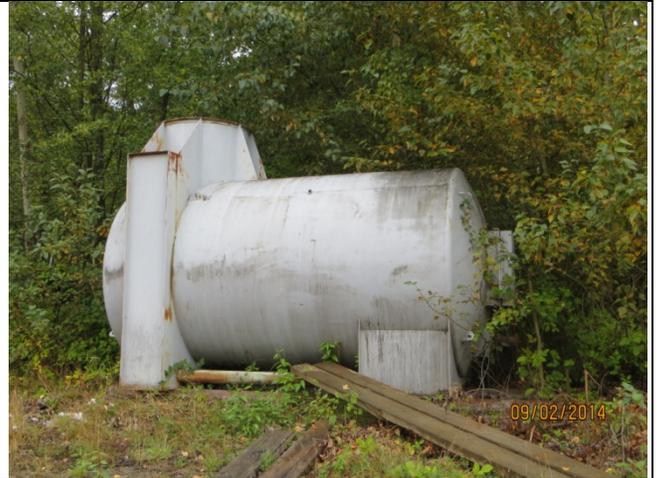
#524

Mr. Gill stated that this unit is an incinerator manufactured at the facility. It is unknown if the unit is empty.

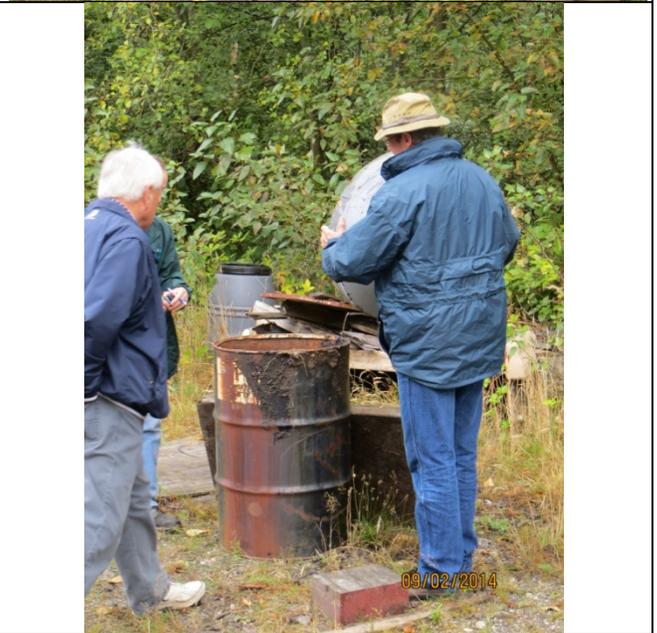
#525

This photograph illustrates an open 55-gallon drum of suspected tall oil wastes.

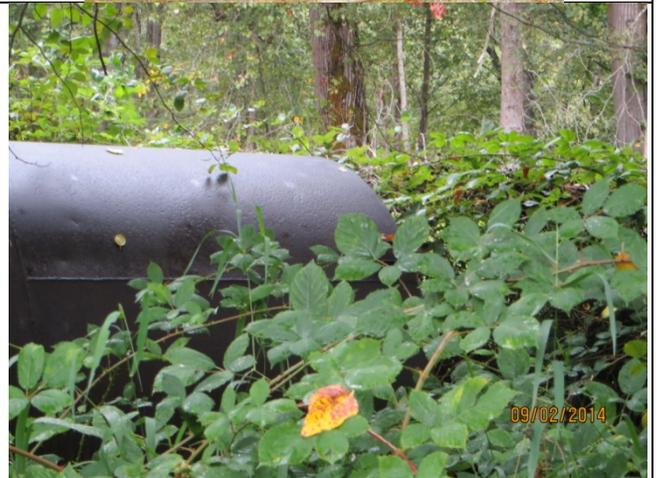
#526

This photograph shows a tank. It is suspected that this tank was empty due to its open valves (not pictured).

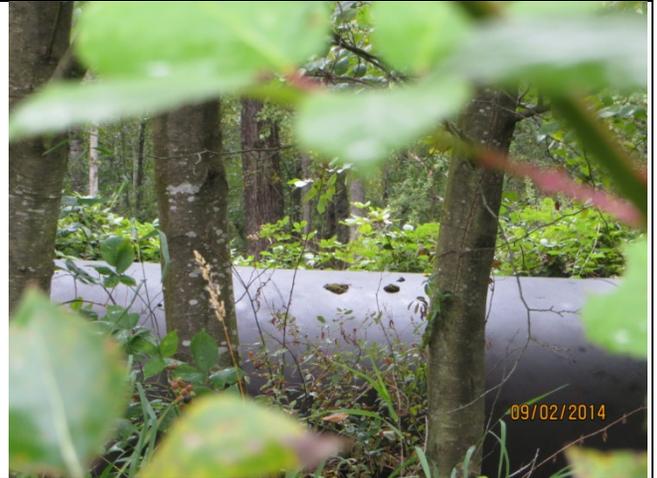
#527

Another view of the tank pictured in photograph #526.
Note the holes in the top of the tank.

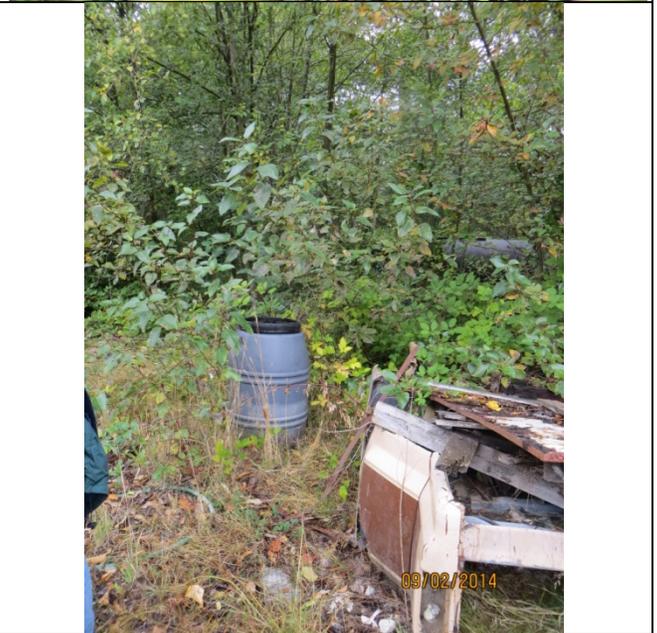
#528

The drum in this photograph contained an unknown waste.
The trailer in the right corner of the frame contained scrap wood.

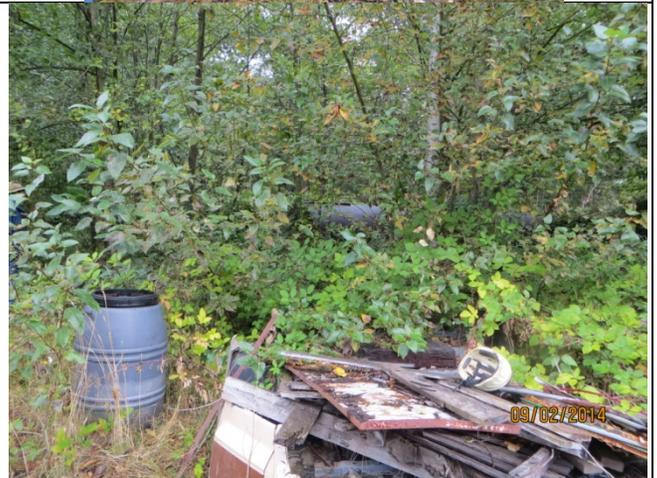
#529

Another view of the drum depicted in photograph #528.

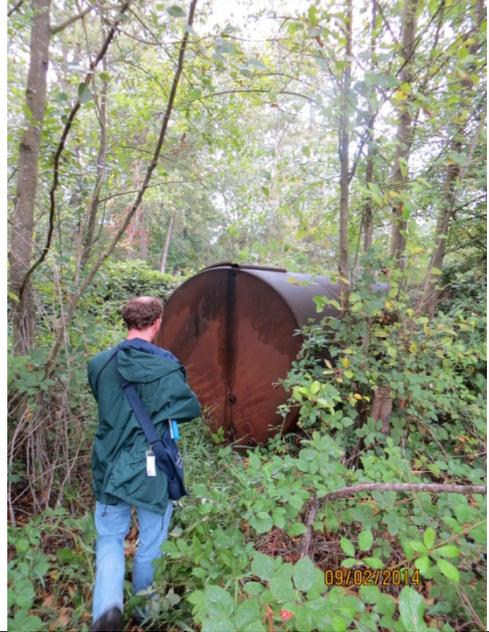
#530

This photograph provides another view of the side of the tank depicted in photograph #526.

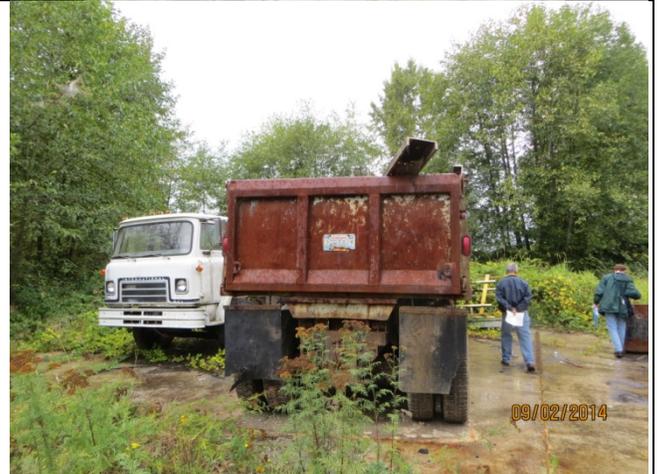
#531

This photograph shows two trucks at the facility. It is unknown what is in the bed of the truck.

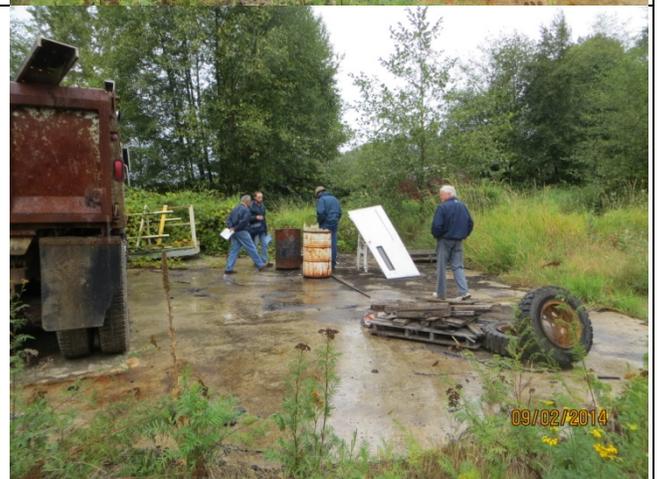
#532

This photograph shows two more drums of unknown wastes and some more discarded equipment.

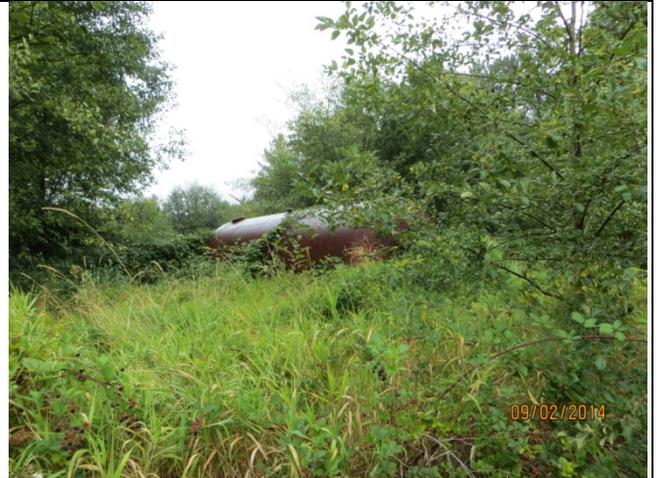
#533

This tank was difficult to access due to thick vegetation. The tank's contents are unknown.

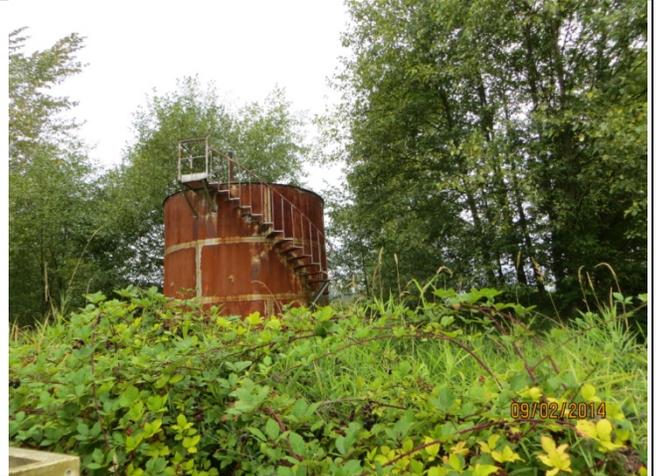
#534

This tank was also difficult to access due to thick vegetation. The tank's contents are unknown.

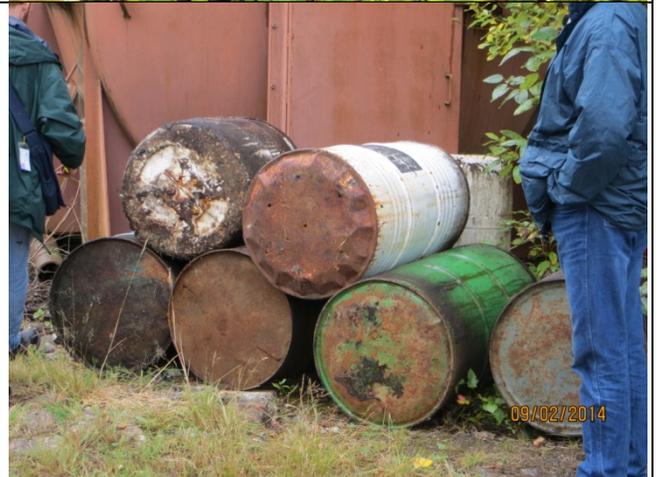
#535

These drums were empty and had their bottoms perforated for use as a sieve.

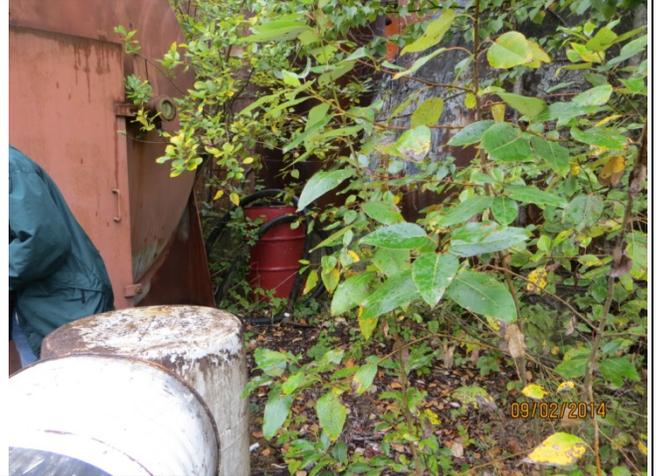
#536

The drums in the foreground of this photograph were empty. The red drum in the background contained an unknown waste.

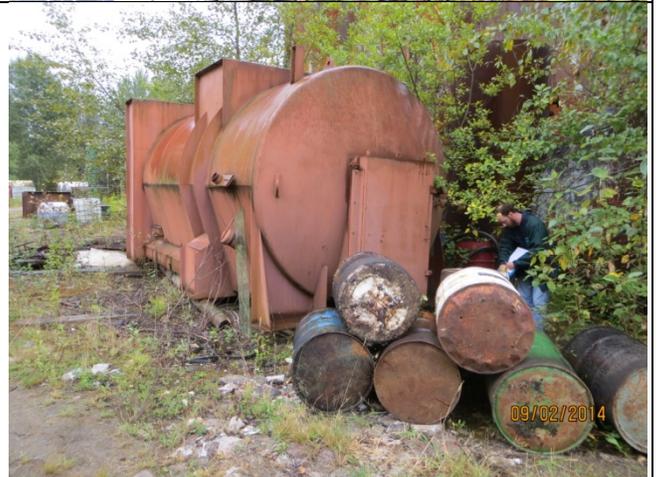
#537

The red piece of equipment in this photograph is another incinerator manufactured at the facility. It is unknown if it is empty.

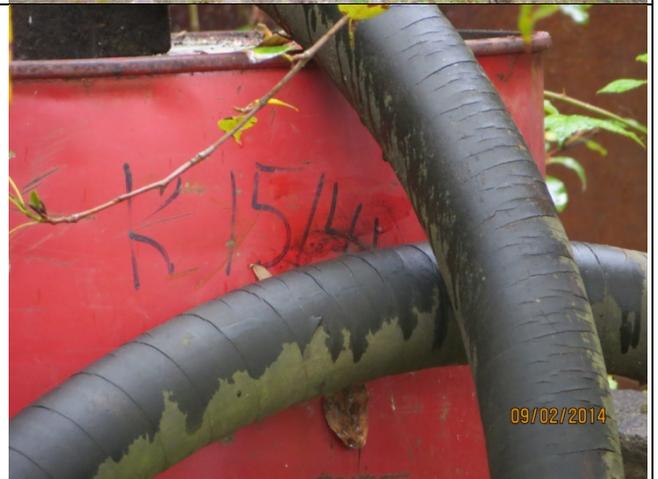
#538

A close up of the drum pictured in photograph #536. The hand written label says "K 15/40." The contents of the drum are unknown.

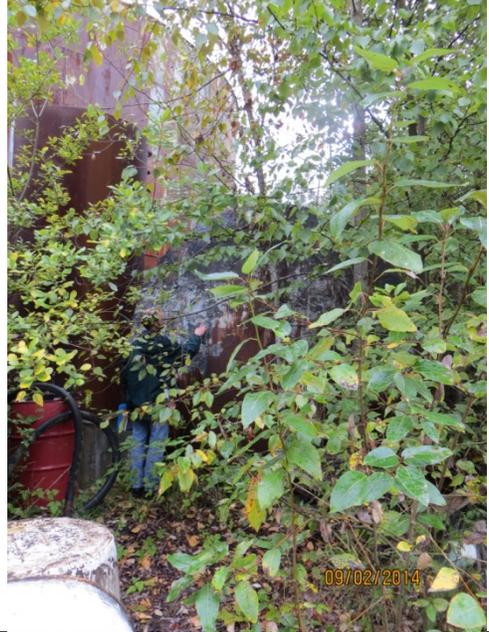
#539

In the vegetation at the north end of the plant perimeter were four tanks with unknown contents.

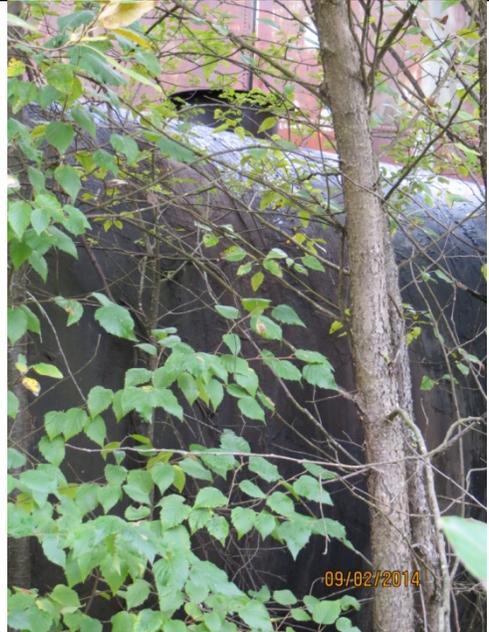
#540

This photograph provides another view of one of the tanks depicted in photograph #539.

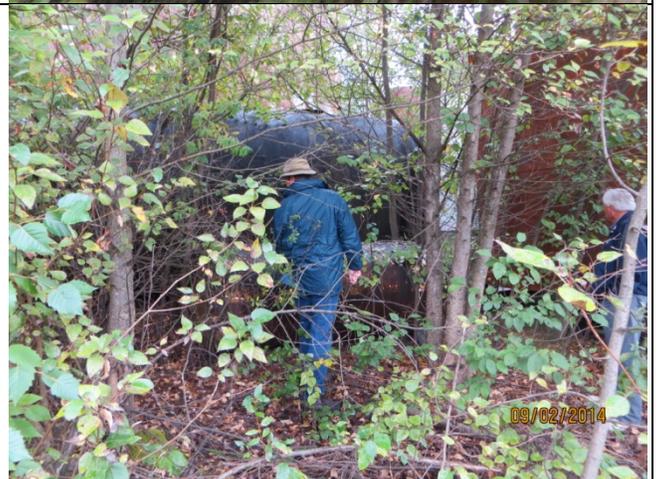
#542

Another view of the tanks depicted in photograph #539.

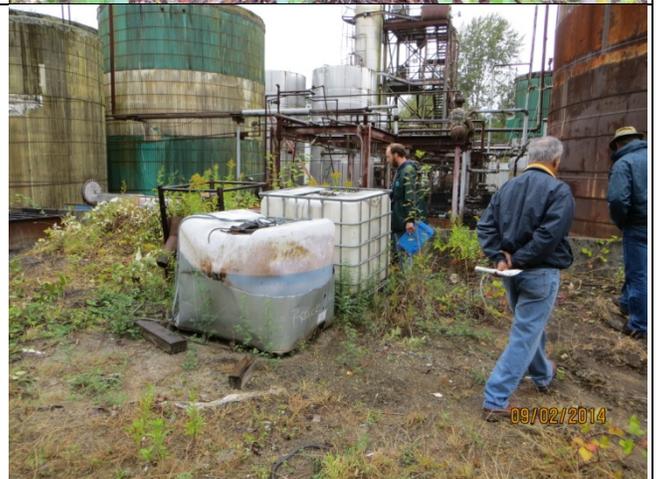
#543

These two totes reportedly contain tall oil or tall oil derivatives wastes. The contents of the tanks in the background of this photograph are unknown but reportedly contain tall oil or tall oil derivatives.

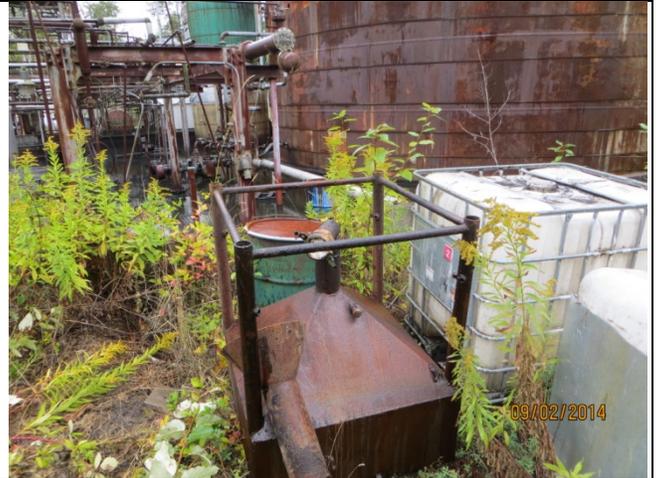
#544

The piece of equipment in the foreground of this frame contained an unknown white powder waste. The totes on the right and the 55-gallon drum in the background contain unknown wastes.

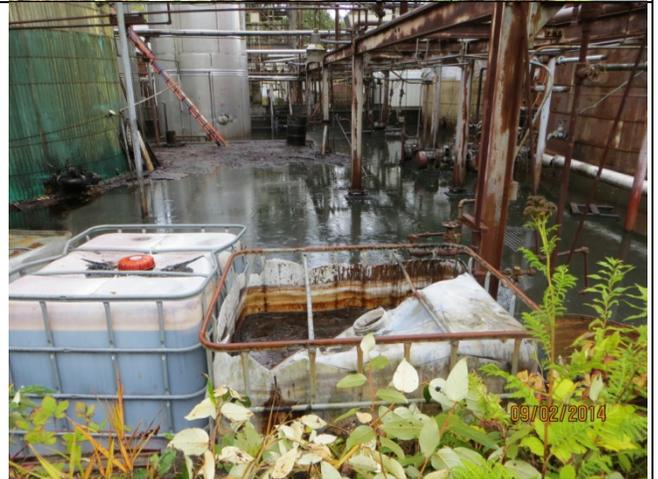
#545

The tote in this photograph contains waste tall oil or tall oil derivatives. Note the hole in the top of the tote.

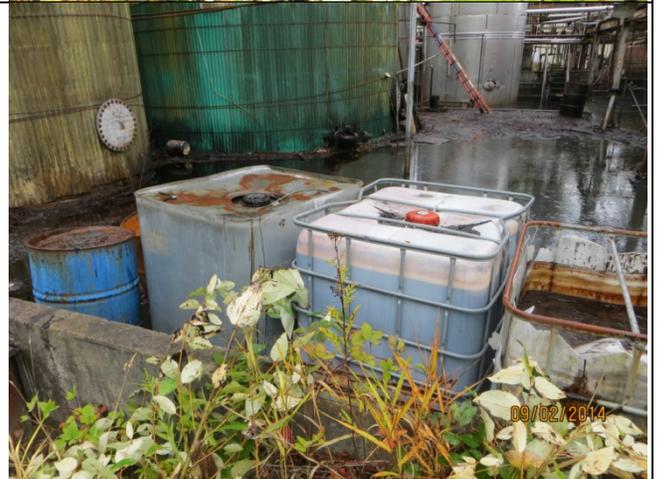
#546

The totes and drums depicted in this photograph are located within the secondary containment of the main plant. They reportedly contain tall oil or tall oil derivatives.

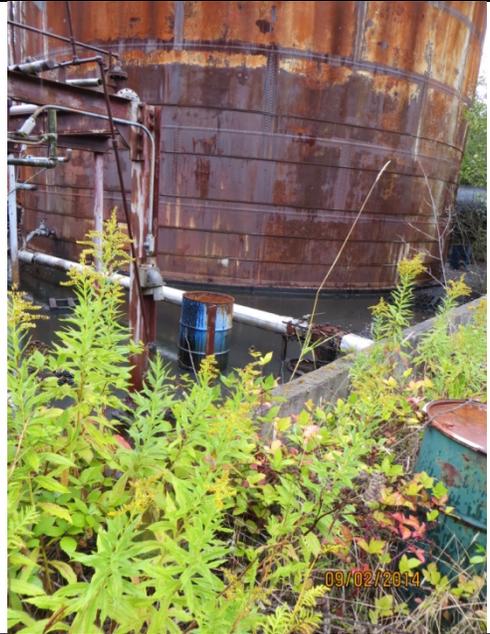
#547

Another view of a 55-gallon drum of waste located within the secondary containment of the main plant. Also note that several inches of spilled tall oil and contaminated storm water area also inside the secondary containment.

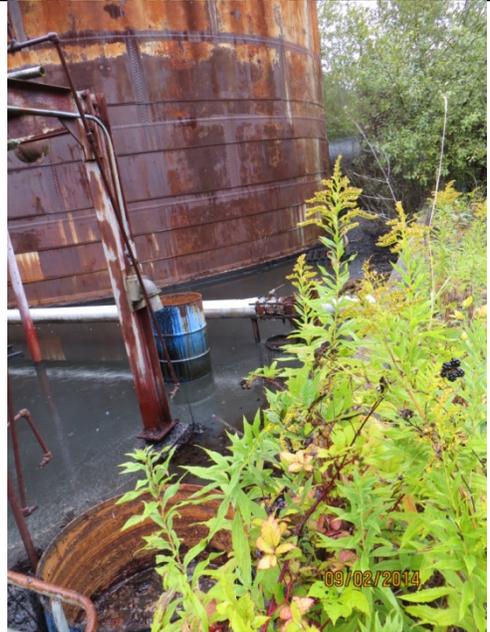
#548

This photograph also depicts the drum and secondary containment area shown in photograph #547.

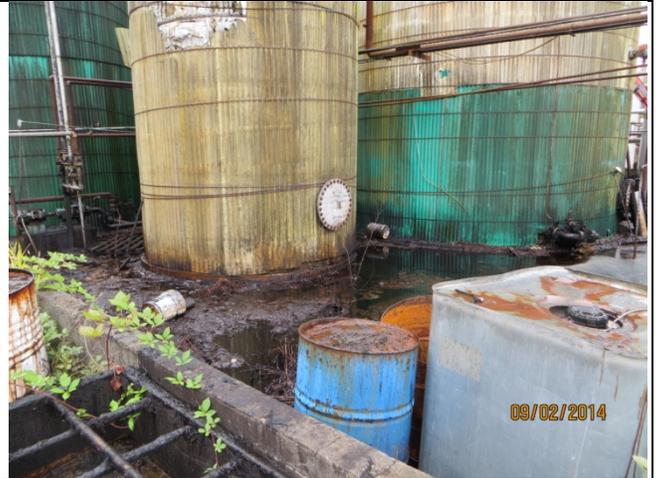
#549

This photograph shows the accumulation of sludge and debris within the plant secondary containment.

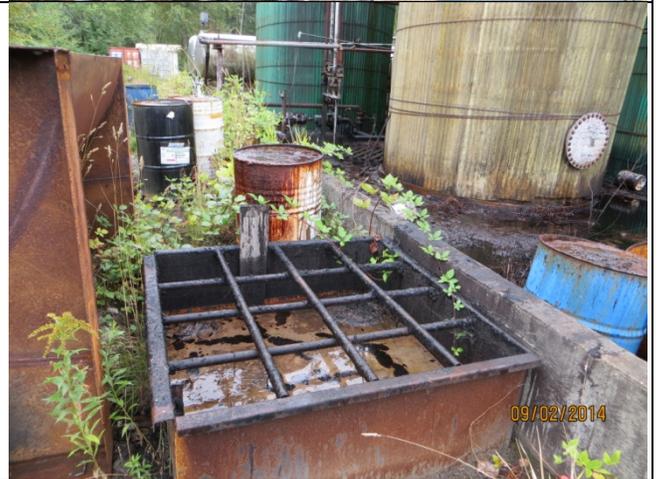
#550

The tank in the foreground of this photograph contains waste tall oil or tall oil derivatives and contaminated storm water.

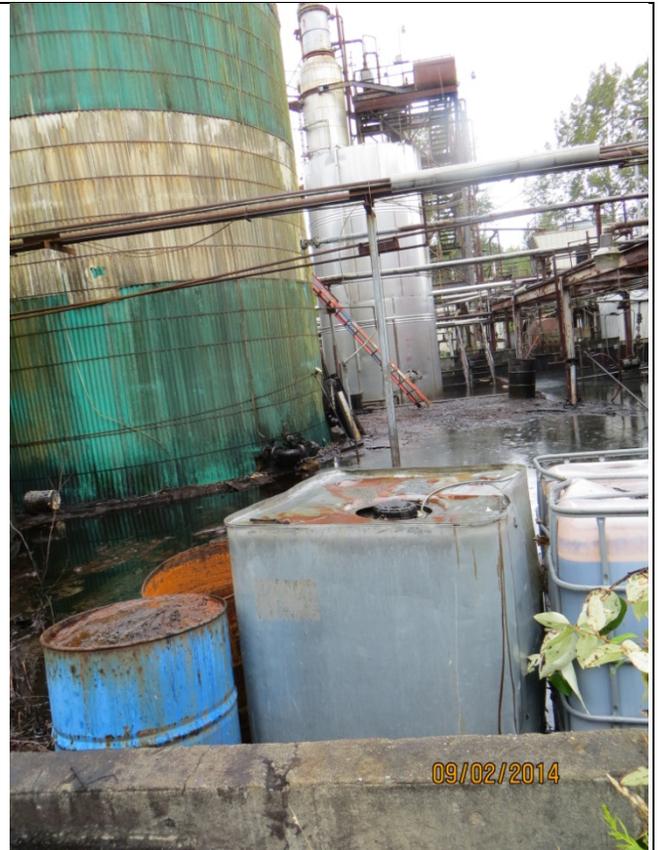
#551

Another photograph showing the containers depicted in photograph #546.

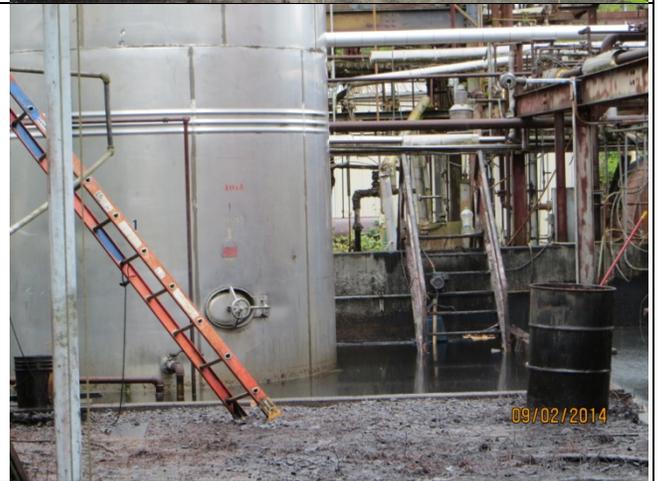
#552

The contents of the drum in this photograph are unknown.

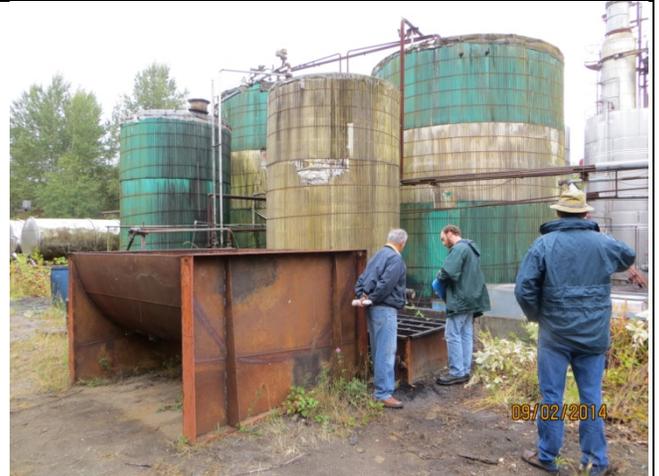
#553

The tank on the left part of the frame in this photograph contained accumulated rainwater.

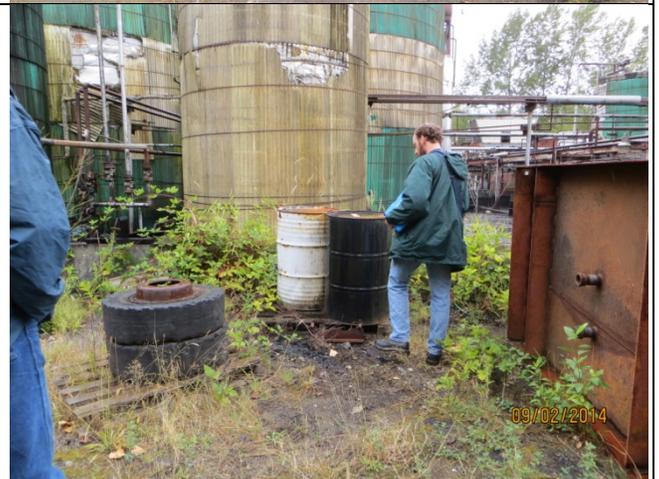
#554

The two 55-gallon drums in this photograph contain unknown waste.

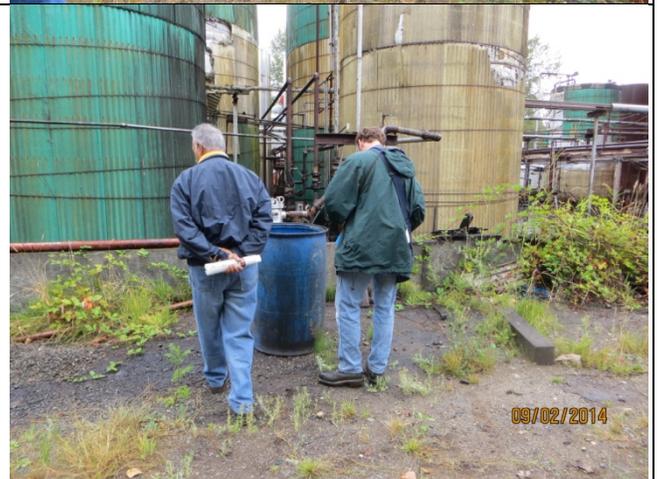
Location: Plant Perimeter

The open 55-gallon drum in this photograph contained several inches of tall oil or tall oil derivatives.

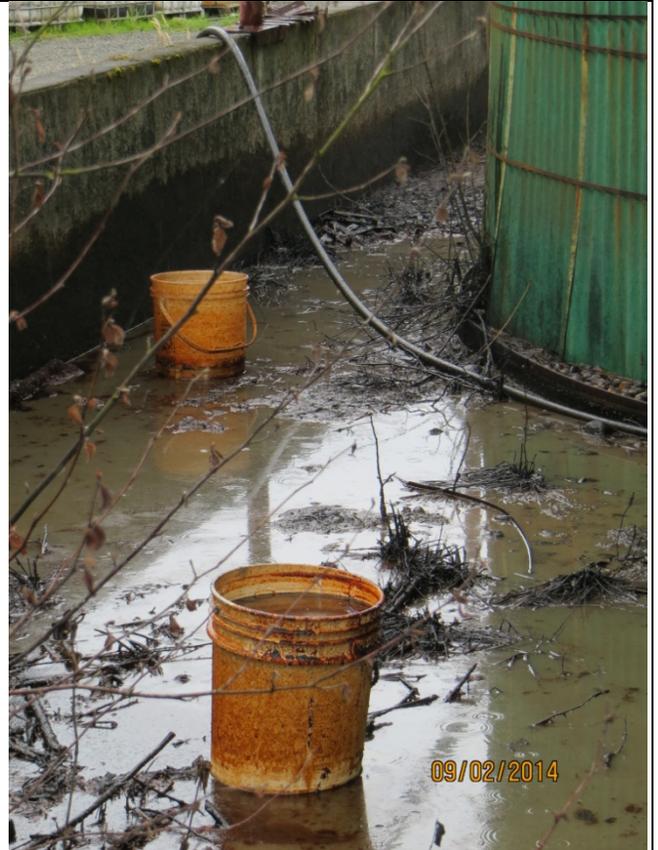
#556

This photograph depicts two 5-gallon poly containers sitting inside the contaminated secondary containment of the main plant.

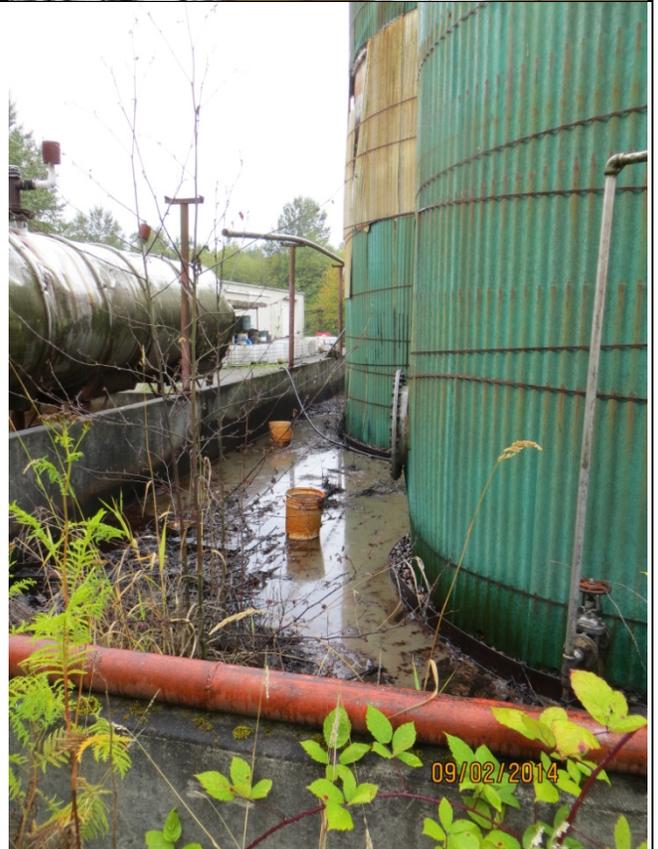
#557

Another view of the containers depicted in photograph #556.

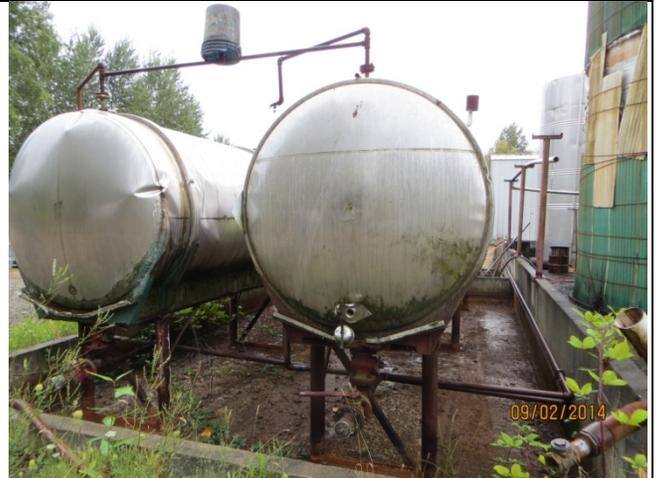
#558

These two tanks are marked with a flammable placard UN1230 (methanol). The contents of the tanks are unknown.

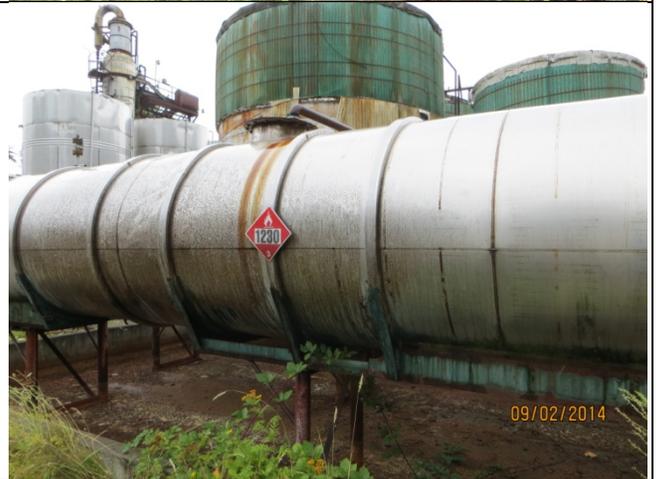
#559

This photograph shows the flammable placard on the tanks depicted in photograph #558.

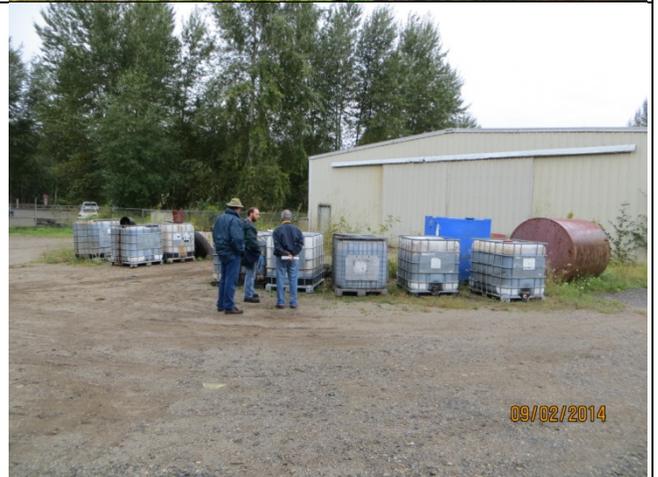
#560

The eight totes depicted in this photograph reportedly contain tall oil or tall oil derivatives. The contents of the tank are unknown.

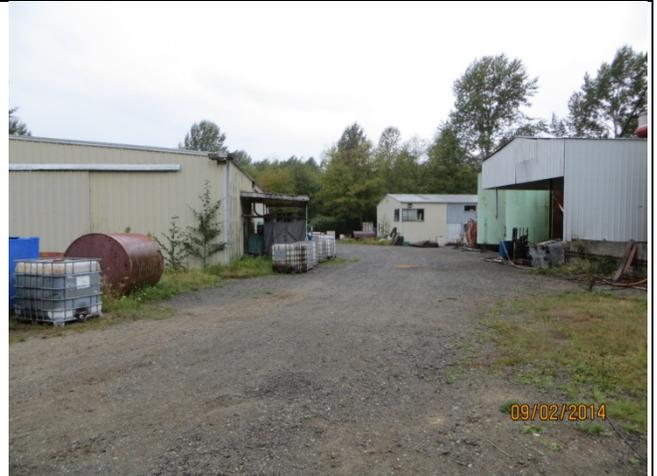
#561

An additional row of six totes of tall oil wastes was stored on the north side of the Fabrication Building.

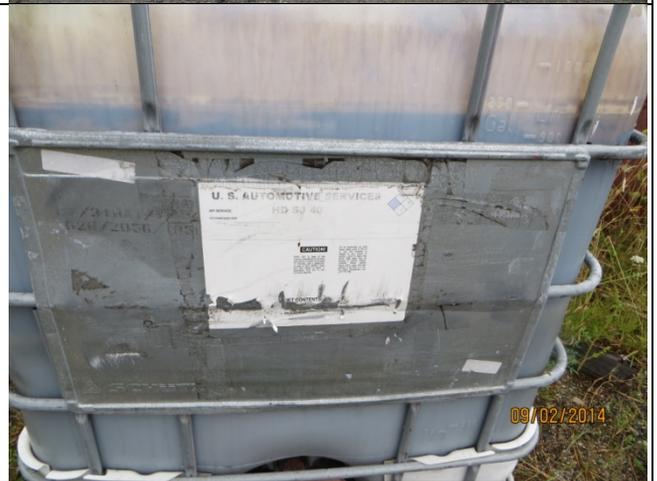
#562

This photograph shows a close up of an old product label on a tote of waste tall oil.

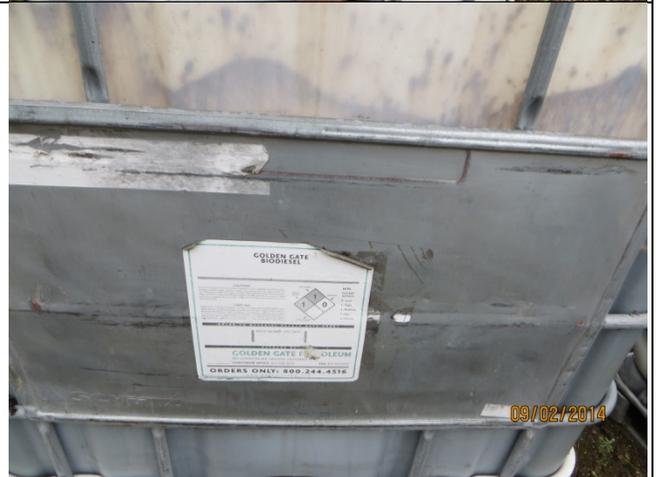
#563

This photograph shows a close up of an old product label on a tote of waste tall oil.

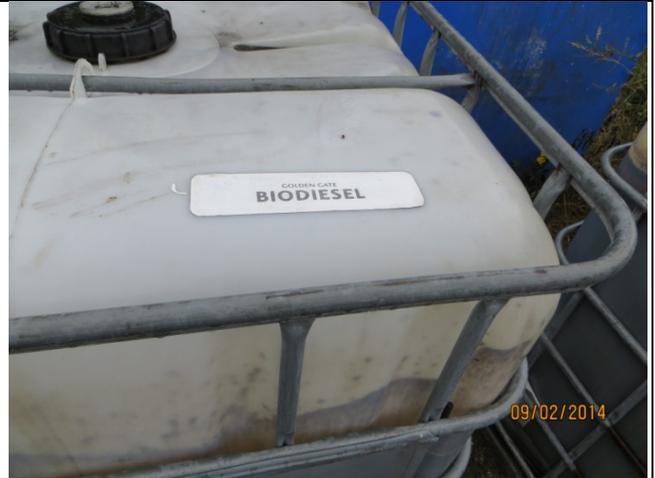
#564

This photograph shows a close up of an old product label on a tote of waste tall oil.

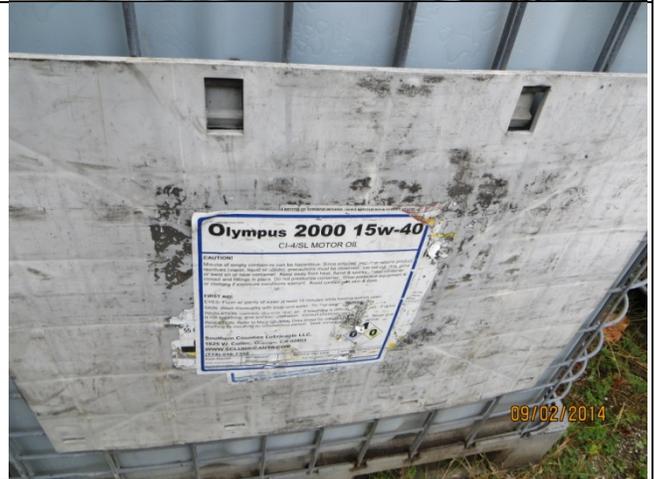
#565

This photograph shows a close up of an old product label on a tote of waste tall oil.

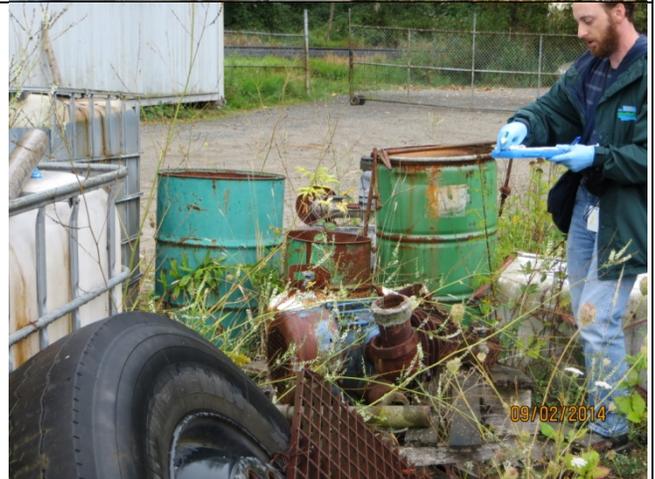
#566

This photograph depicts a 55-gallon drum of an unknown liquid (green drum). The blue drum at the left of the frame contained black oil suspected as tall oil.

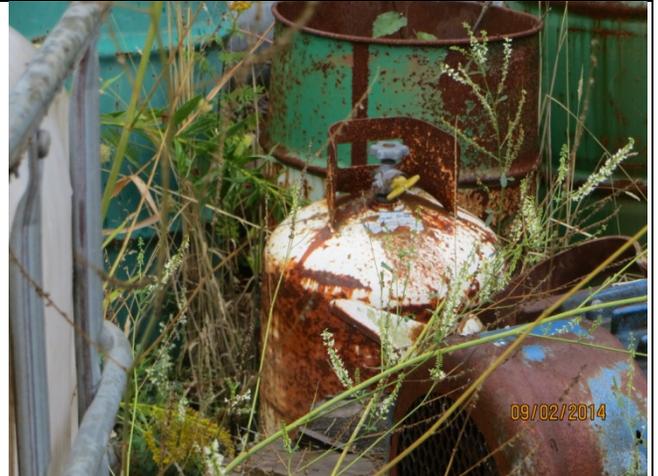
#567

This cylinder contains an unknown waste.

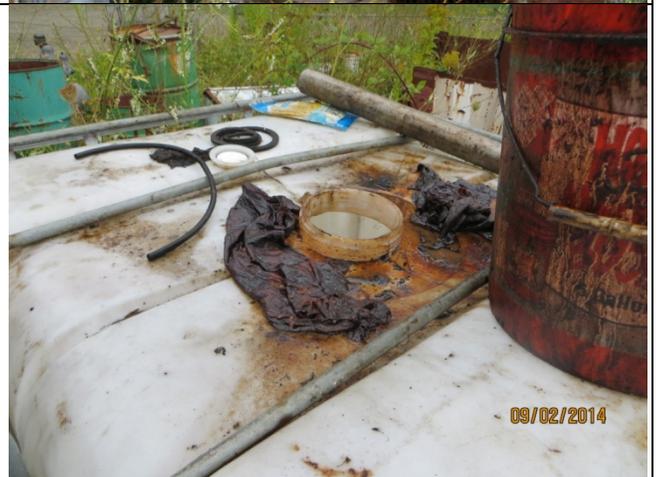
#568

This photograph shows the open top of a tote depicted in photograph #560.

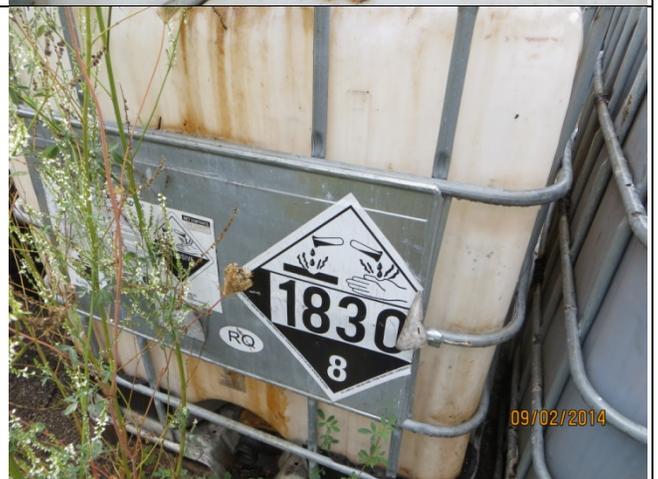
#569

This photograph shows a close up of an old product label on a tote of waste tall oil.

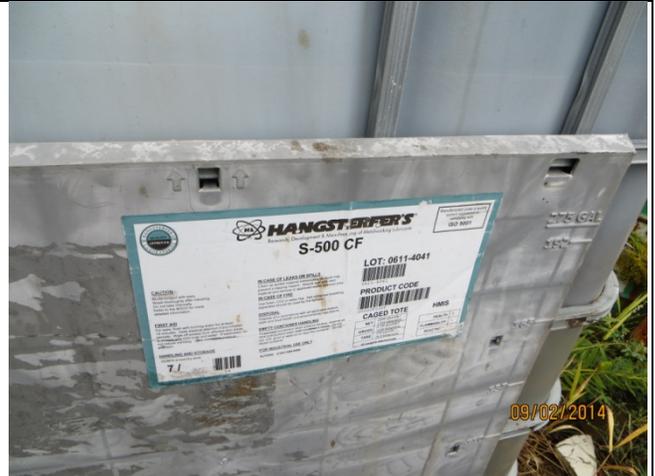
#570

This photograph shows a close up of an old product label on a tote of waste tall oil.

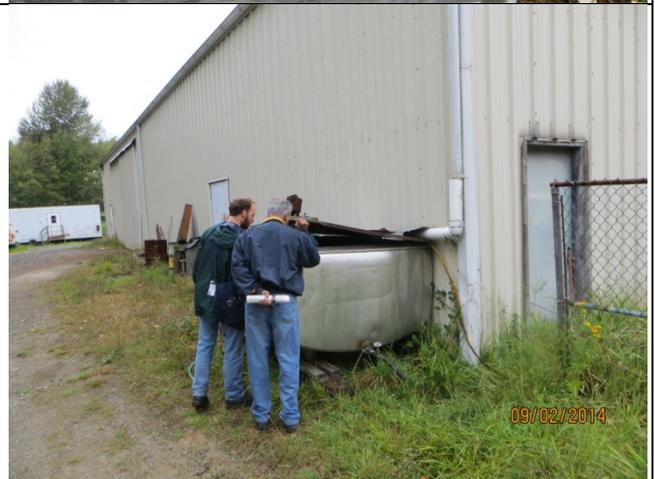
#571

The tank in this photograph collected rainwater from the building roof.

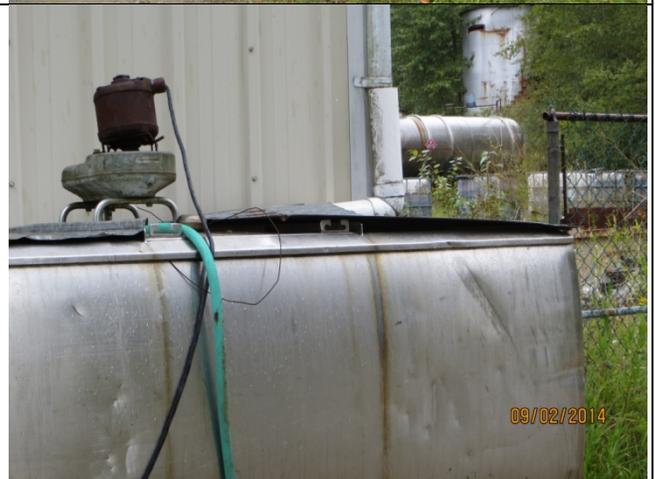
#572

A second photograph showing the tank depicted in photograph #571.

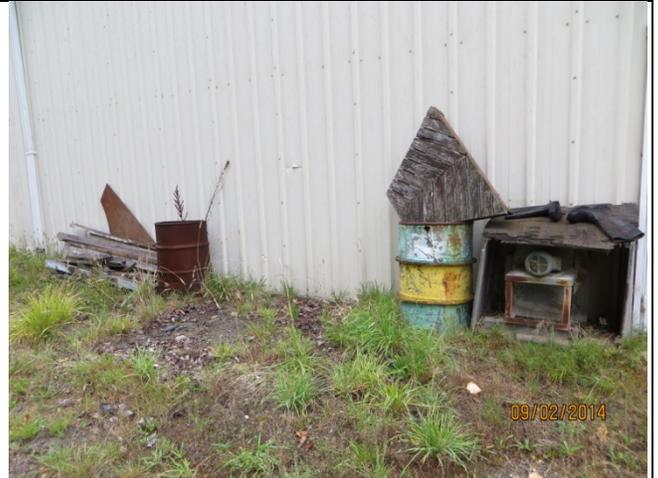
#573

The two drums in this photograph contain wood scraps and pieces of scrap metal.

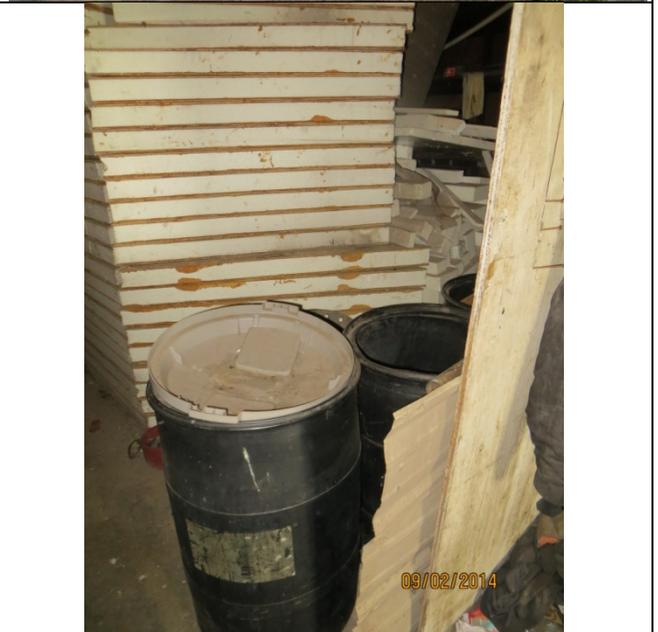
#575

The drums in the foreground of this photograph contain household trash (food and consumables packaging).

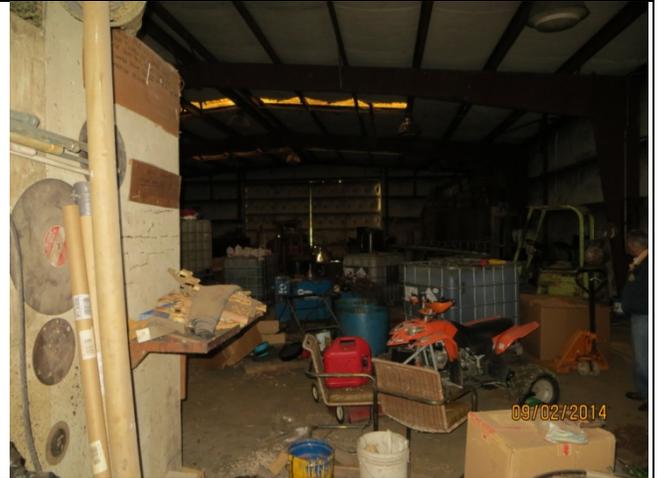
#576

The totes in the background of this photograph reportedly contain waste tall oil.

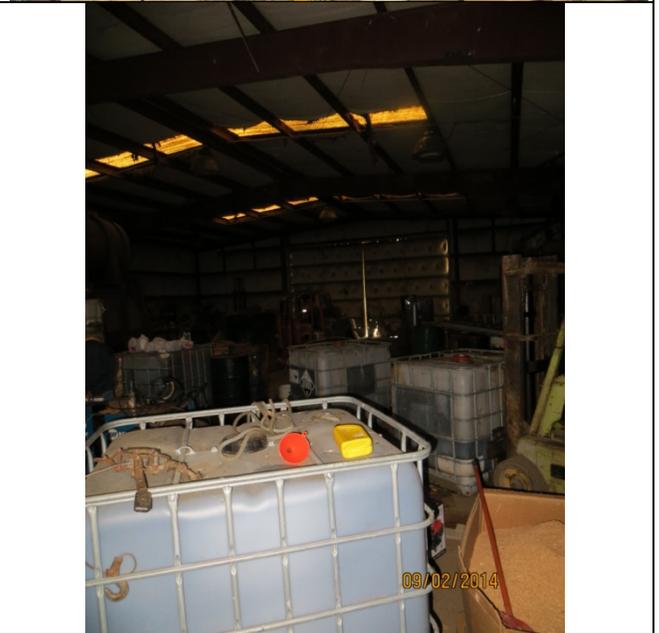
#577

Another view of the totes depicted in photograph #576.

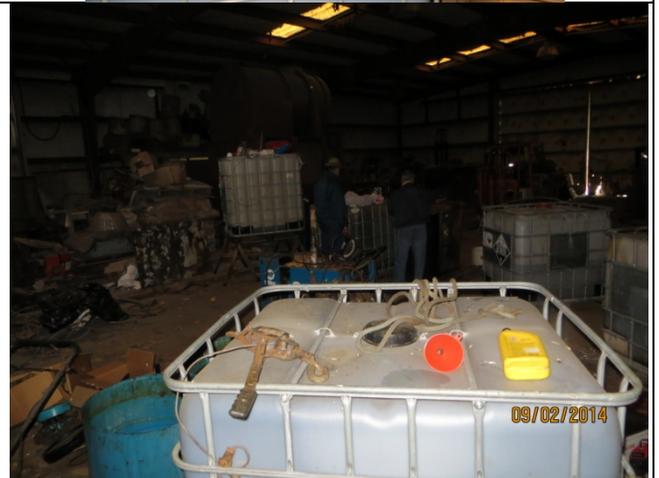
#578

Another view of the totes depicted in photograph #576.

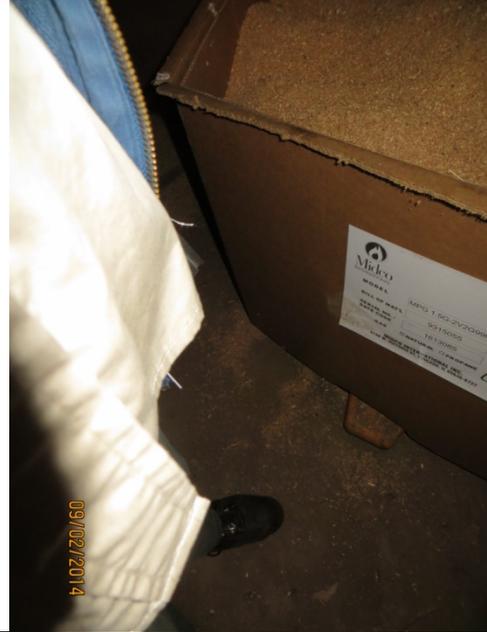
#579

This photograph shows a box of sawdust utilized as spill absorbent.

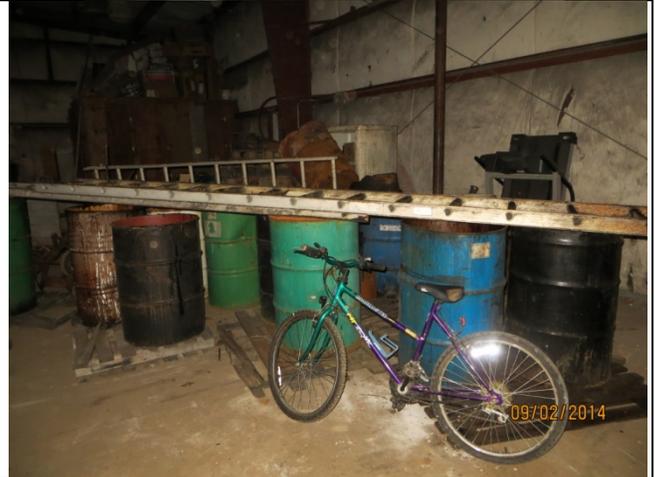
#580

The six drums depicted in this photograph contain tall oil spill cleanup debris.

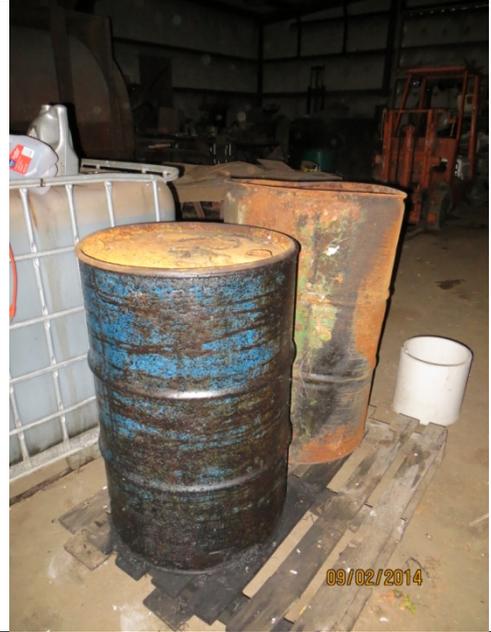
#581

These drums contain unknown wastes.

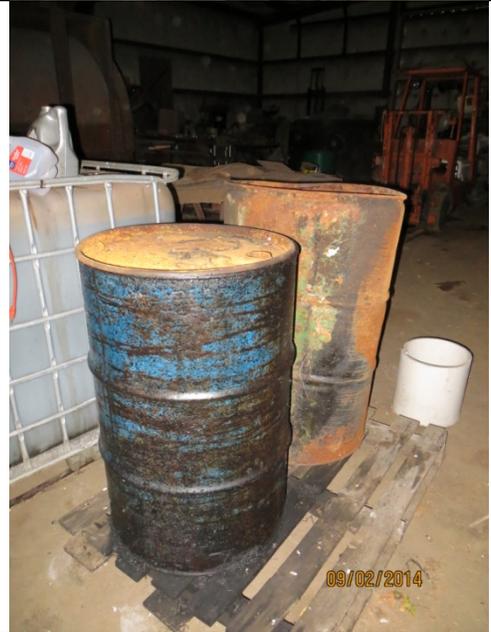
#582

Another view of the drums depicted in photograph #581.

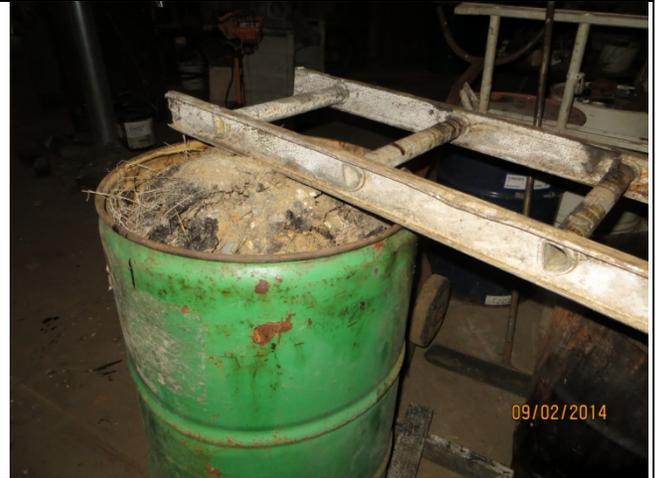
#583

This container holds a mixture of waste refractory material and spilled tall oil cleanup debris.

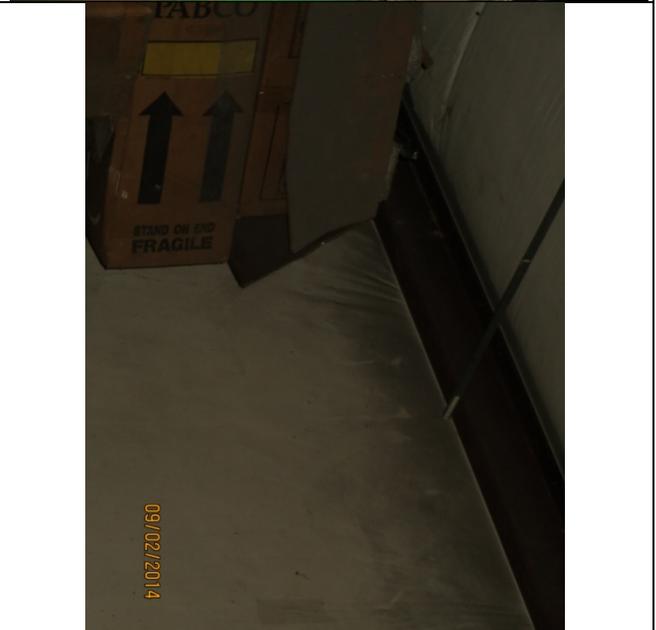
#584

This photograph shows spilled refractory dust on the floor.

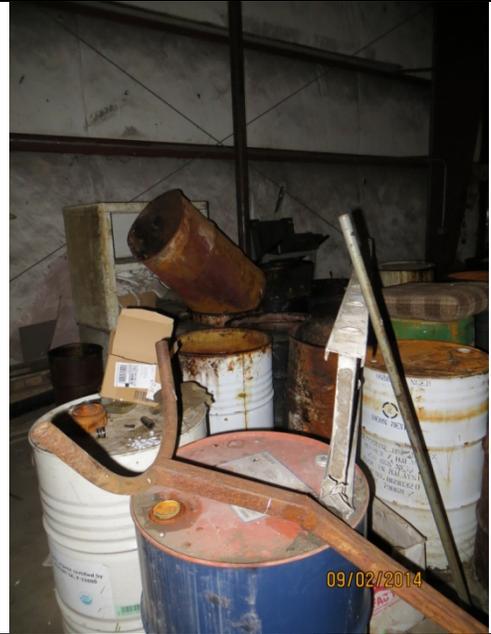
#585

These drums were reported to contain raw materials for the construction of refractory insulation but their exact contents are unknown.
