**Re: Dangerous Waste Compliance Inspection on September 2, 2014 at Treoil Industries,
4242 Aldergrove, Ferndale, WA 98242 - RCRA Site ID: N/A Facility Site ID: 2919**

Washington State Department of Ecology Hazardous Waste and Toxics Reduction Program

NOTICE TO COMPLY

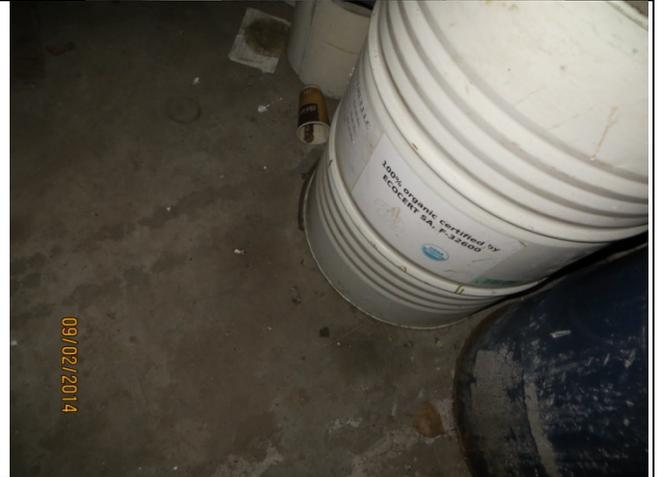
#586

A close up of the label of one of the drums pictured in photograph #585.

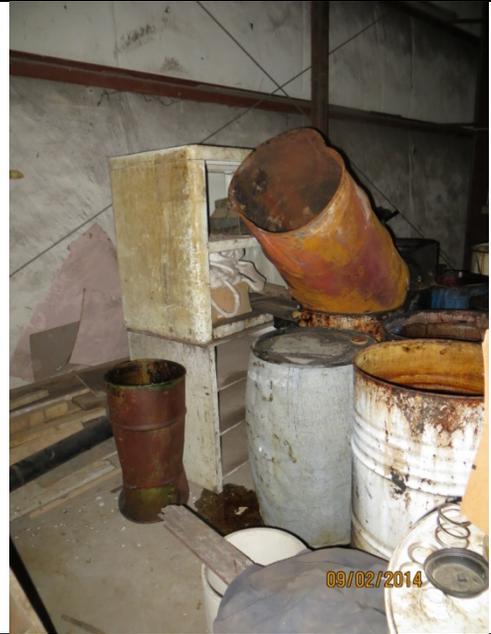
#587

These containers contain waste from the construction of incinerator insulation.

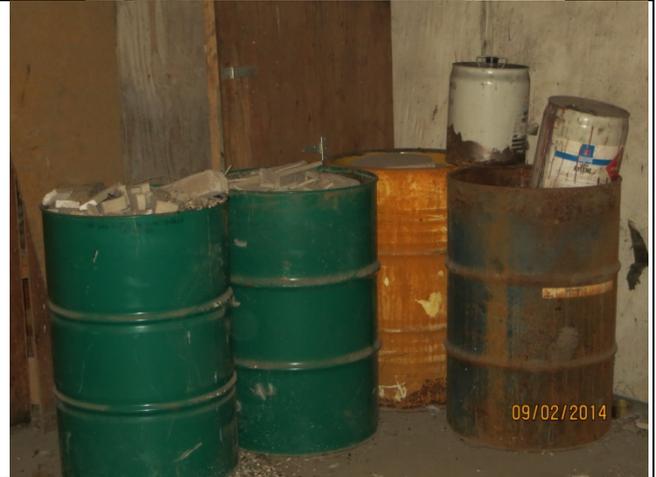
#588

These containers contain waste from the construction of incinerator insulation.

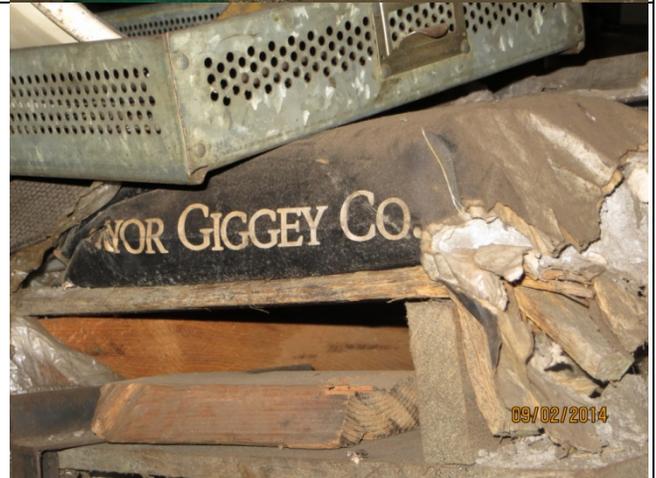
#589

This photograph shows waste refractory materials.

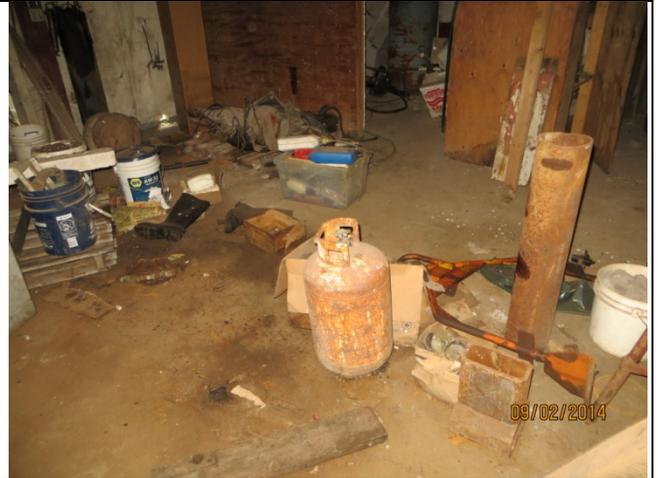
#590

The cylinder in this photograph contains an unknown waste.

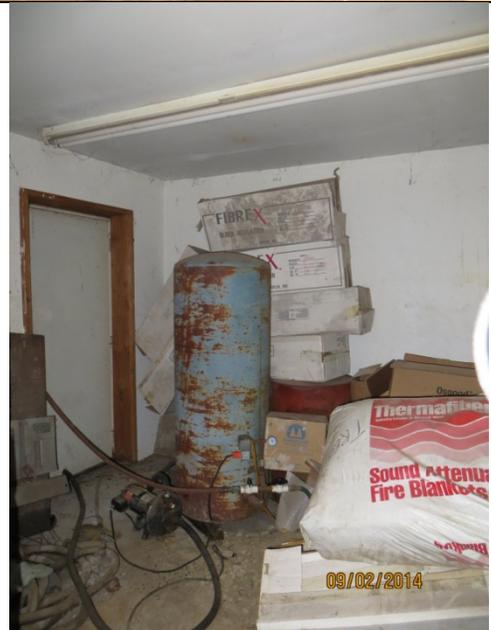
#591

The contents of these boxes are unknown. The blue tank in the center of the picture is reportedly an empty compressor.

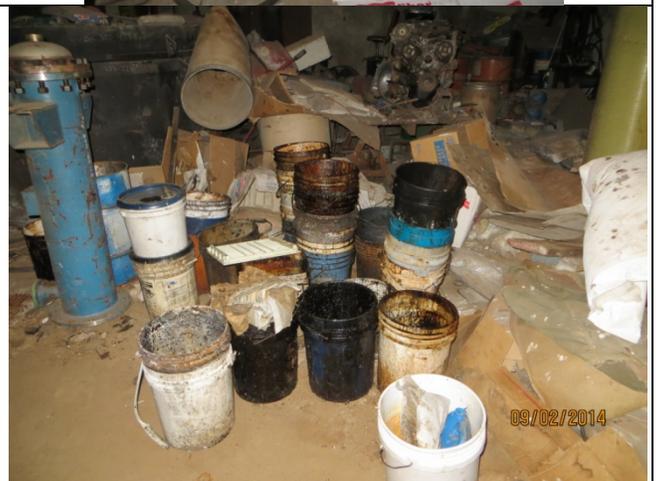
#592

Most of these 5-gallon poly buckets were empty but contaminated with tall oil residues.

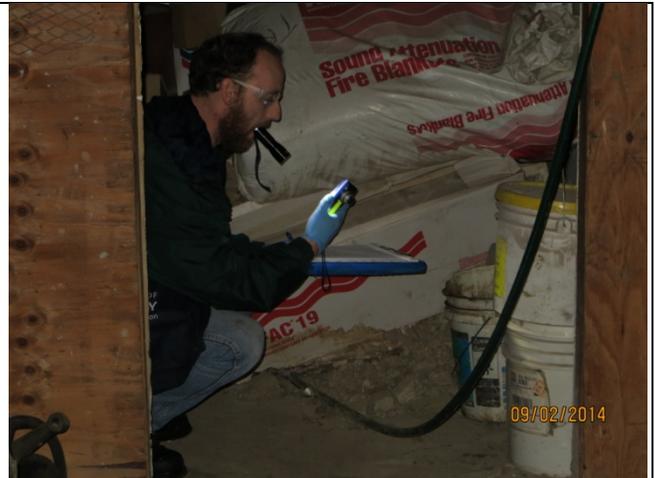
#593

The poly containers to the right of the frame are depicted clearly in photograph #28 and contain waste” Econoset 50.” The bags in the background contain waste insulation.

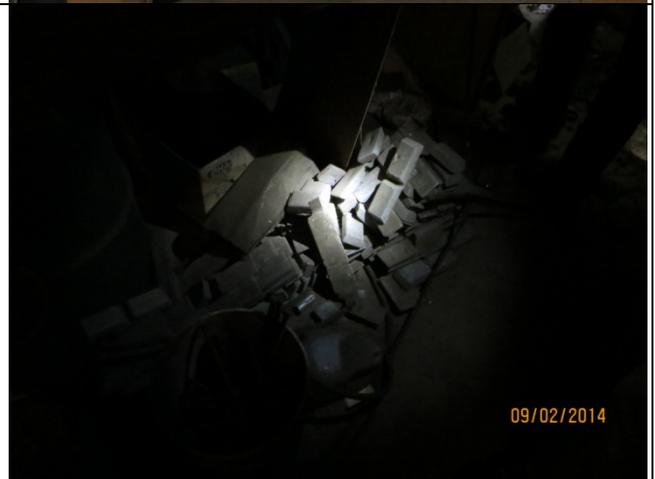
#594

This photograph shows a pile of discarded insulation.

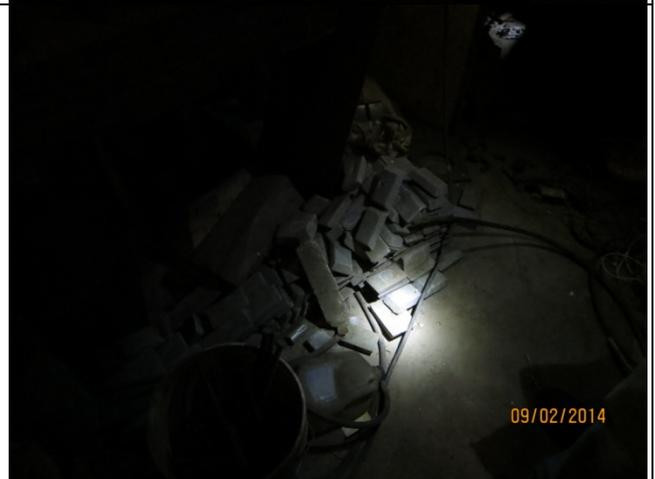
Location: Fabrication Building Interior

This photograph also shows a pile of waste insulation.

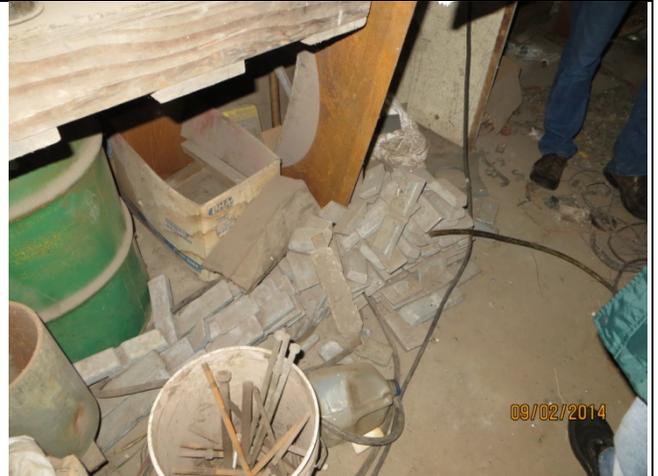
#596

The grey bricks in this photograph are discarded insulation waste.

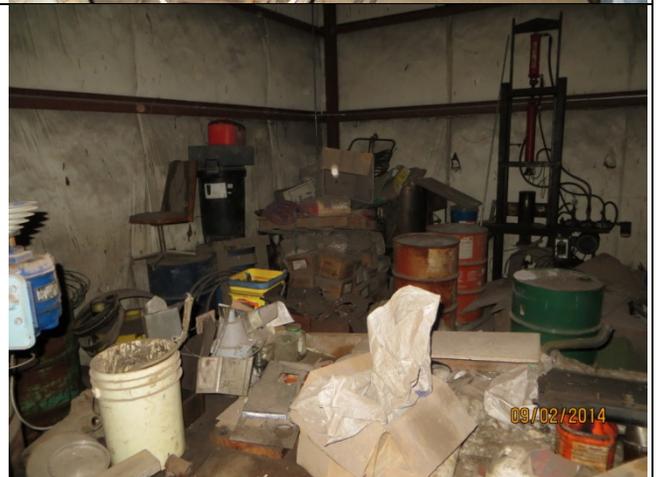
#597

These containers and this area held a variety of wastes from insulation construction.

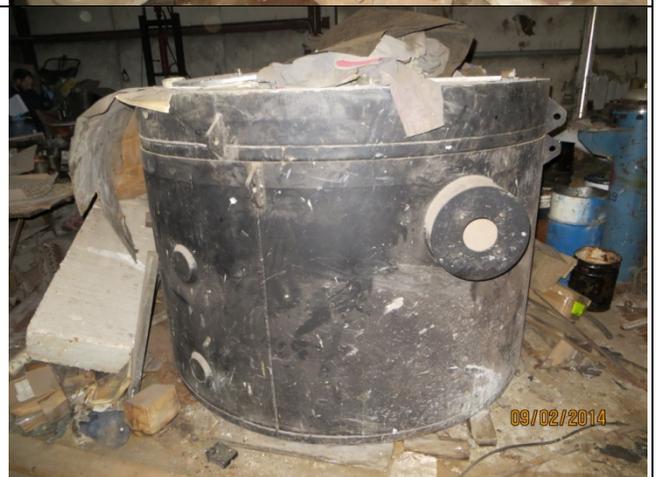
#598

The contents and purpose of this piece of equipment are unknown.

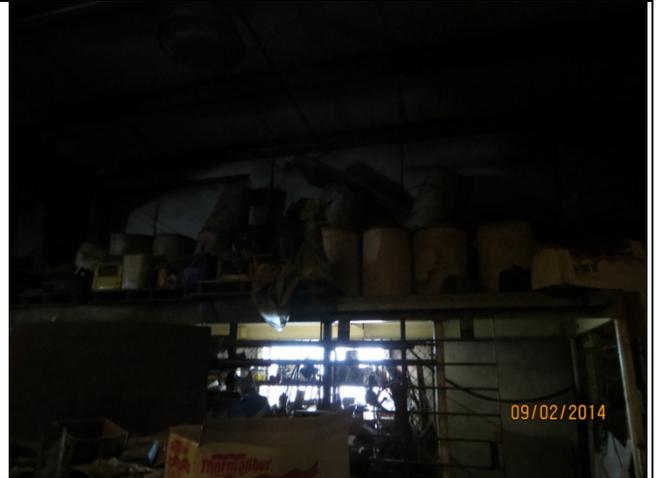
#599

The contents of these fiber containers are unknown.

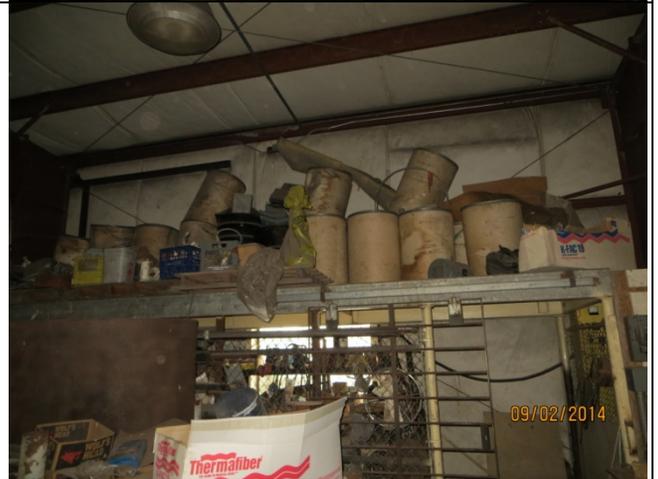
#601

This photograph shows the containers with unknown contents from photographs #599 and 600 with better lighting.

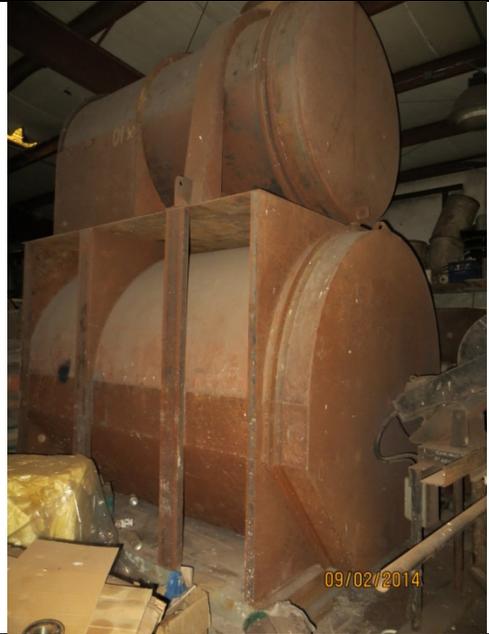
#602

This photograph depicts an incinerator reportedly manufactured at the facility. It is unknown if this incinerator is empty.

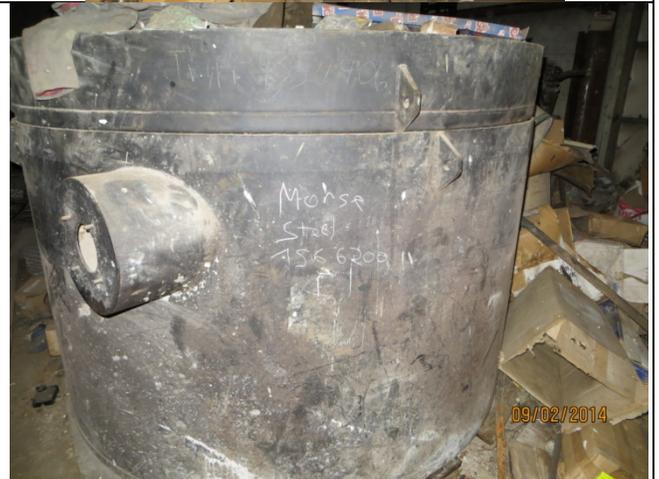
#603

The contents or purposes of this piece of equipment are unknown.

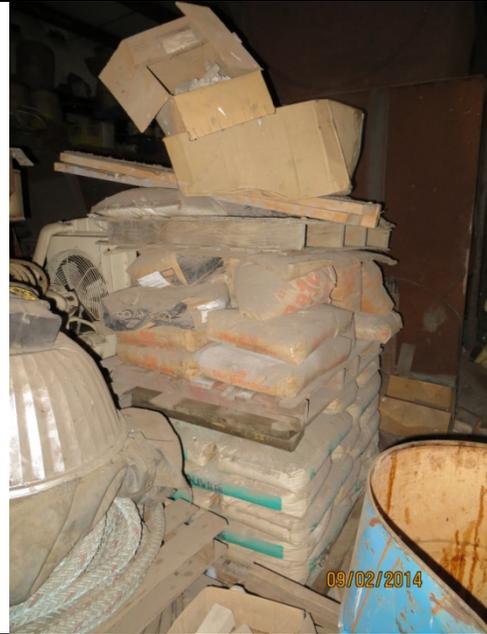
#604

This photograph shows a pallet of materials used to construct refractory insulation for incineration units manufactured at the plant.

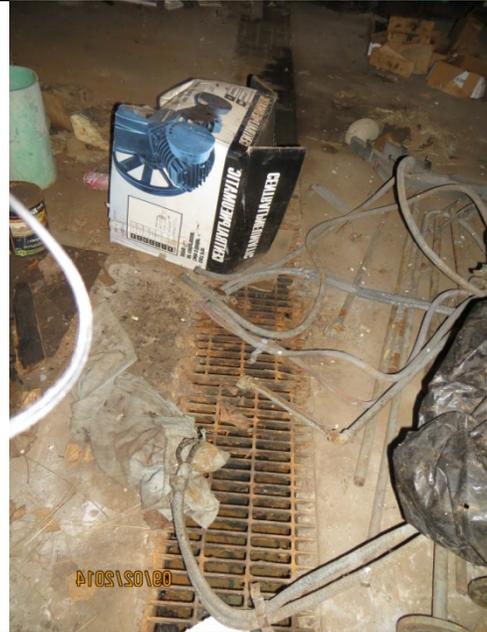
#605

The trench drain pictured in this photograph contained sediment and water with a visible sheen.

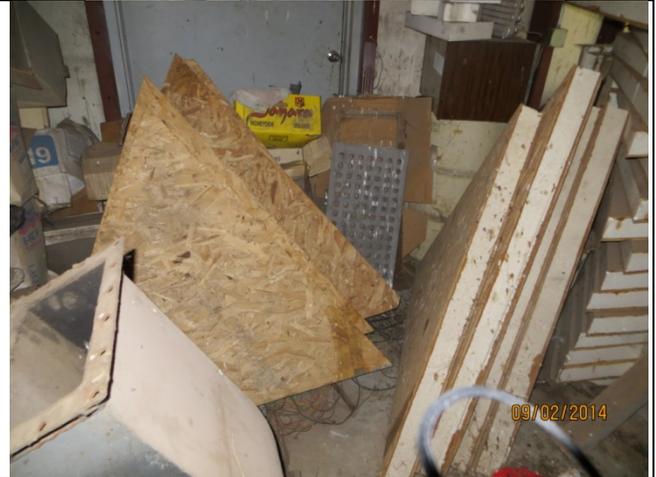
#607

This photograph shows wooden frames and other pieces of discarded equipment.

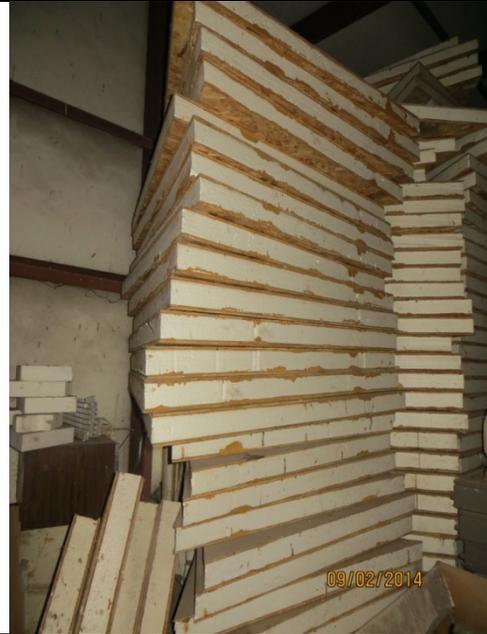
#608

This photograph shows more wooden frames pictured in photograph #607.

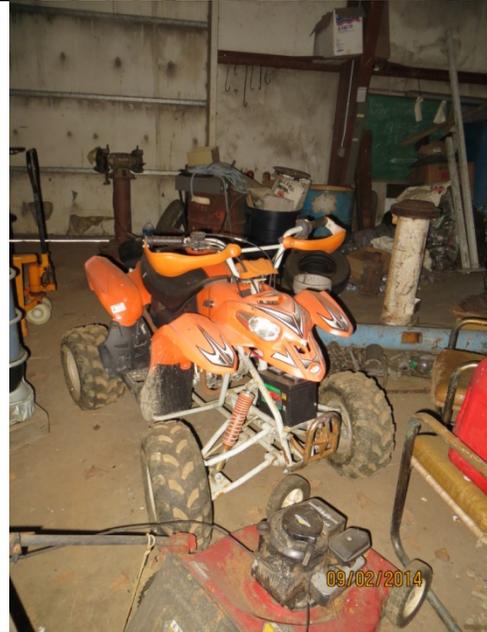
#609

The equipment in this photograph may contain hazardous components such as gasoline, lead acid batteries, or motor oil.

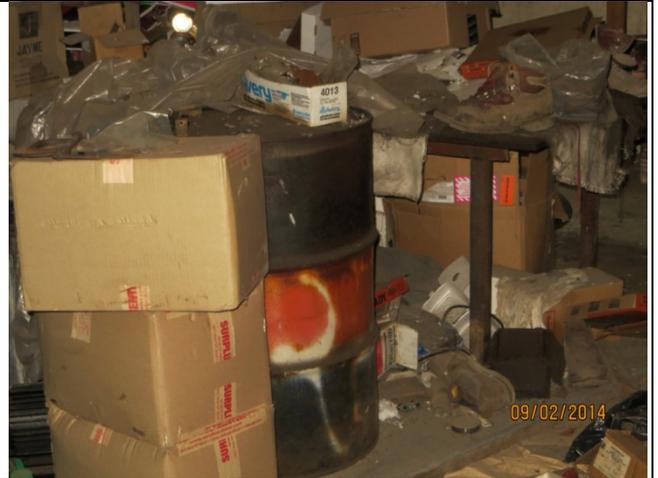
#610

The contents of this drum and these cardboard boxes are unknown.

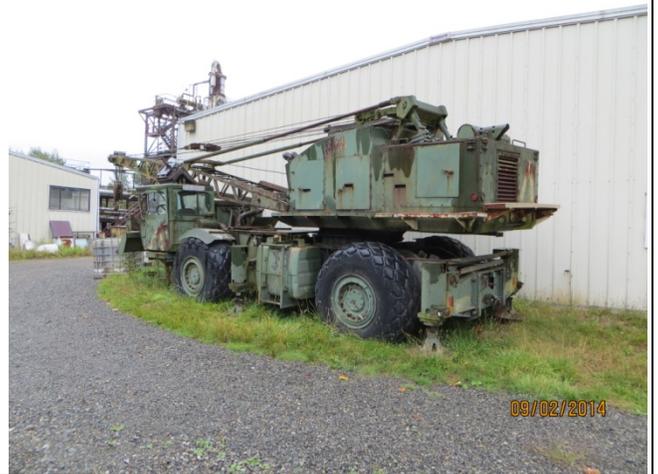
#611

This piece of equipment is reportedly operational.

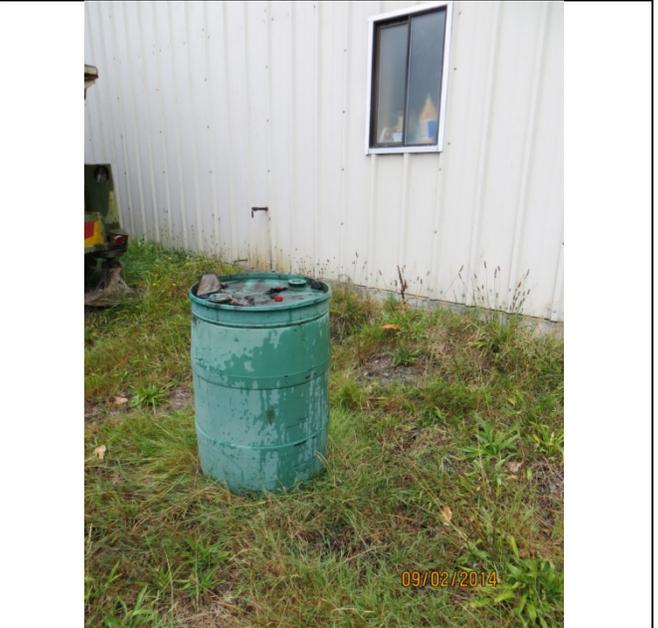
#612

The contents of this drum are unknown.

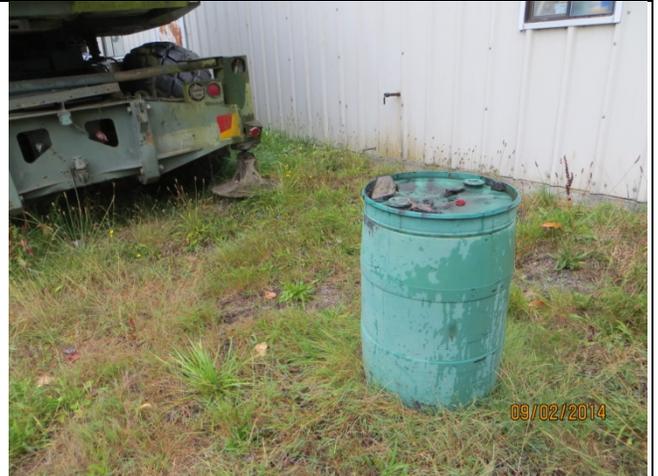
#613

This photograph shows a second view of the container shown in #612.

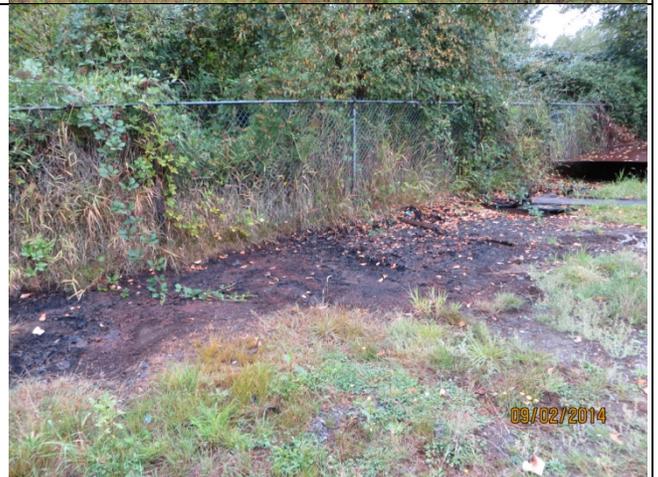
#614

This photograph shows an area of soil suspected to be contaminated with tall oil or tall oil derivatives.

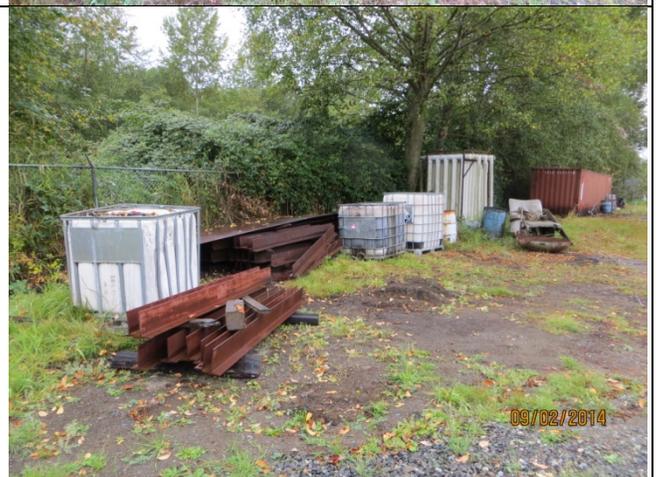
#615

The totes depicted in this photograph reportedly contain tall oil or tall oil derivatives.

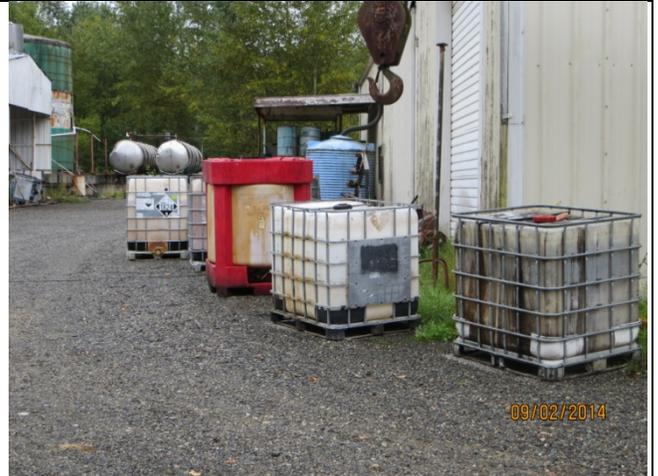
#616

The totes in this photograph reportedly contain discarded tall oil or tall oil derivatives.

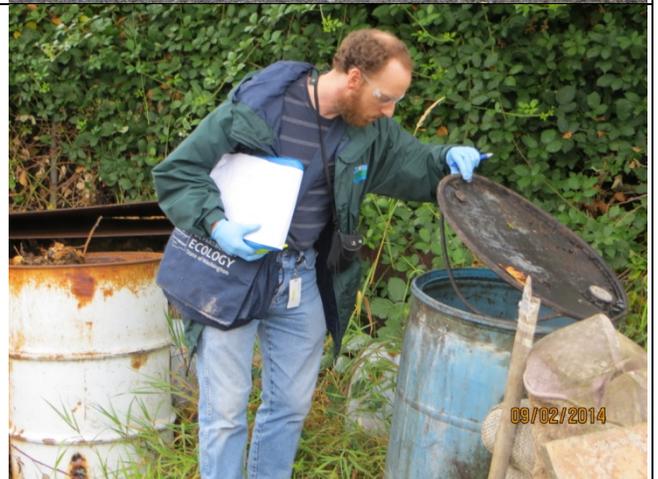
#617

These containers reportedly contain tall oil spill cleanup debris.

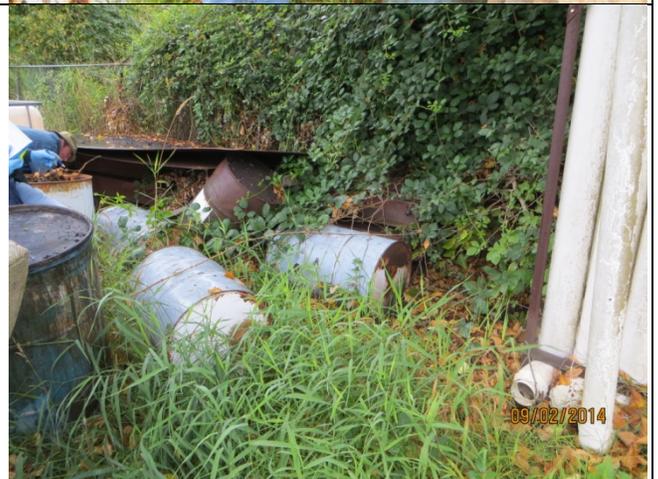
#618

These drums reportedly contain tall oil spill cleanup debris.

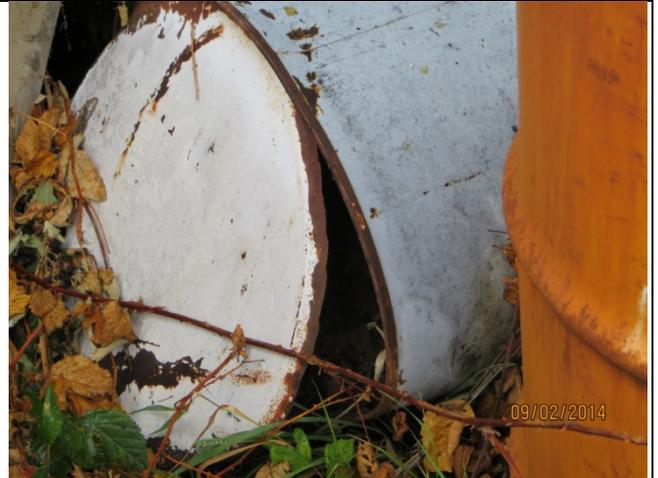
#619

This container of tall oil spill cleanup debris has fallen over and the base of the container has corroded and failed.

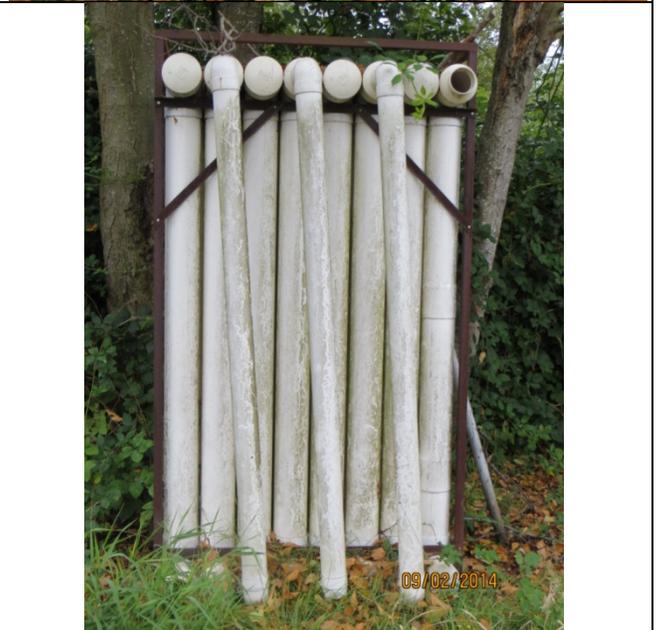
#620

This piece of equipment was reportedly a filter constructed at the facility for tall oil wastewater processing.

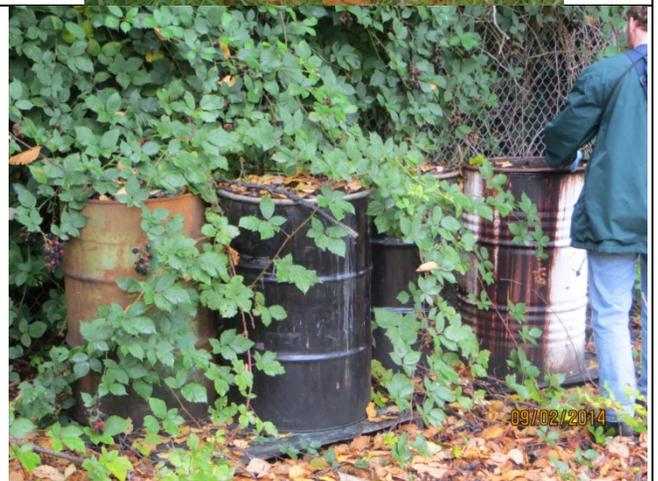
#621

These drums reportedly contain tall oil spill clean up debris.

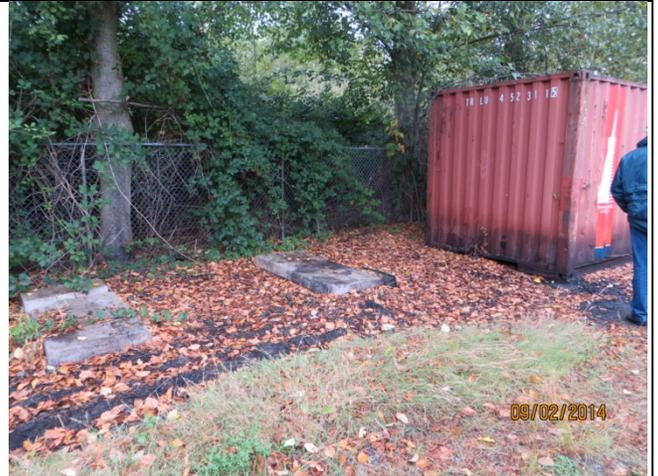
#622

This photograph shows an area of soil suspected to be contaminated with tall oil or tall oil derivatives.

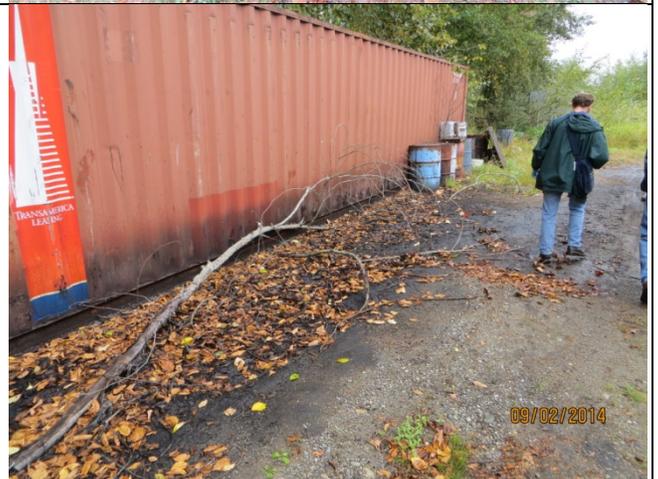
#623

This shipping container reportedly holds drums of biological oil.

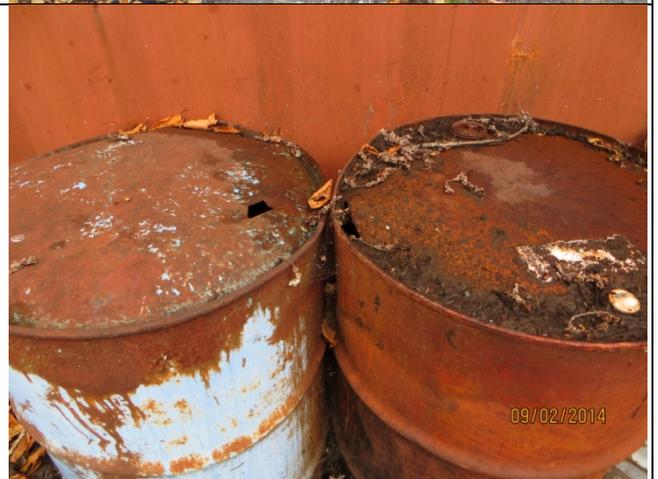
#624

These drums reportedly contained tall oil spill cleanup debris.

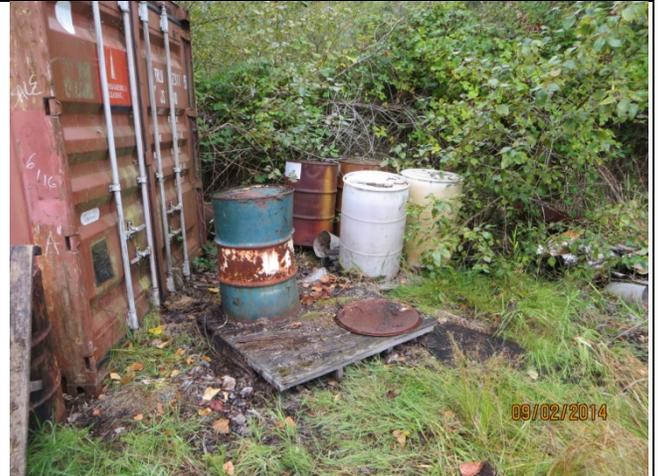
#625

These drums reportedly contained tall oil spill cleanup debris.

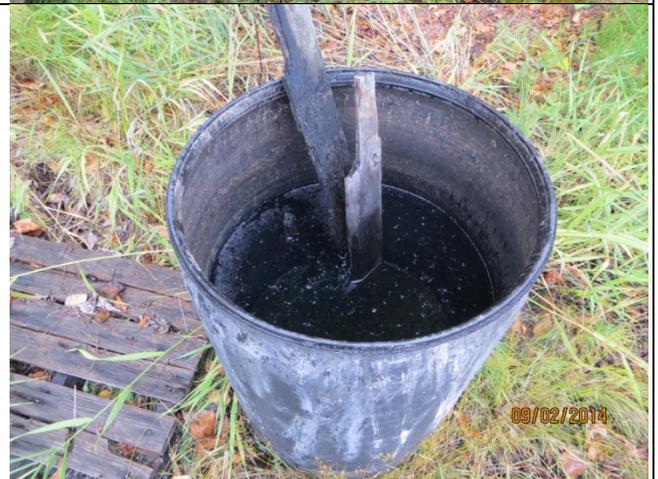
#626

This container holds waste tall oil or tall oil derivatives.

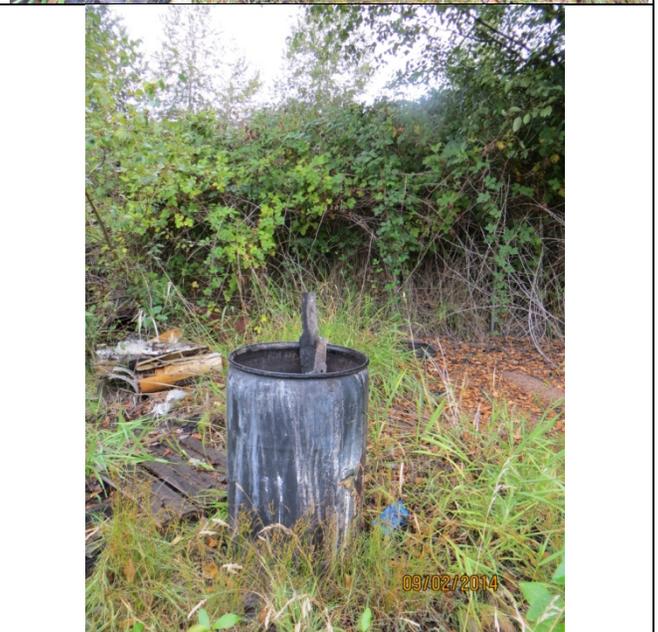
#627

This container provides a second view of the container shown in photograph #626.

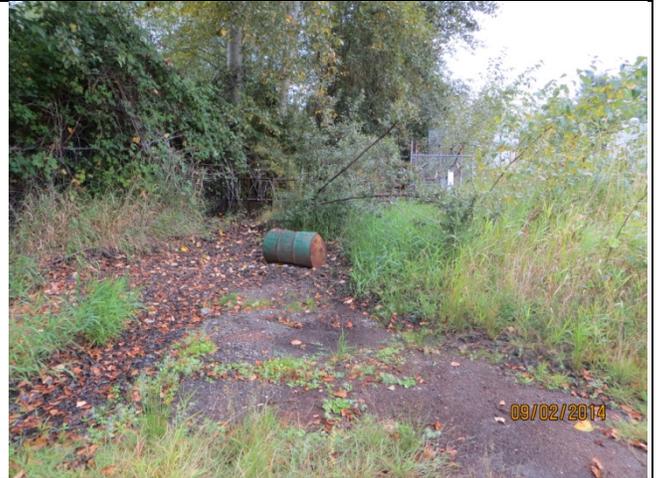
#628

The contents of this drum are unknown.

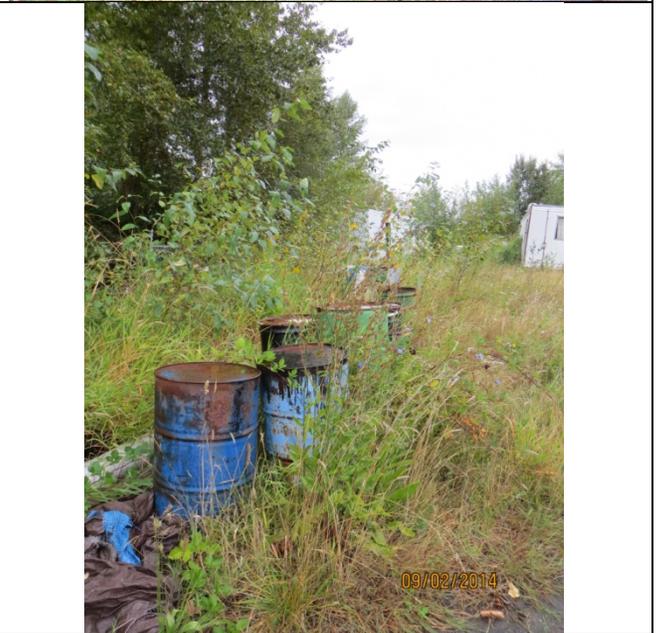
#629

These drums reportedly contain waste tall oil or tall oil derivatives.

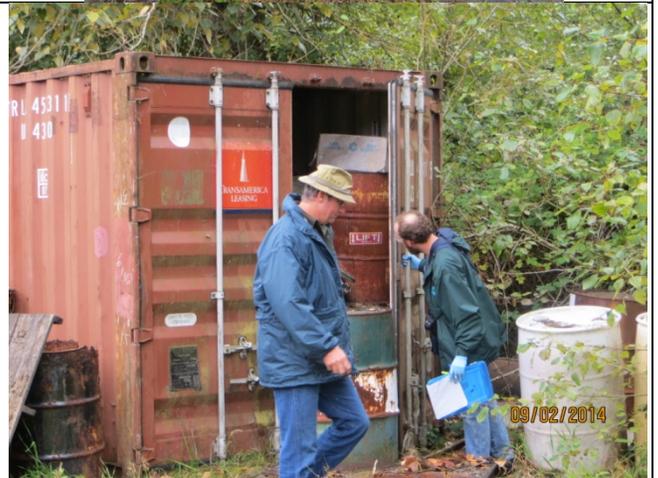
#630

The interior of the shipping container shown in photograph #623 held numerous drums, discarded equipment, and undesigantated solid wastes.

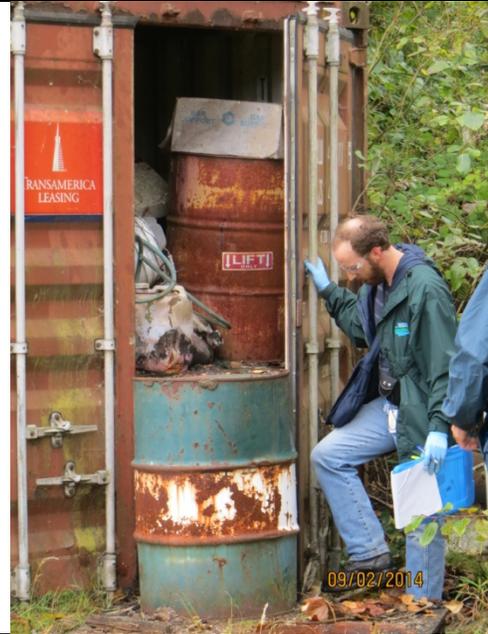
#631

This photograph shows the interior of the shipping container depicted in photograph #623.

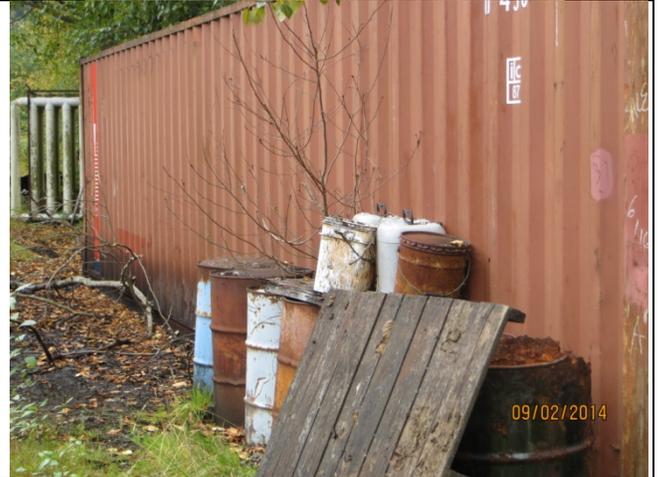
#632

These containers reportedly contain tall oil spill cleanup debris.

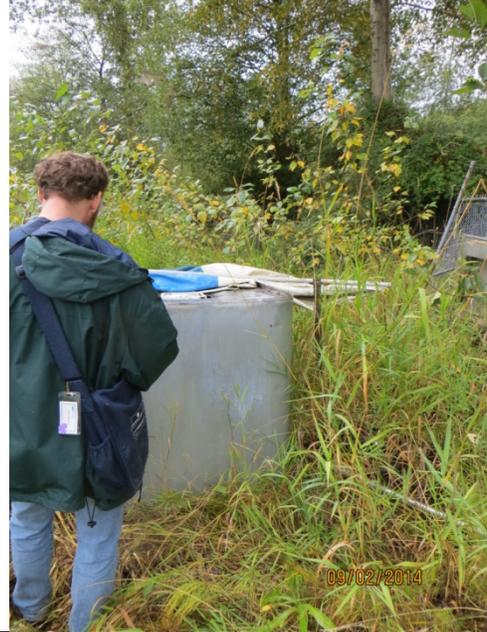
#633

The tote in this photograph contains an unknown waste.

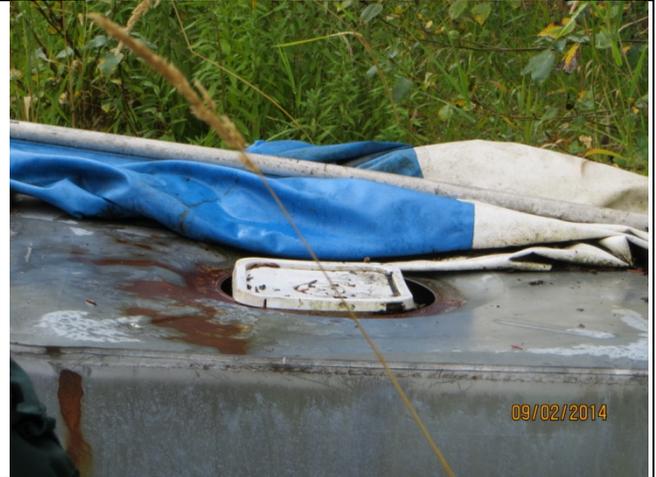
#634

The top of the tote depicted in photograph #633 was closed with plastic sheet and a loose fitting plastic lid.

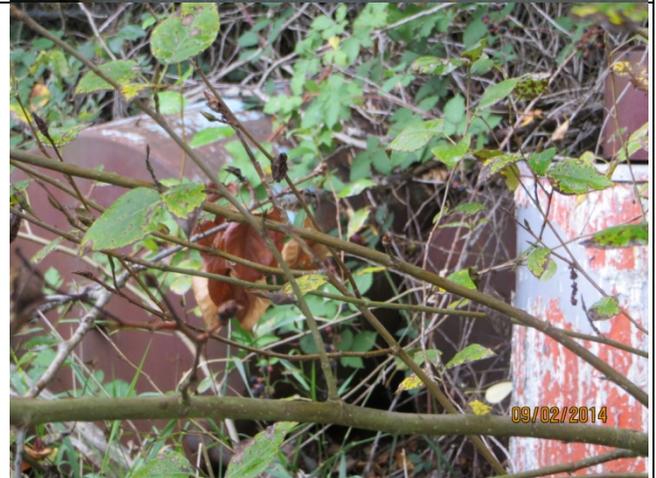
#636

Location: Western Facility Boundary

This photograph depicts another view of the tanks shown in photograph #635.

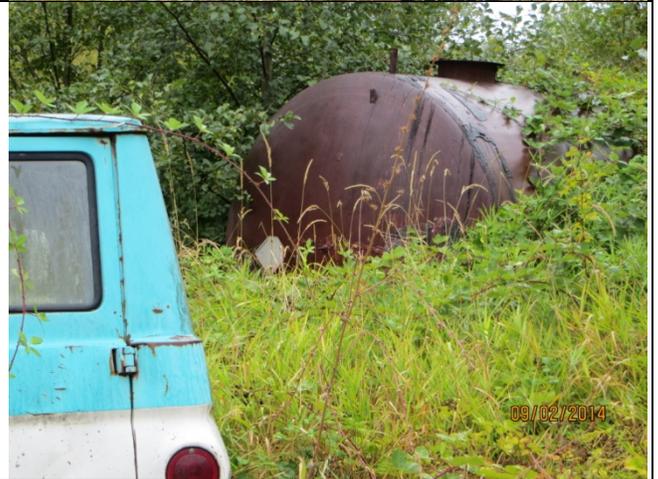
#643

Location: Northern Facility Boundary

This photograph provides another view of the tank depicted in photograph #642.

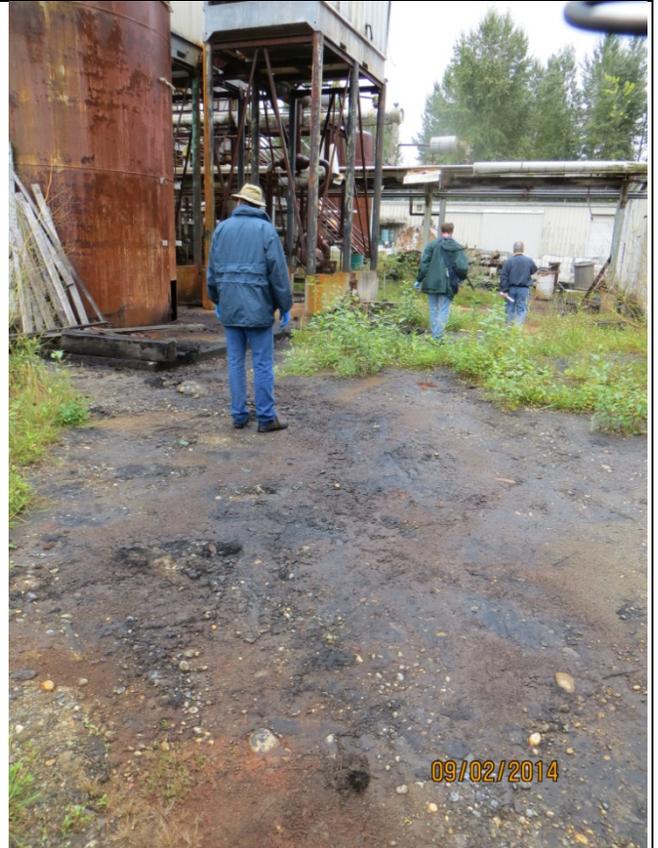
#646

Location: Exterior of Control Building

This photograph depicts an area of soil suspected to be contaminated with spilled tall oil or tall oil derivatives. This area is located to the west of the soil depicted in photograph #645 on the north side of the control building.

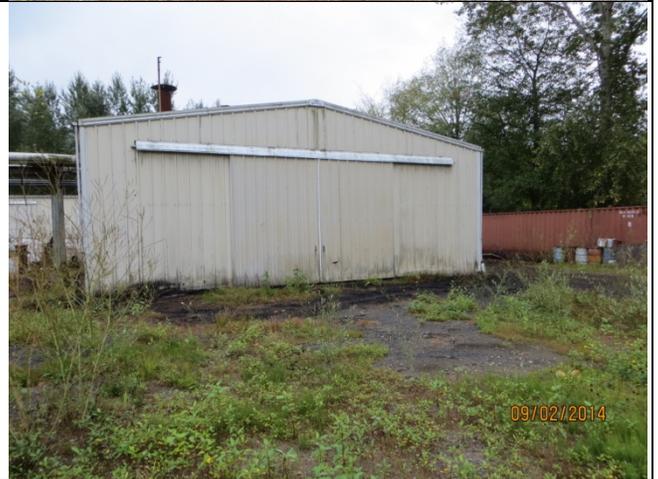
#647

Location: Exterior of Control Building

This photograph provides a closer view of the area of contamination documented in photograph #646. This area is located to the west of the soil depicted in photograph #645 on the north side of the control building.

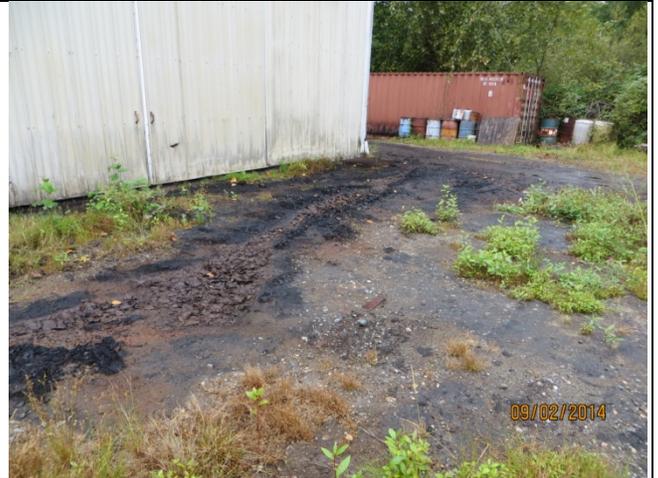
#648

Location: Exterior of Control Building

This photograph provides another view of the area of contamination documented in photograph #646. This area is located to the west of the soil depicted in photograph #645 on the north side of the control building.

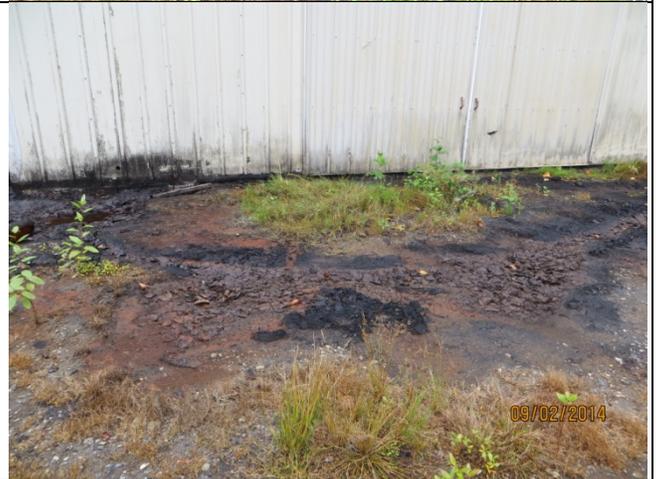
#649

Location: Exterior of Control Building

This photograph provides another view of the area of contamination documented in photograph #646. This area is located to the west of the soil depicted in photograph #645 on the north side of the control building.

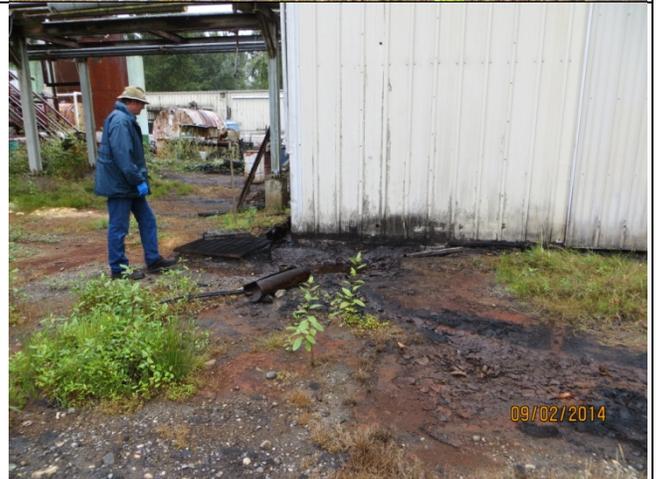
#650

Location: Exterior of Control Building

This photograph illustrates an area that appears to be a dumpsite for contaminated water, tall oil, or tall oil derivatives.

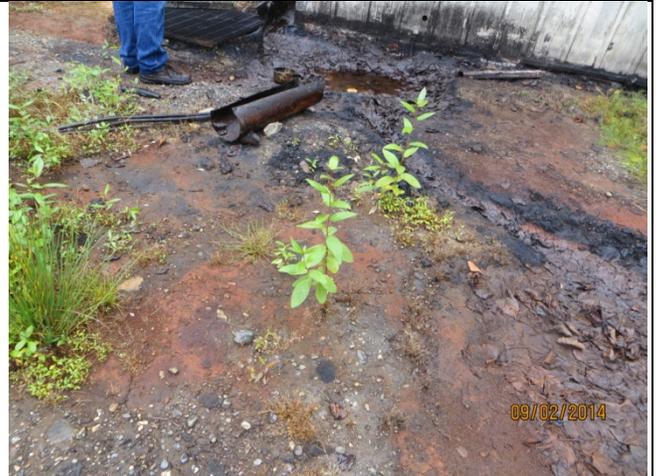
#651

Location: Exterior of Control Building

This photograph provides another view of the area of contamination documented in photographs #645 and #646. This photograph shows the area connecting these two locations.

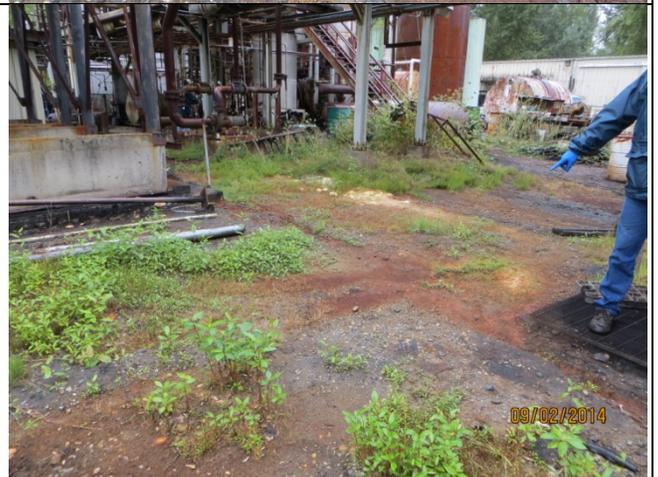
#652

Location: Processing Plant

This photograph depicts a concrete containment sump full of tall oil or tall oil derivatives.

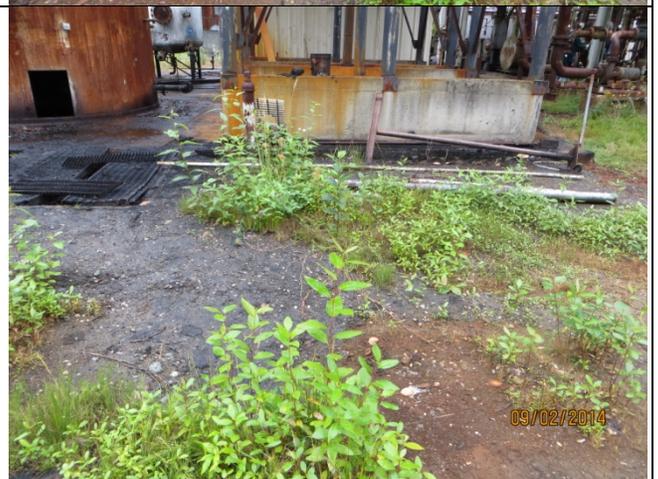
#653

Location: Processing Plant

This photograph provides another view of the contaminated sump depicted in photograph #652.

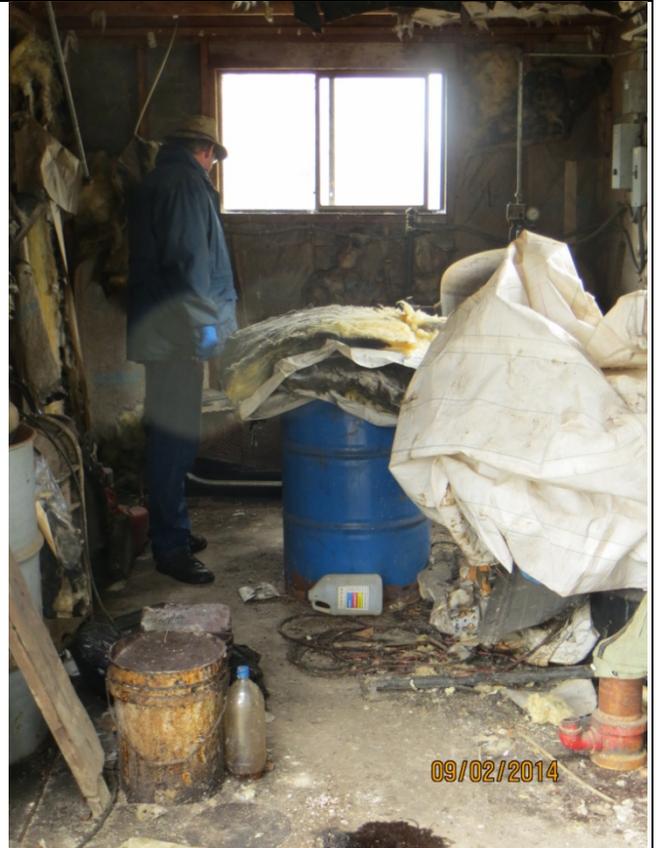
#658

Location: Processing Plant

This photograph provides a second view of the room depicted in photograph #657.

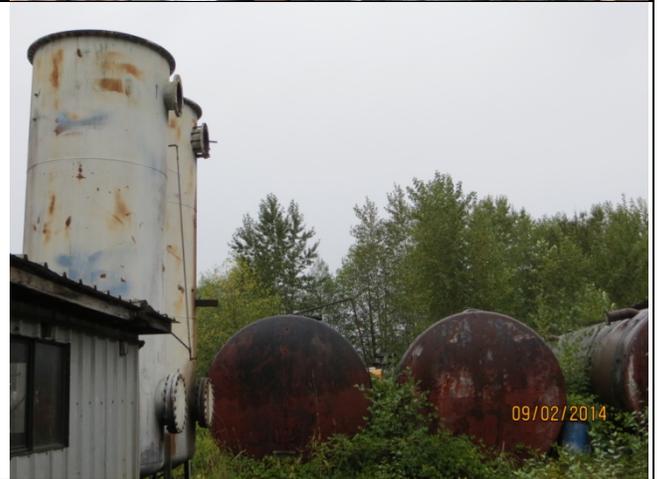
#665

Location: Processing Plant

This photograph provides another view of the tanks depicted in photograph #644.

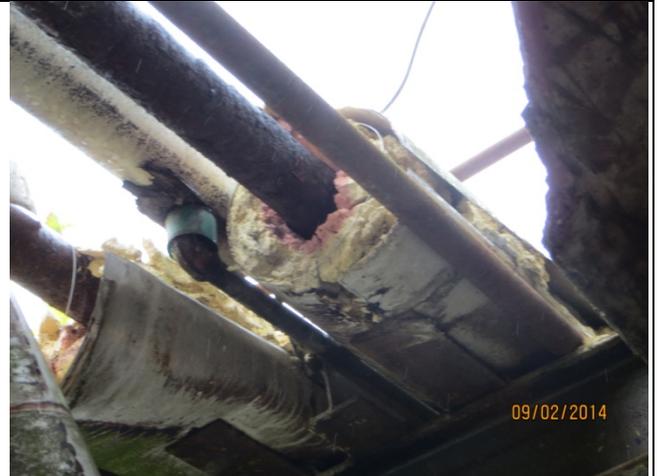
#666

Location: Processing Plant

This photograph provides another view of pipe insulation in the Processing Plant. It is unknown if this insulation is asbestos free.

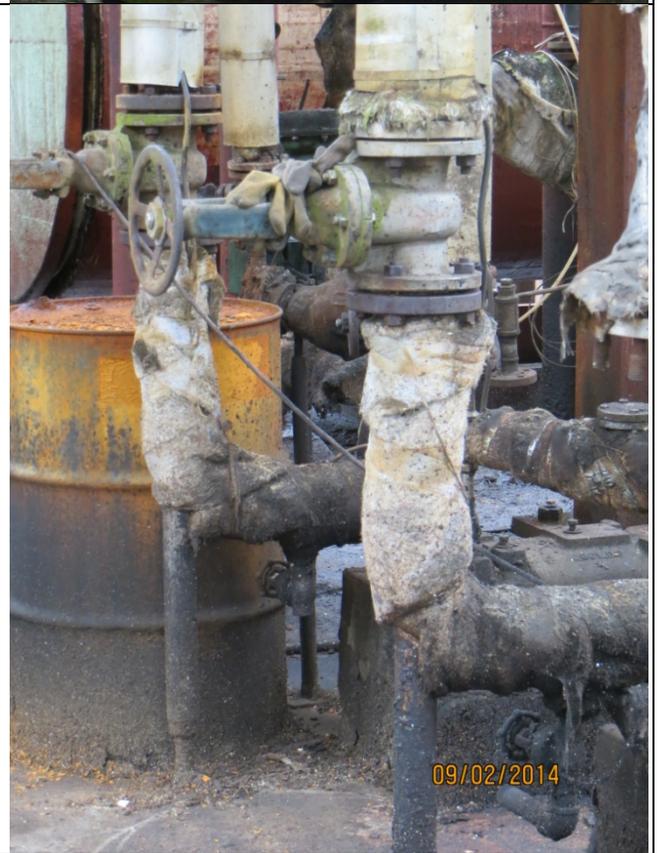
#667

Location: Processing Plant

The contents of the 55-gallon drum depicted in this photograph area unknown.

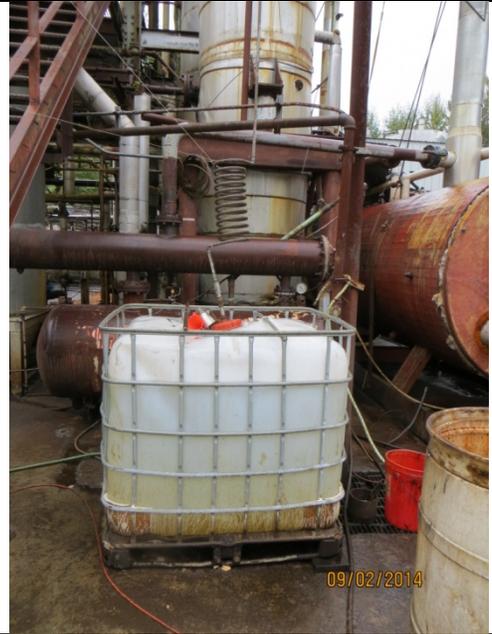
#668

Location: Processing Plant

This photograph provides another view of the tote depicted in photograph #663. The contents of this tote are unknown.

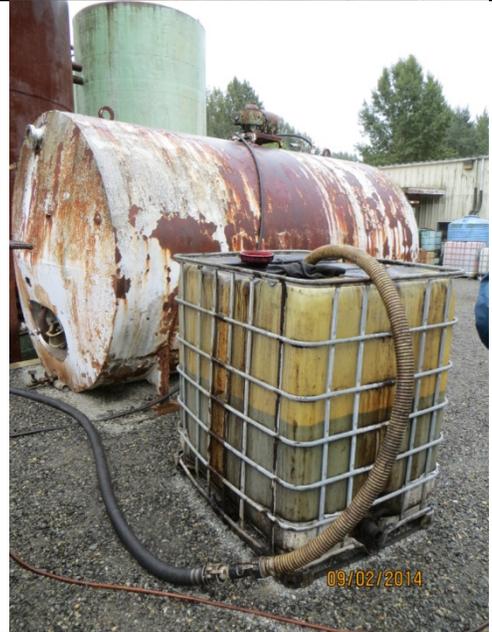
#669

Location: Processing Plant

The tote depicted in this photograph reportedly contains waste from biodiesel production.

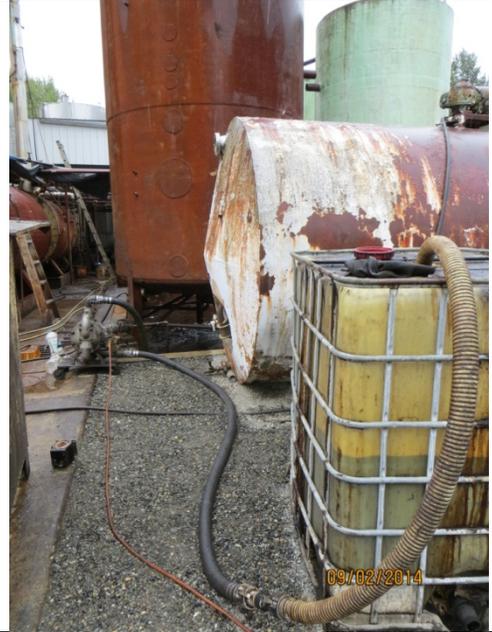
#670

Location: Processing Plant

This photograph shows a pump and connected hoses drawing waste products from biodiesel processing into the tote depicted in photograph #669.
