**Re: Dangerous Waste Compliance Inspection on September 2, 2014 at Treoil Industries,
4242 Aldergrove, Ferndale, WA 98242 - RCRA Site ID: N/A Facility Site ID: 2919**

Washington State Department of Ecology Hazardous Waste and Toxics Reduction Program

NOTICE TO COMPLY

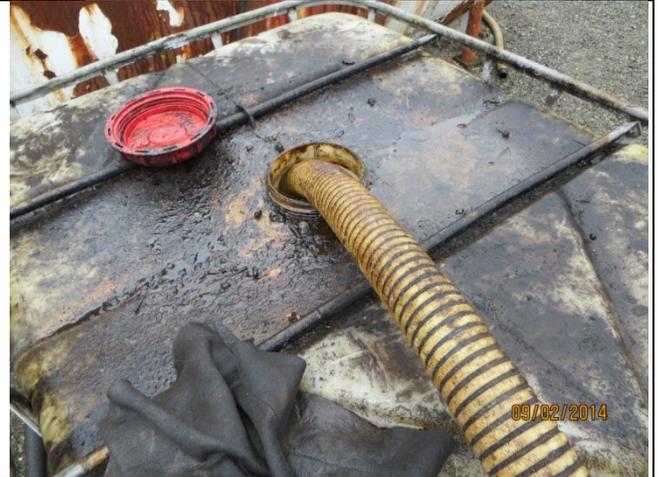
#671

Location: Processing Plant

This photograph illustrates the open top of the tote depicted in photograph #669.

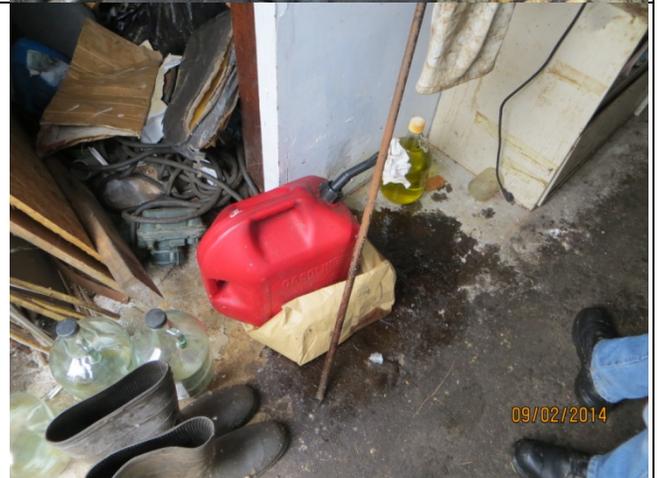
#672

Location: Control Building

The gas can and the 1-gallon glass container in this photograph contain unknown wastes.

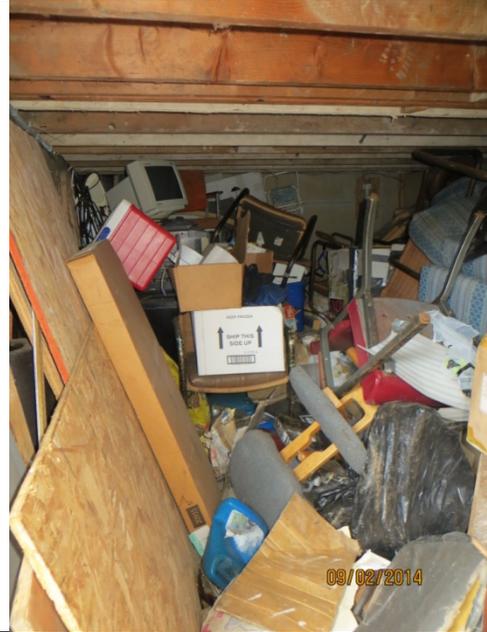
#673

Location: Control Building

The quantity of solid waste and discarded equipment piled into this room prevented an accurate assessment of the potential for hazardous waste to be located in this room. Note the CRT monitor in the back of this room contains leaded glass and must be disposed of properly.

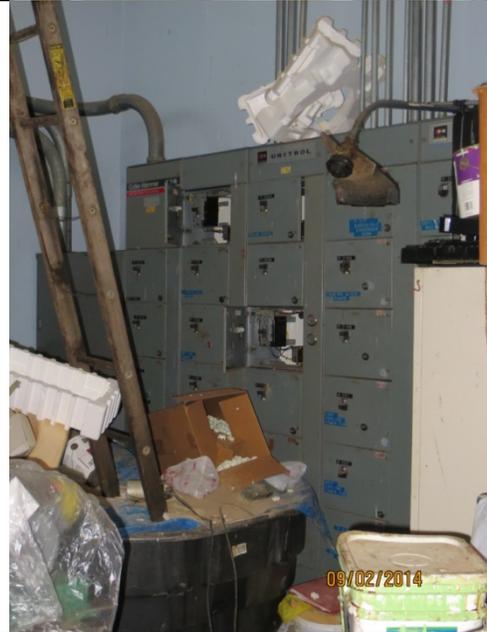
#674

Location: Control Building

The black tub in the bottom of the frame reportedly contains unprocessed ore previously utilized in research and development of precious metal extraction technology.

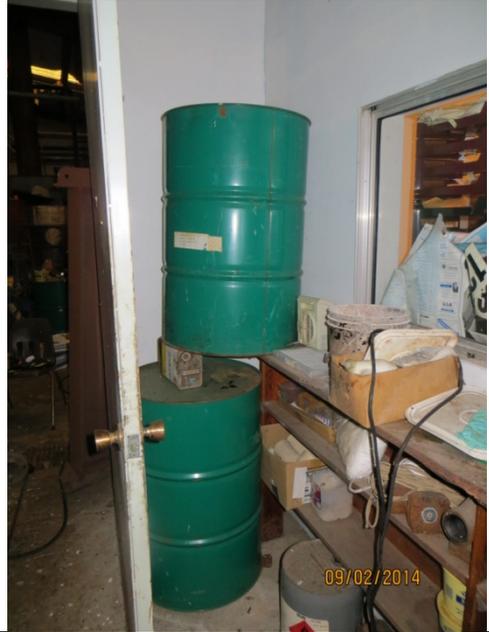
#675

Location: Control Building

This photograph shows two 55-gallon drums with unknown contents.

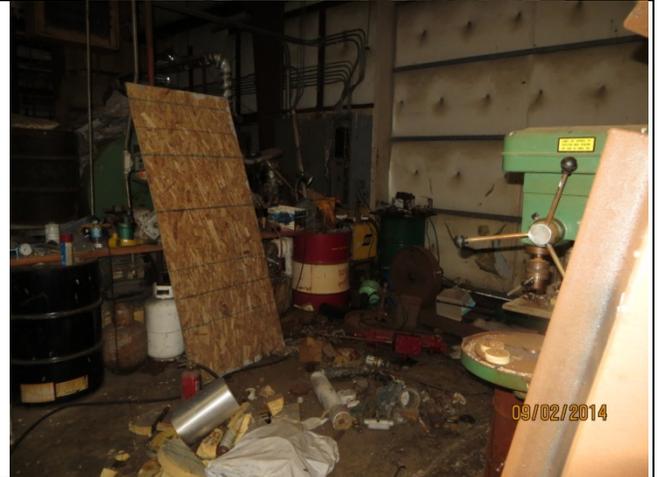
Location: Control Building- Boiler Room

This photograph shows the interior of the Boiler Room. This room was very full and cluttered which prevented an accurate and timely inventory of all potential hazardous wastes in this room. The contents of the drums and cylinders depicted in this room are unknown.

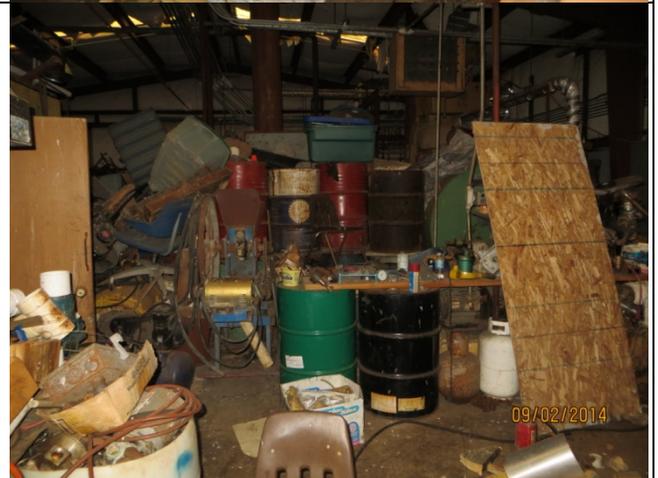
#678

This photograph provides a second view of the interior of the Boiler room.

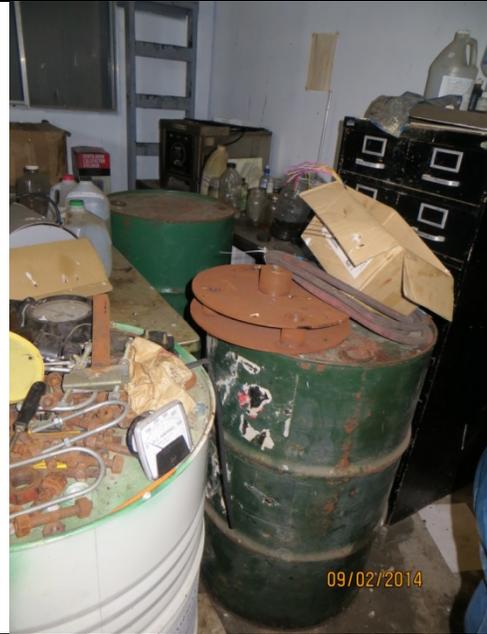
#679

This photograph shows three 55-gallon drums with unknown wastes and several other one gallon glass and poly containers also with unknown wastes.

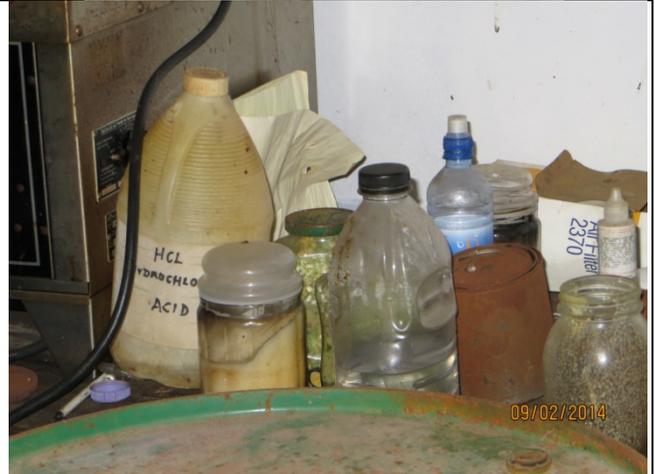
#680

This photograph shows a collection of small glass containers primarily holding unknown and unlabeled wastes. A 1-gallon poly container of waste hydrochloric acid is present on the left of the frame.

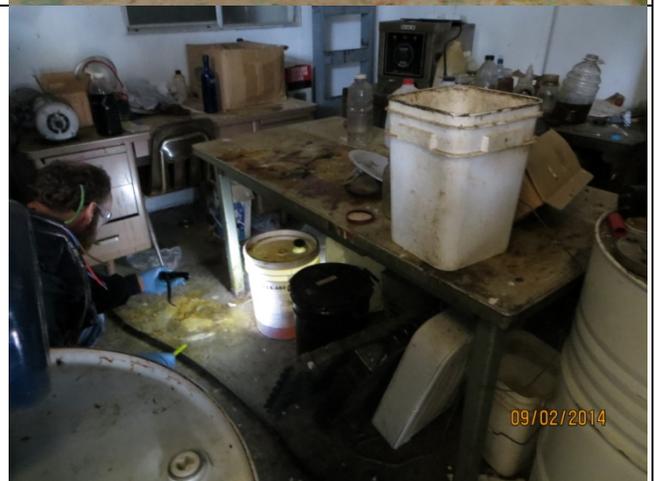
#681

This photograph provides another angle to the room depicted in photographs #679 and 680. Numerous containers of waste in various containers were present in this room.

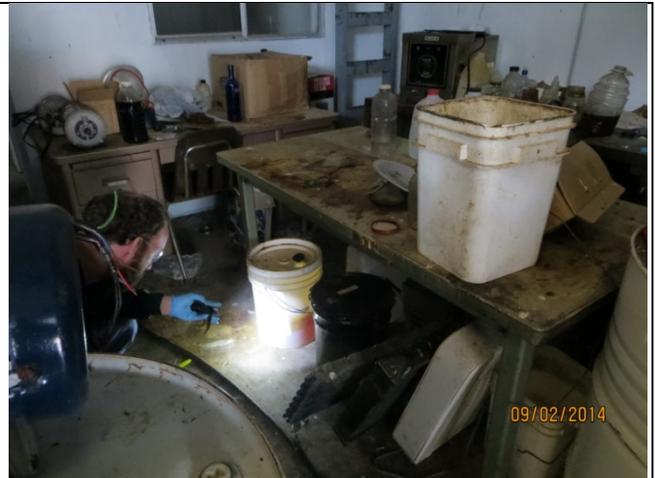
#682

This photograph provides a second view of the area depicted in photograph #681.

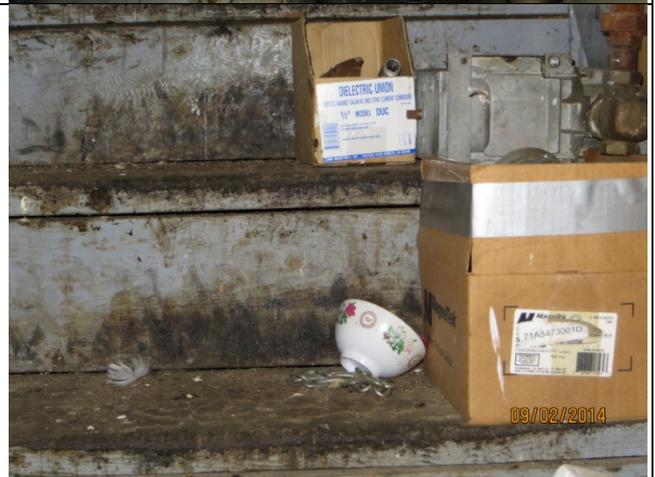
#683

This photograph shows some equipment stored on the stairs.

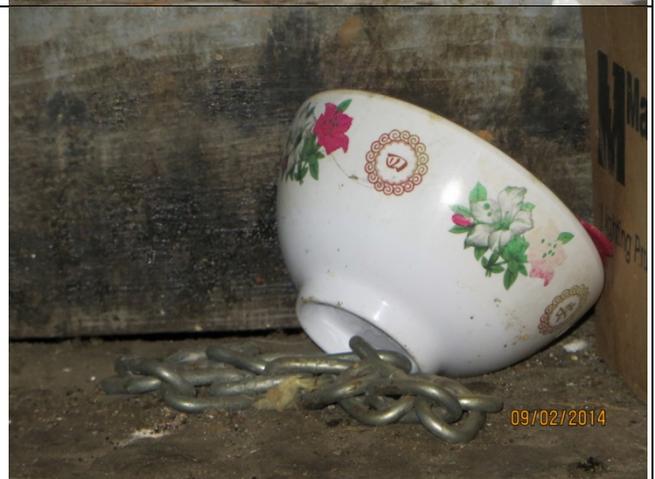
#684

This photograph provides a close-up view of rice bowl and a chain depicted in photograph #683. This bowl did not appear to contain hazardous waste.

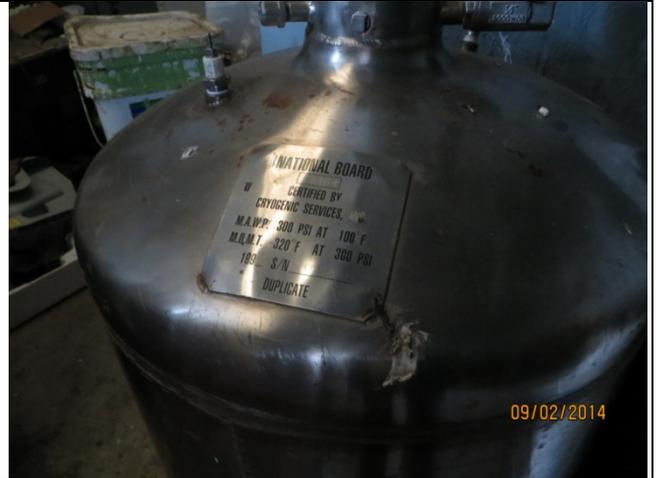
#685

The contents of the piece of equipment presented in this photograph are unknown.

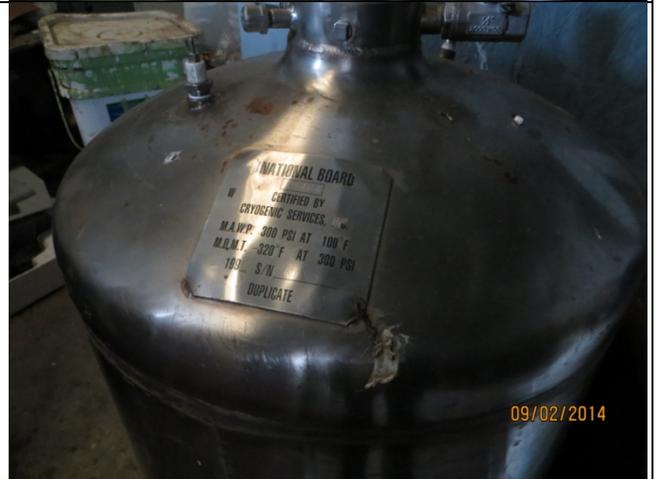
#686

A second view of the equipment depicted in photograph #685.

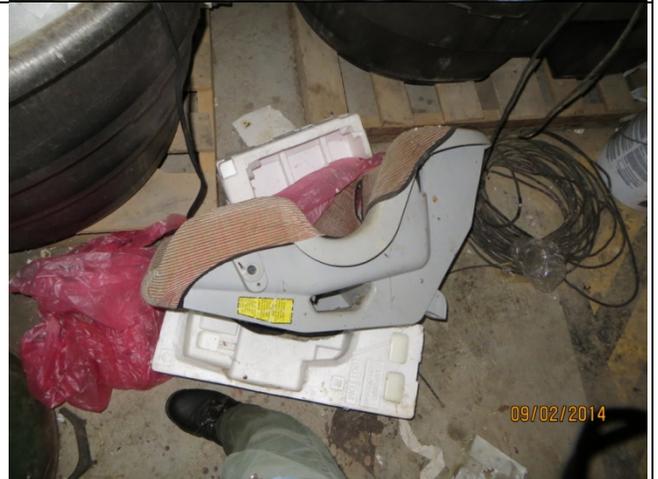
#687

This photograph shows discarded baby car seat in the control building.

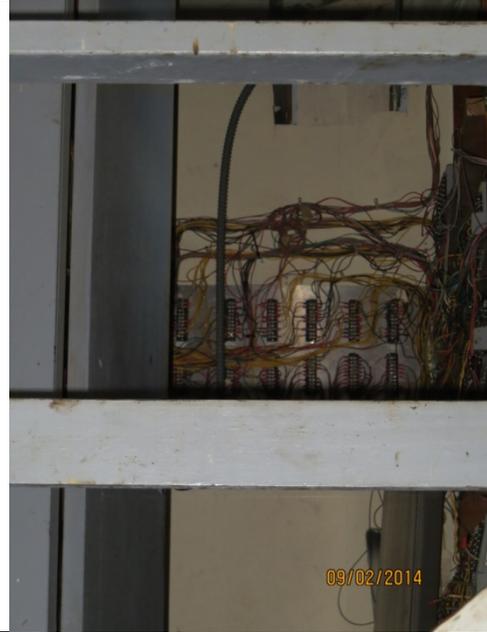
#688

This photograph shows the old control panel previously used to operate the plant. Thieves have scavenged parts of this panel for copper.

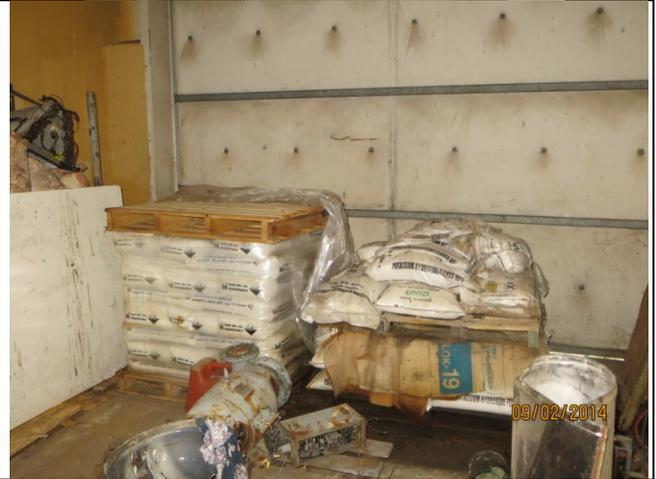
#689

The pallet on the left of the frame holds fifty-pound sacks of sodium hydroxide; the right pallet contains sacks of potassium hydroxide.

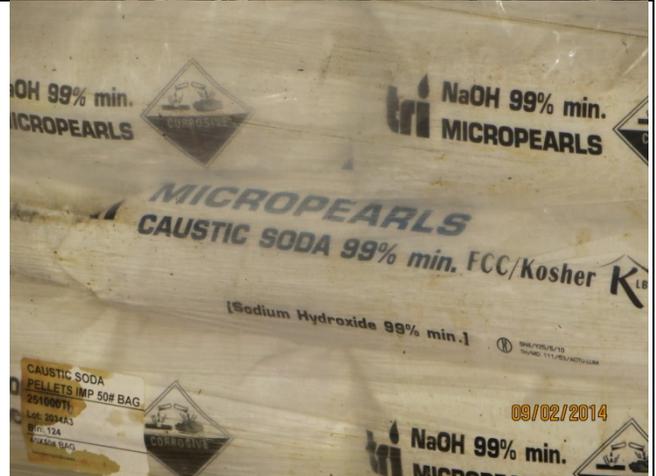
#690

This photograph shows a close up of the label on the sacks shown in photograph #689.

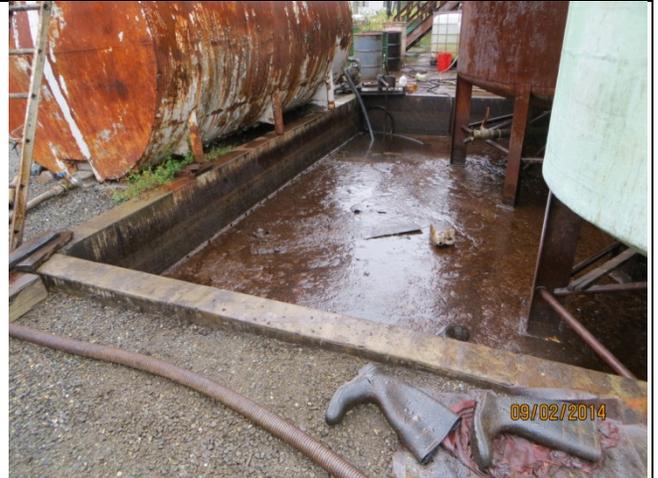
#691

This photograph shows a concrete containment sump that reportedly contains waste products from biodiesel production.

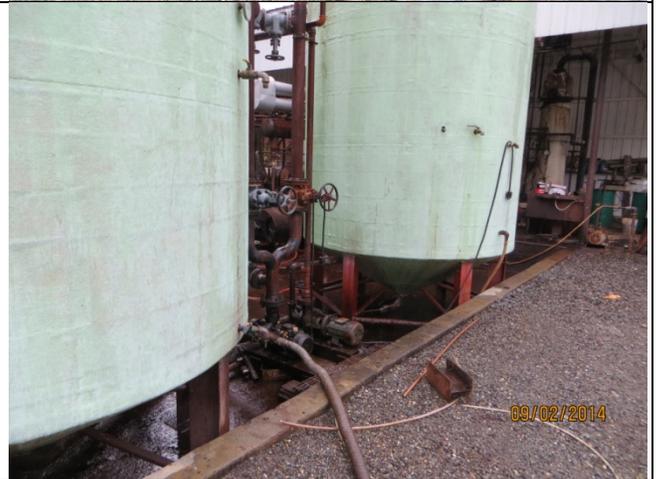
#692

These two tanks reportedly contain waste products from biodiesel production.

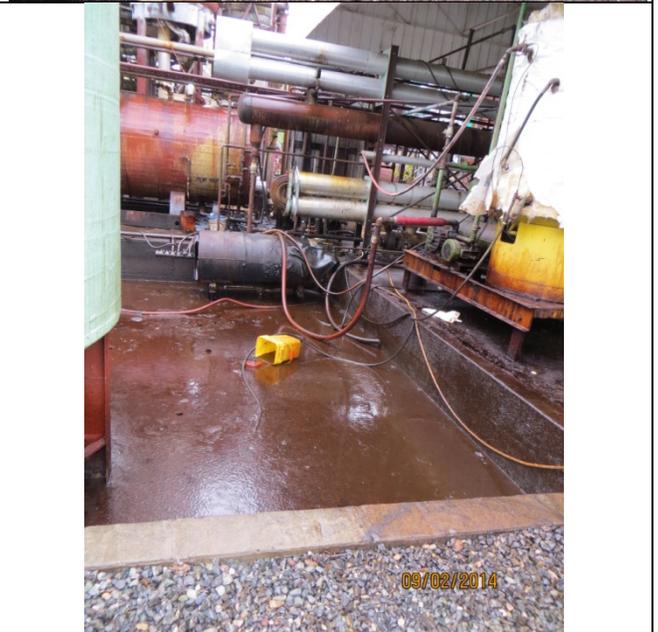
#693

This photograph provides another view of the containment sump depicted in photograph #691.

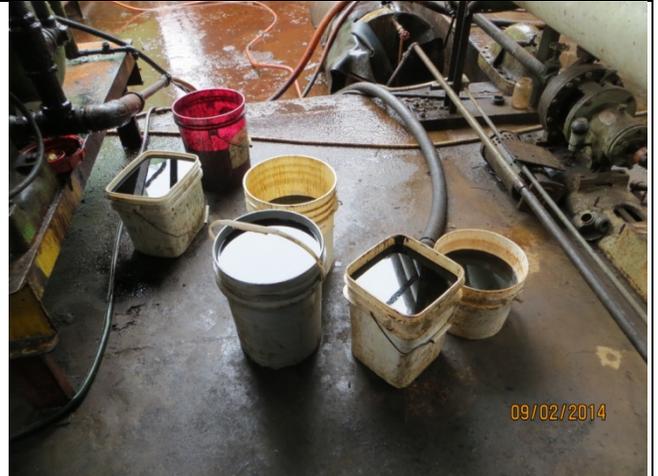
#694

This photograph shows a collection of 5-gallon buckets which reportedly contain waste products from biodiesel production.

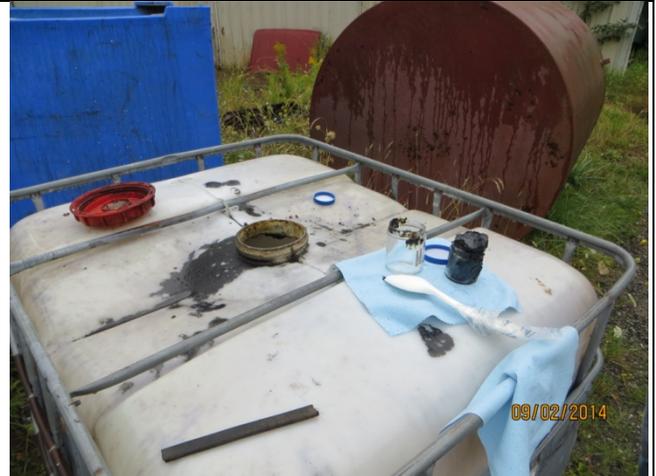
#698

This photograph shows a tote which reportedly contains tall oil pitch which we sampled.

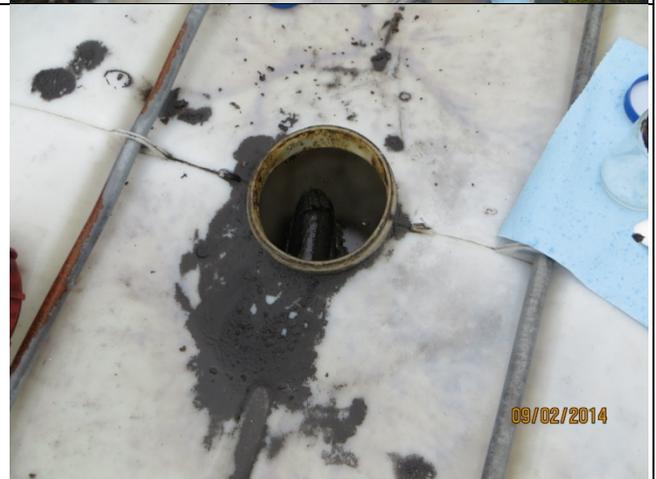
#699

This photograph shows the interior of the tote depicted in photograph #698.

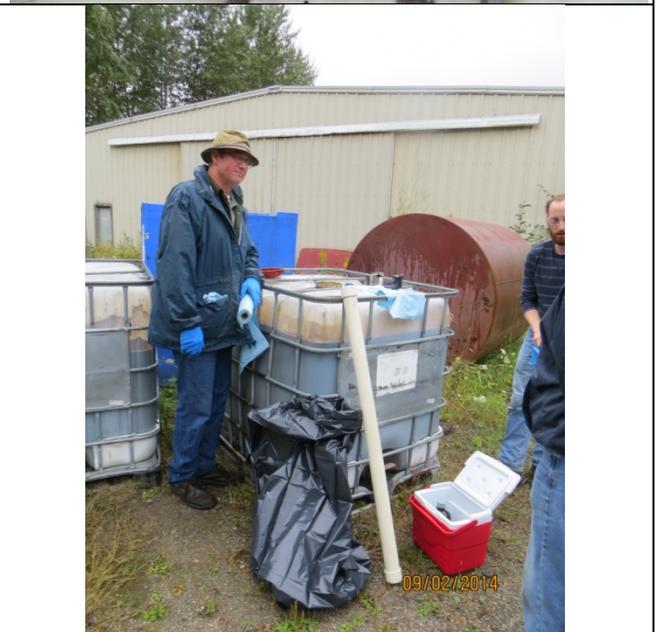
#700

This photograph shows another view of the sampling process for this tote.

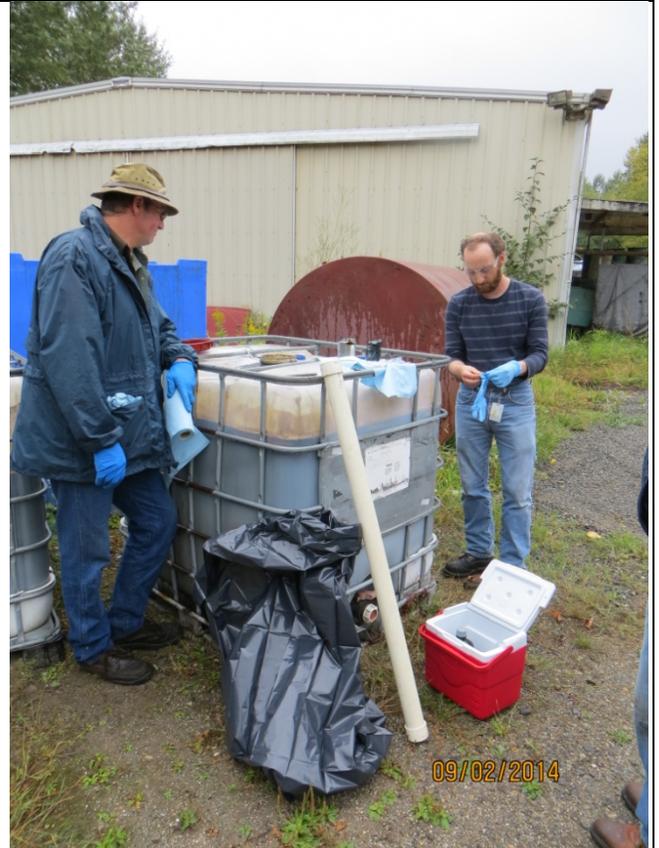
#701

This photograph shows another view of the sampling process for this tote.

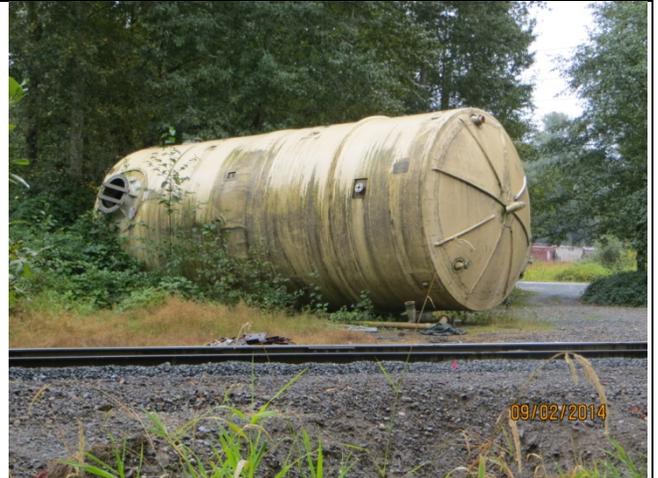
#703

This photograph shows an empty tank stored along the driveway leading into the facility.

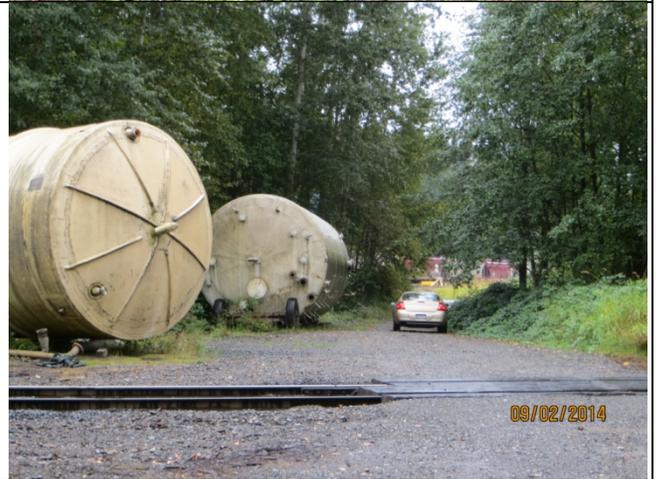
#704

This photograph provides another view of two empty tanks located along the driveway leaving the facility.
