February 2018
Port Gamble Bay and Mill Site Cleanup Project

Final Cleanup Action Report – Season 2

Prepared for Pope Resources, LP/OPG Properties, LLC

Prepared by
Anchor QEA, LLC
720 Olive Way, Suite 1900
Seattle, Washington 98101

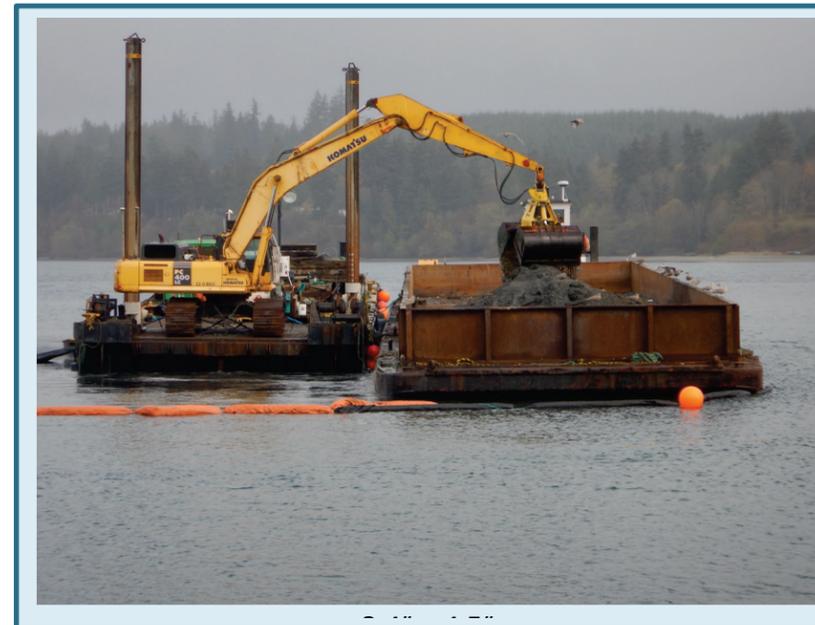
PC400 and Young Bucket Dredging in SMA-1

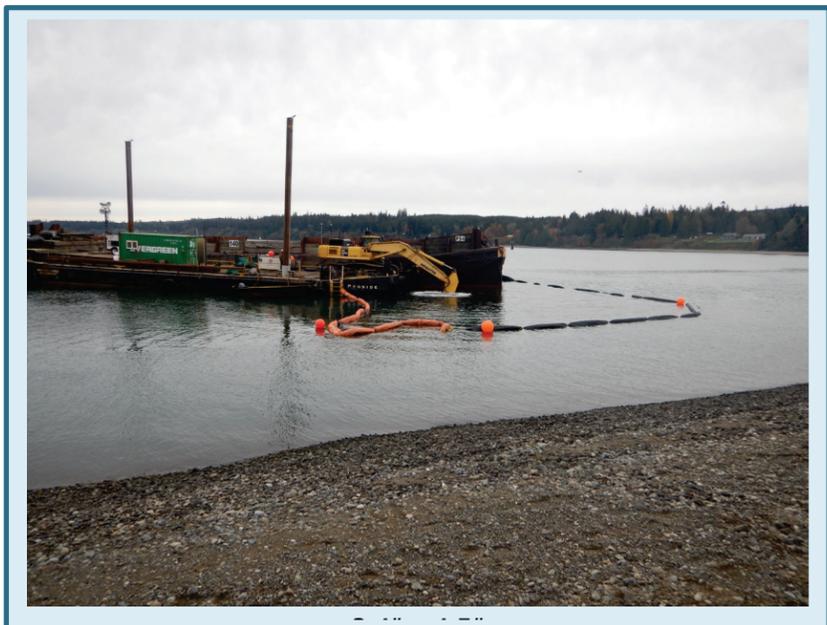
PC400 and White Horse Spud Barge Dredging in SMA-1

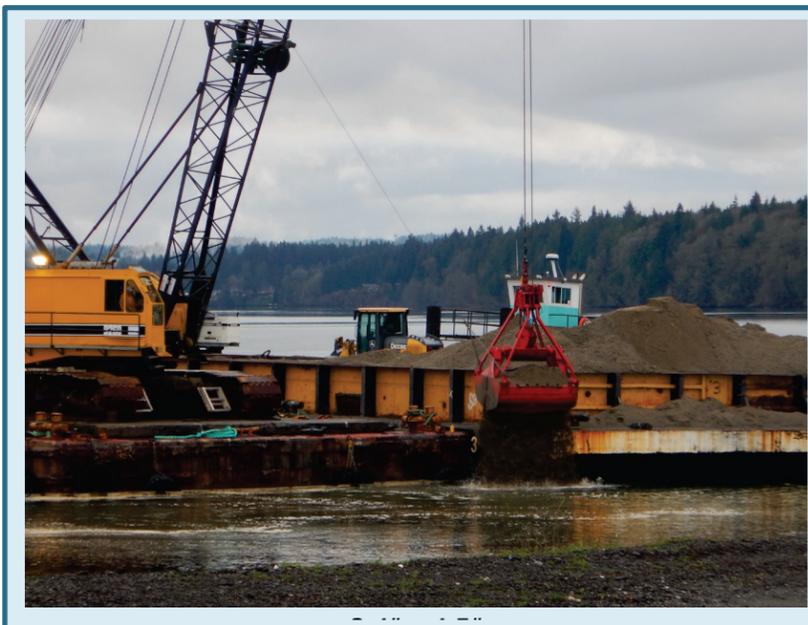
Post-dredging RMC Placement with 9260 Crane and Clamshell Bucket

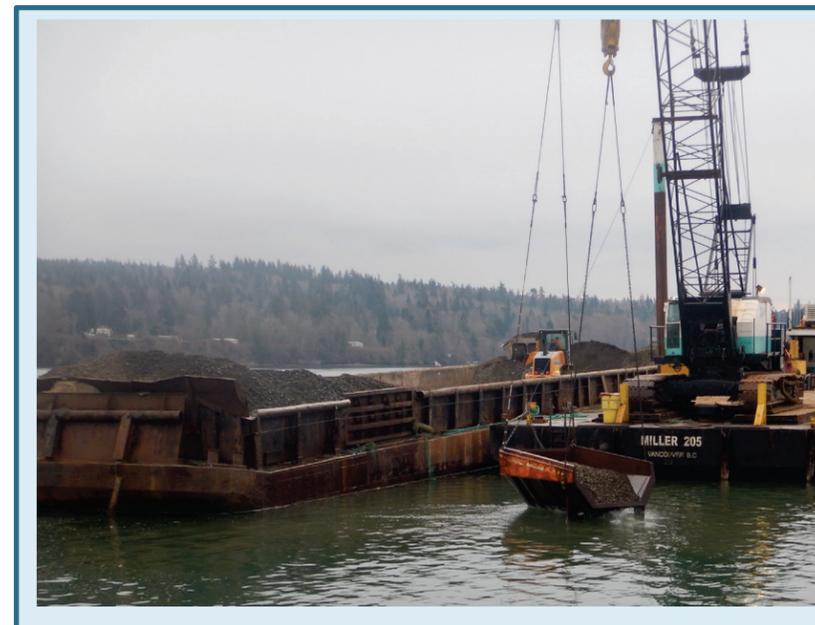
Placement of Angular Gravel Backfill Buttress Material in SMA-2 with 9299 Crane and Skip Box

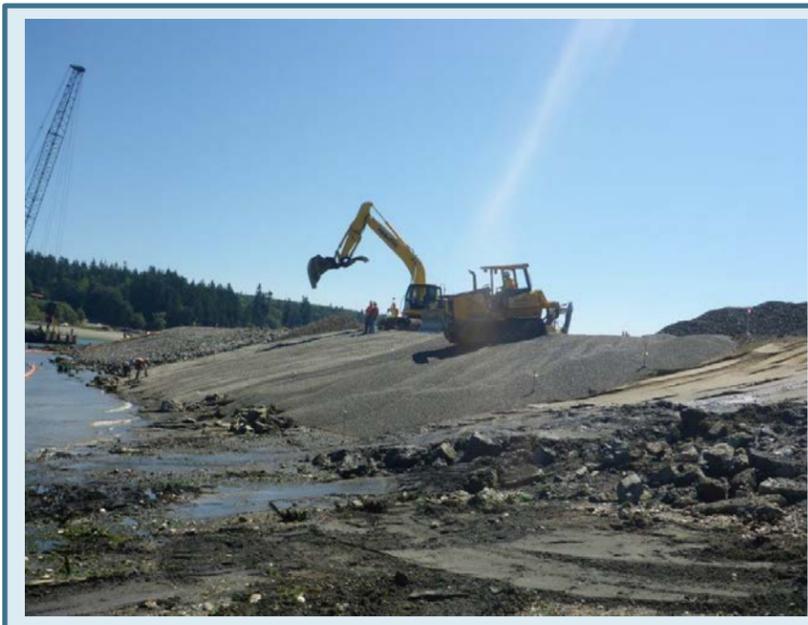
SMA-1 Intertidal Cap Filter Layer Placement

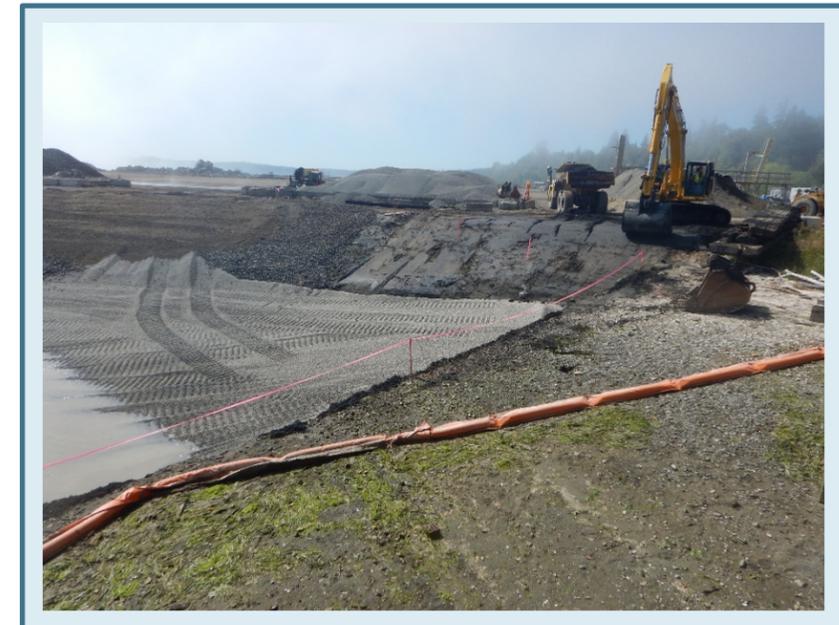
SMA-1 Intertidal Excavation and Capping

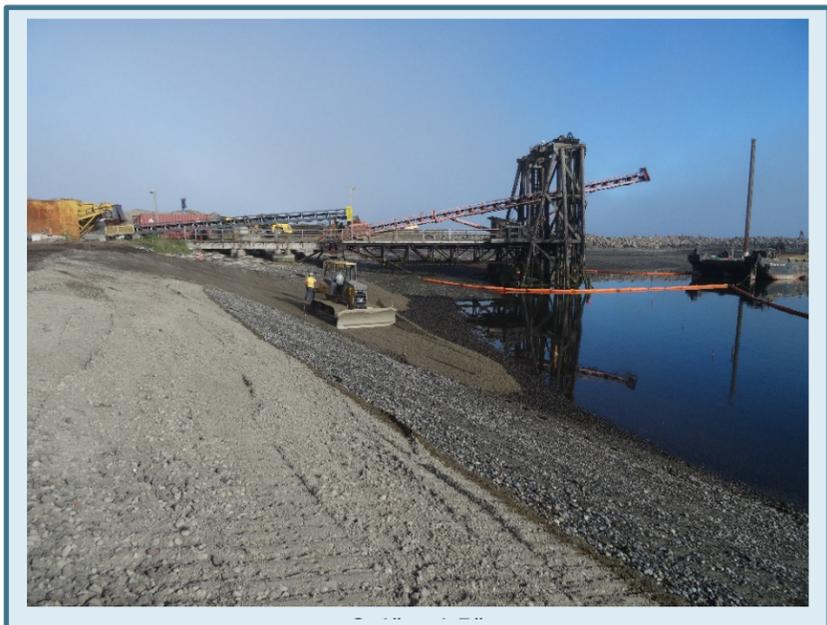
Habitat Substrate Placement on SMA-1 Intertidal Cap

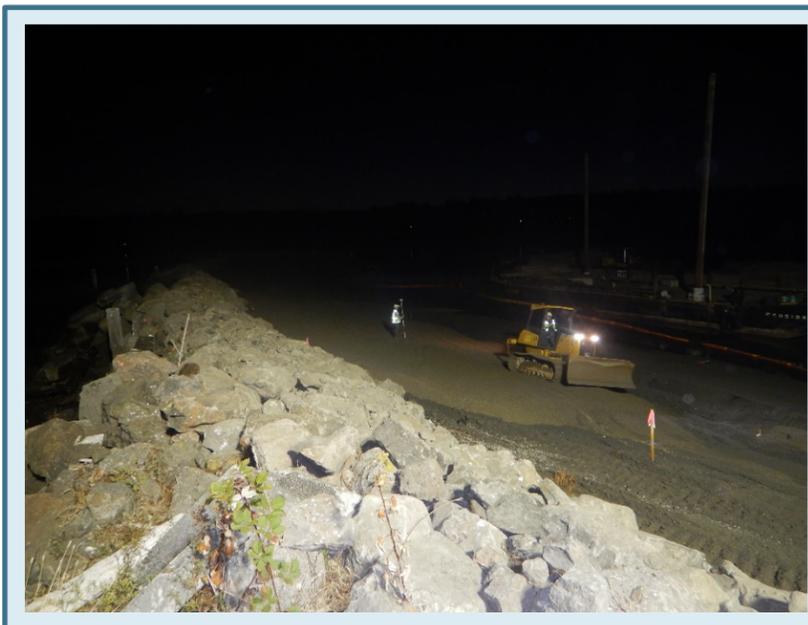
SMA-1 Jetty Area Intertidal Cap Filter Layer Placement

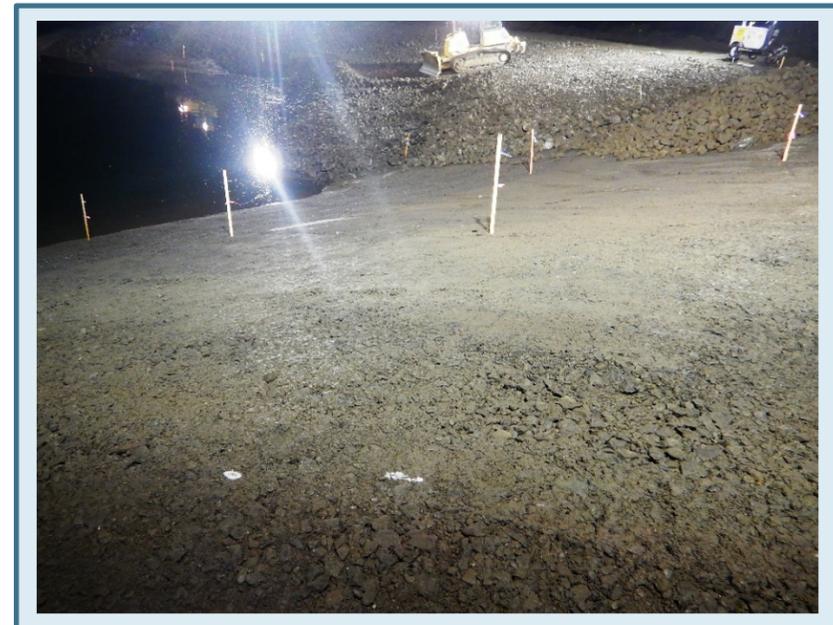
3" Minus Backfill Placement – Former Pier 4 Area Cap

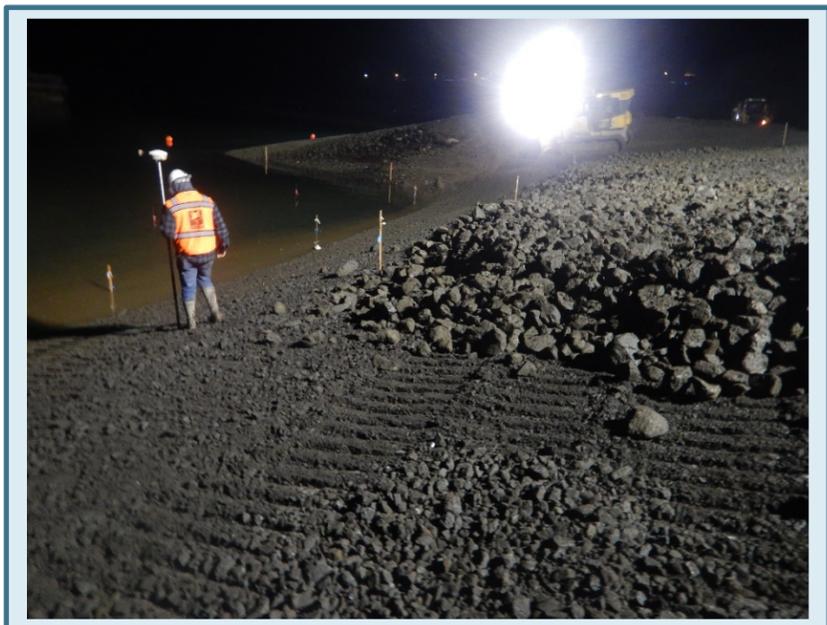
Type 2 Armor Placement – Former Pier 4 Area Cap

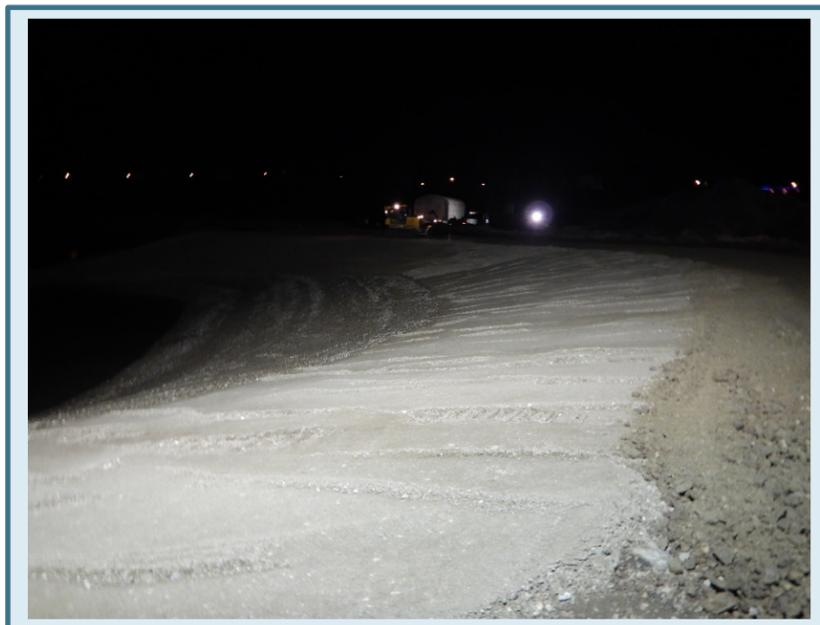
Habitat Substrate Placement – Former Pier 4 Area Cap

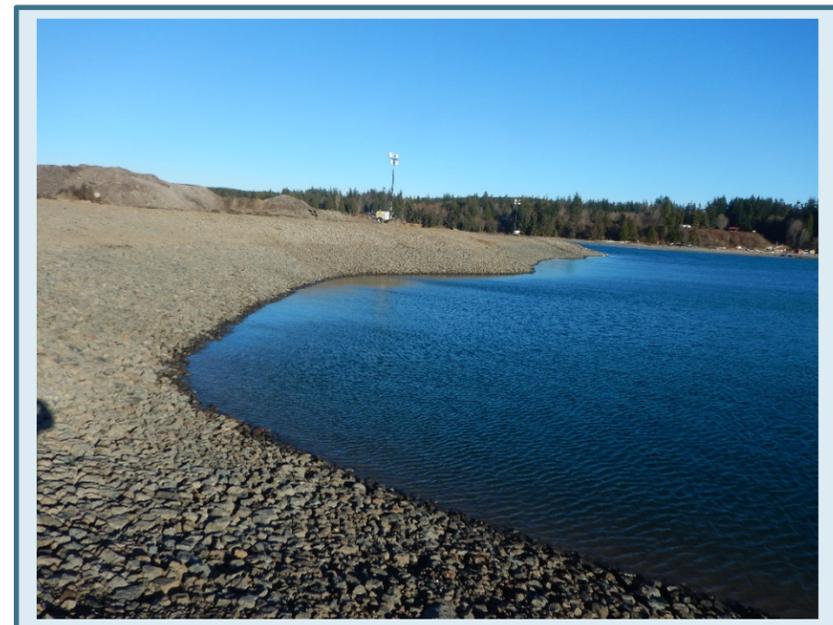
Post-Armor Placement Former Pier 4 Area Shoreline

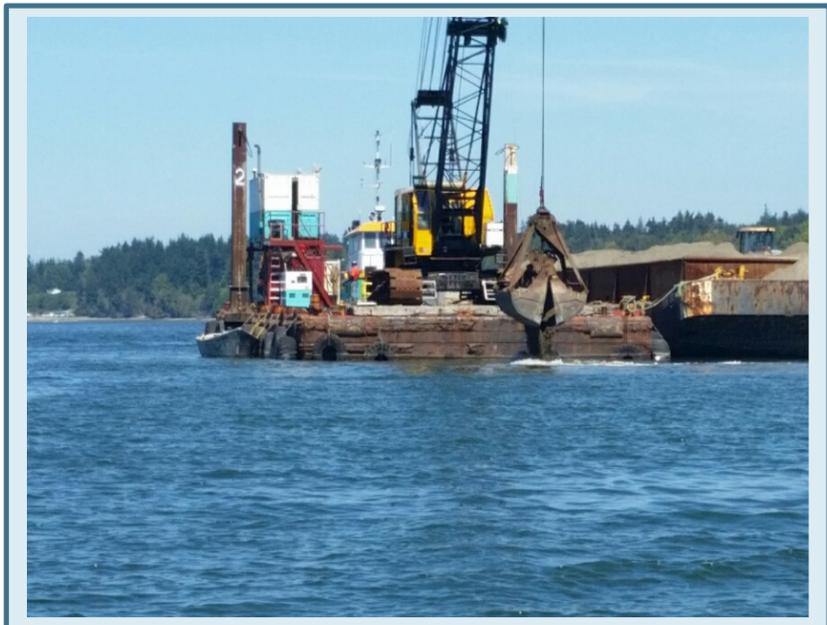
EMNR Placement in SMA-3

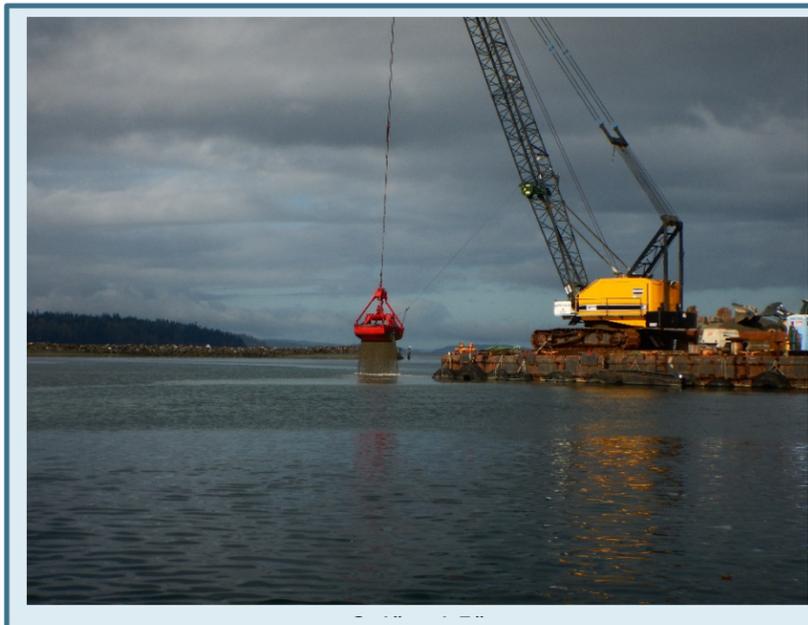
Subtidal Cap Filter Layer Placement in SMA-1

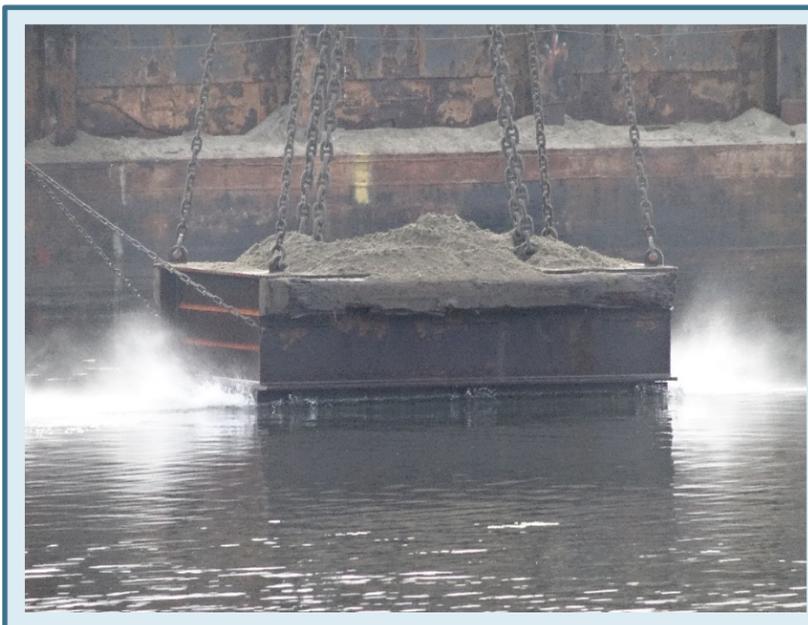
SMA-2 Subtidal Cap Placement – Bombay Box

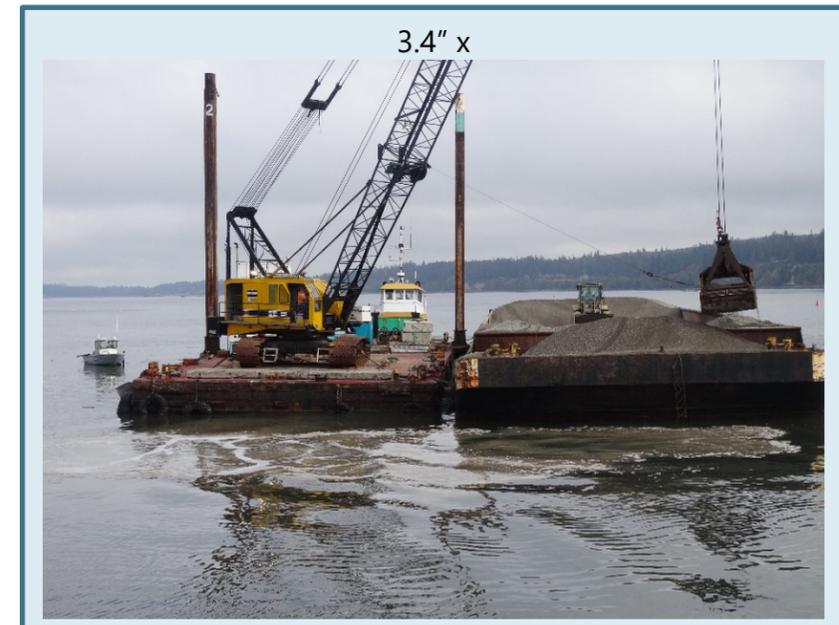
Subtidal Cap Placement in SMA-1 and Water Quality Monitoring

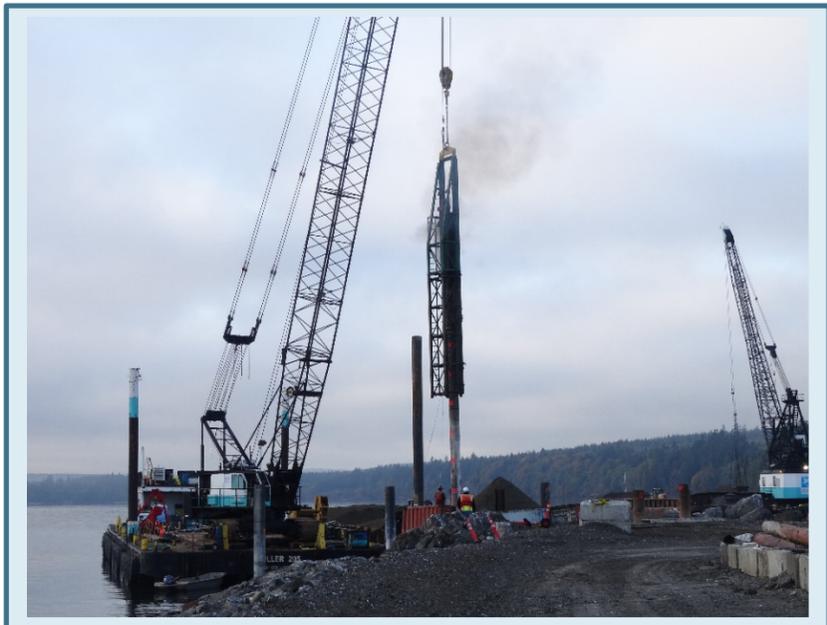
Installation of Temporary Pilings for Transload Extension

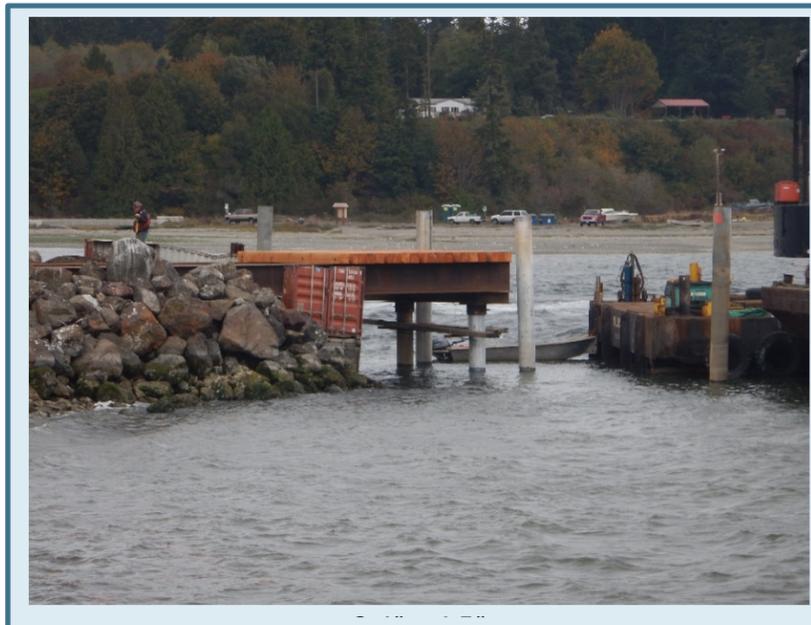
Completed Trestle at Transload Facility for Increased Barge Draft

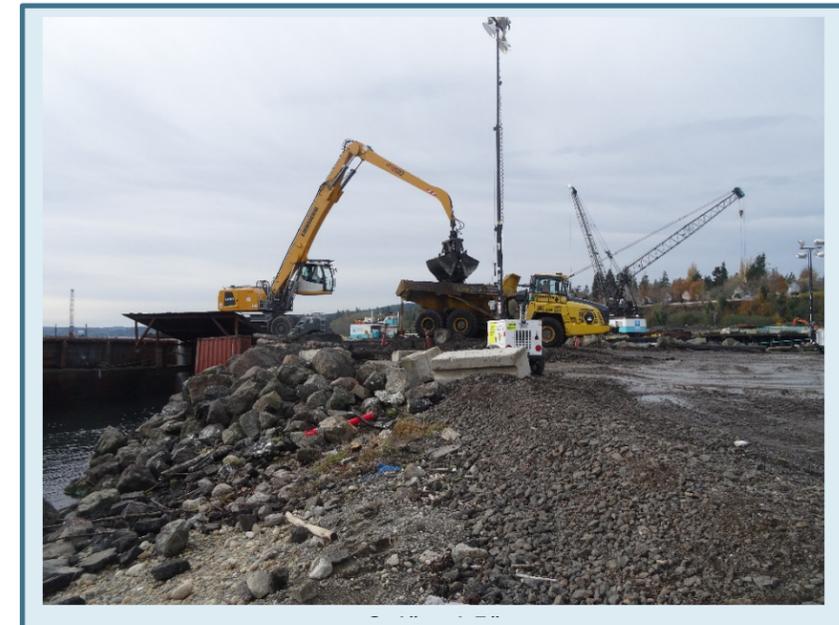
Transload Facility with Trestle, Material Handler, and Spill Apron

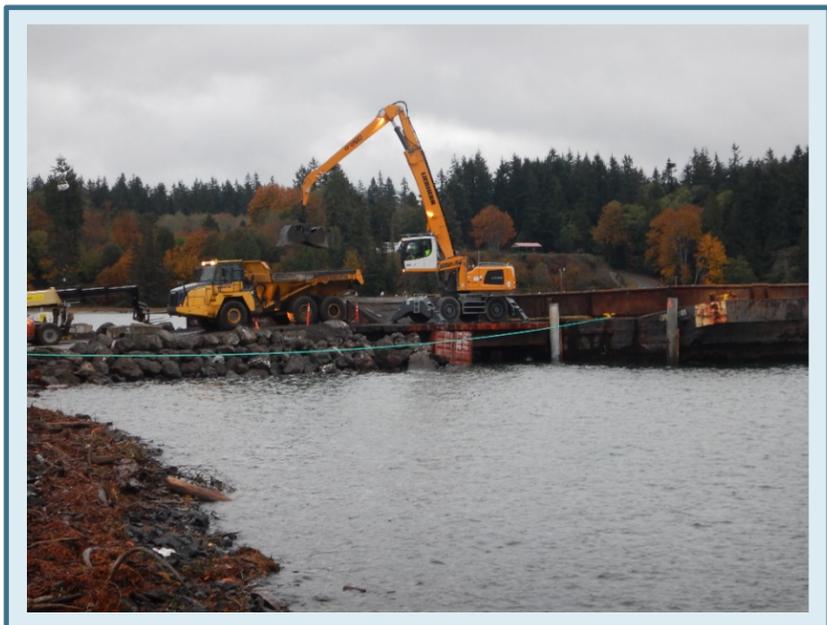
Dredge Material Barge Offloading with Liebherr Material Handler

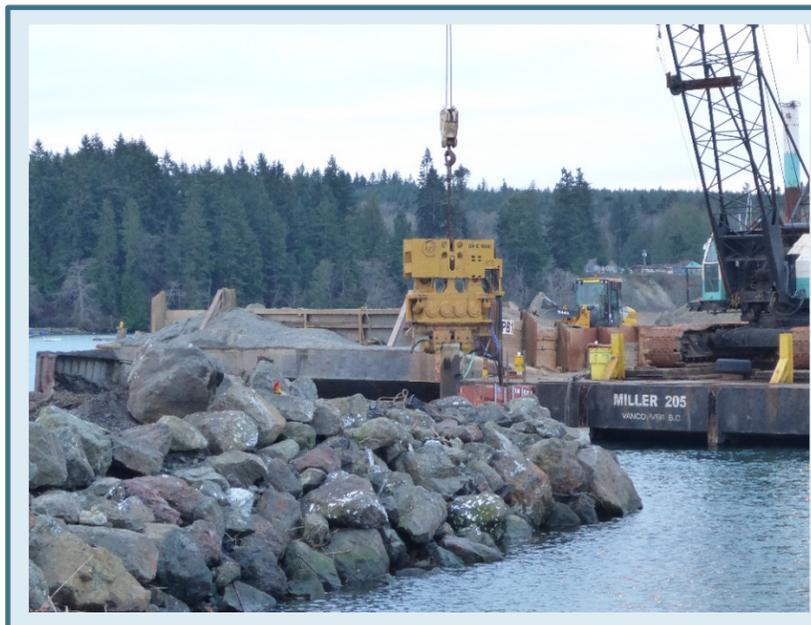
Removal of Transload Trestle and Temporary Pilings

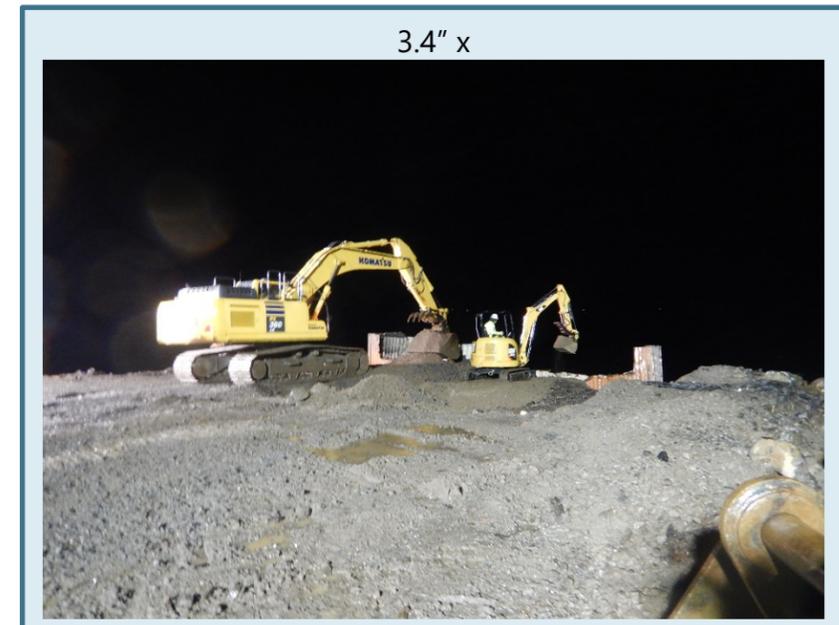
Removal of Temporary Bulkhead at Transload Facility
