LOWER DISPOSAL AREA – INTERCEPTOR TRENCH PROJECT

CONSTRUCTION SUMMARY REPORT

RAVENSDALE SITE

January 8, 2014

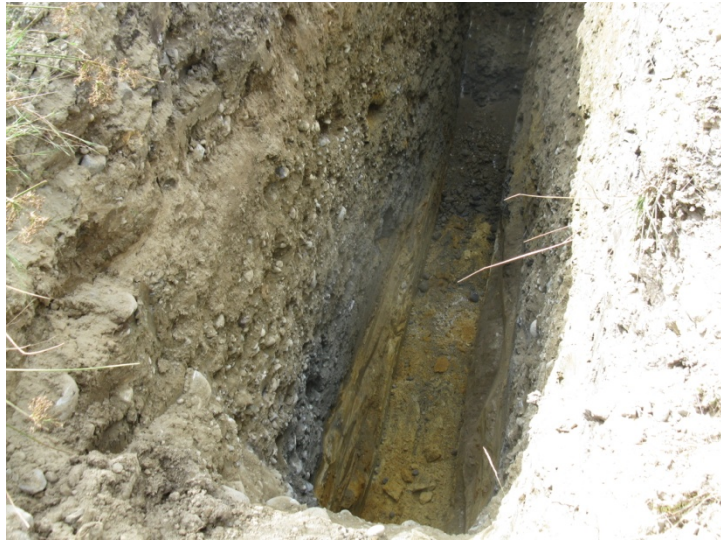
Sandstone/weathered bedrock located near piezometer B-11.

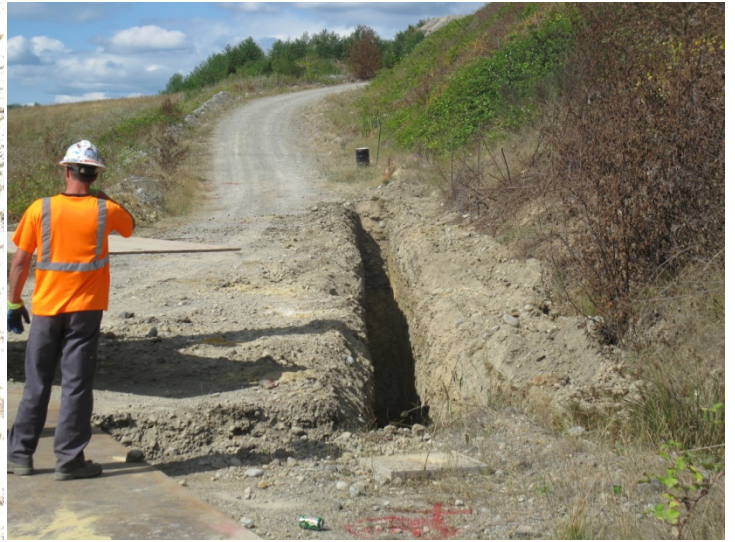
North section of interceptor trench.

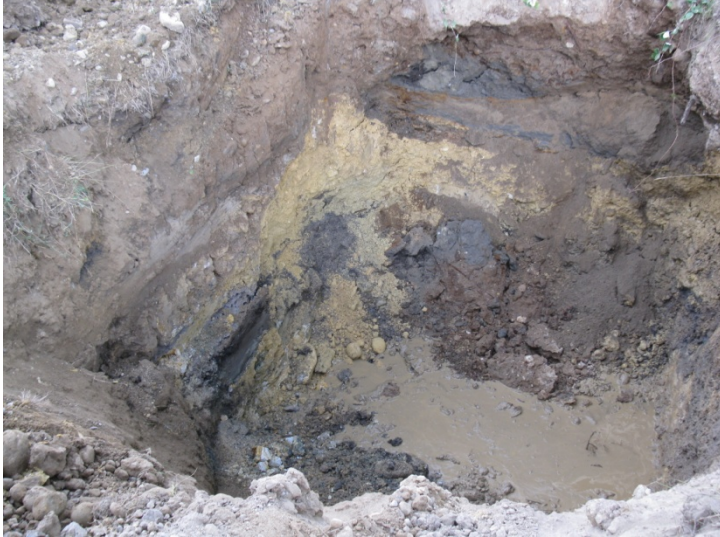
3:10pm move over to test pit #2 to remove a little more material out of north wall of excavation to expose more of gravel lens. Excavation walls very unstable and large collapse's occurred while we were digging. Gravel lens changes from gray to black in color as we dig deeper into north wall but is still loose gravel lens. On east wall gravel lens about 2' thick, after another 1'-2' of material was taken from north wall lens reduced to 3" to 6" and digging was stopped, majority of lens now exposed.

North-west corner of test pit #2 today

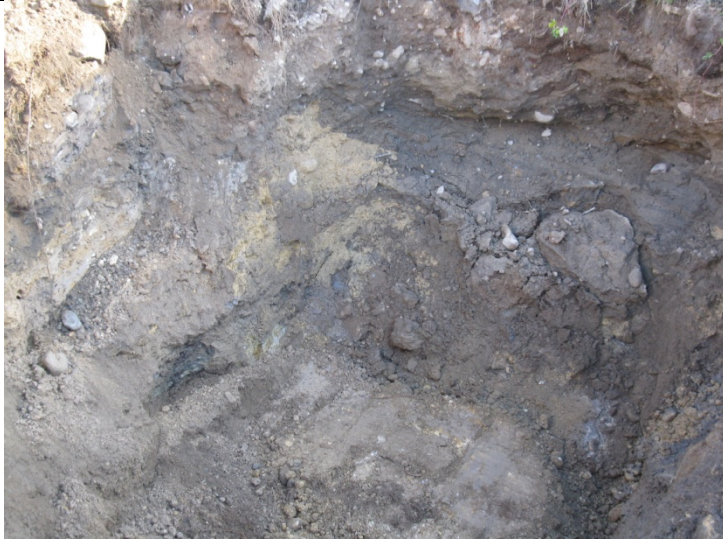
Shift started today with contractor removing sluff that had fallen into t.p. 2 drainage sump. Water producing gravel lens was exposed again and weathered bedrock (orange mottled sandstone) below it. Elevation of trench for t.p. 2 that was dug on 9/7/13 appears to be close to the bottom of gravel lens. Vanessa Rayner field engineer onsite observed trench depth and gravel lens and her opinion was that trench depth/HDPE pipe depth was adequate for drainage. Contractor placed 1'-2' of dry fill into bottom of t.p. 2 and bucket tapped soil into place to raise subgrade to bottom of gravel lens. A piece of 12oz geotextile was then placed across bottom of pit.

Bottom of test pit #2 and water producing gravel lens.

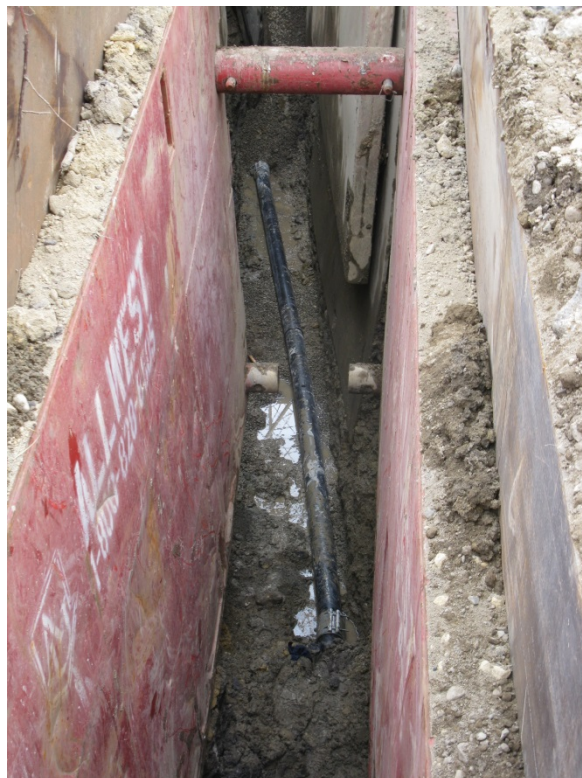
PHOTO 16

HDPE pipe connections at the interceptor trench-plug zone transition with Romac Industries Armor Lock Restraint Couplers and Stiffeners (looking southwest).

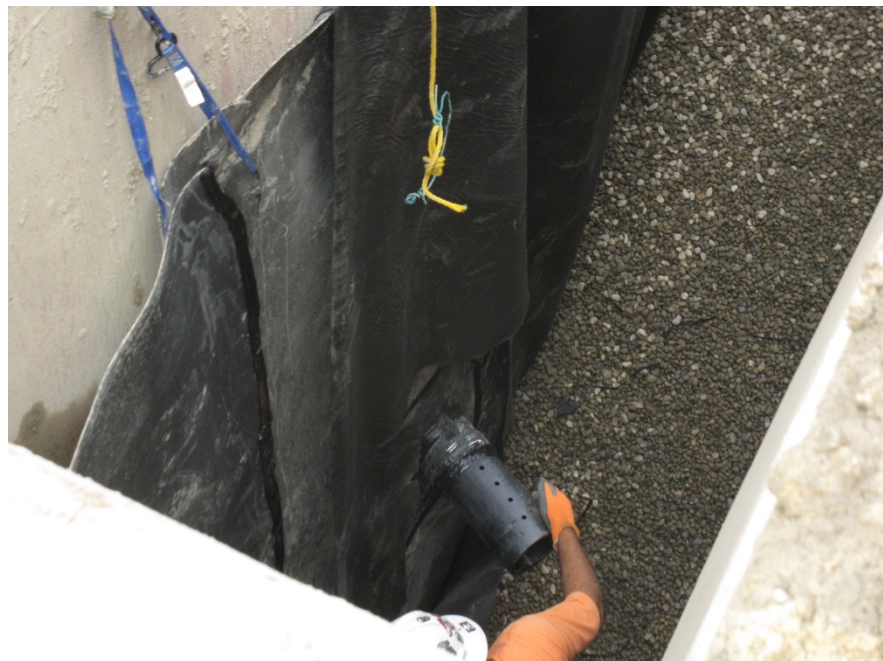
PHOTO 18

TP-2 trench HDPE pipe penetration into main interceptor trench (looking north).

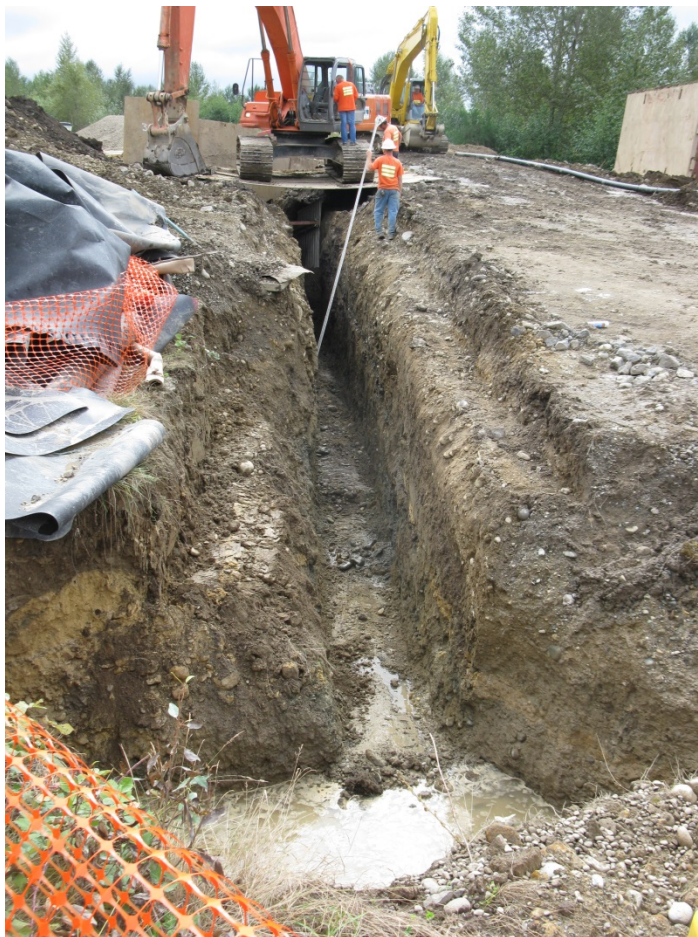
Excavation of TP-2 trench; note seepage in TP-2 in foreground (looking south).
